DEFENDER - VIN: 412051 >

Electrical Reference Library (1a)

JLR 16 25 21\_IE

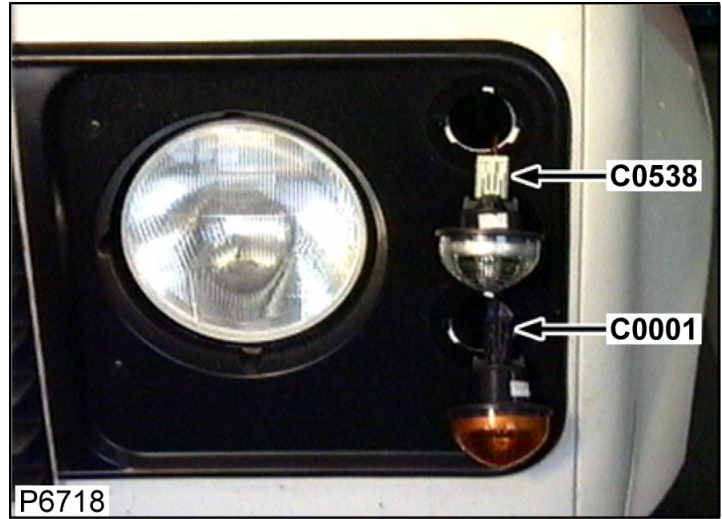
Description: **Turn signal indicator/ hazard warning lamp-Front LH**

Cavities: **2WY**

Harness: **WING LH HARNESS**

CAV	TERMINAL	CSA	COL	CCT	DESTN
1	YPLI0062	0.5D	B	499	CTAP
2	AFU3802	0.75D	GR	499	CI265

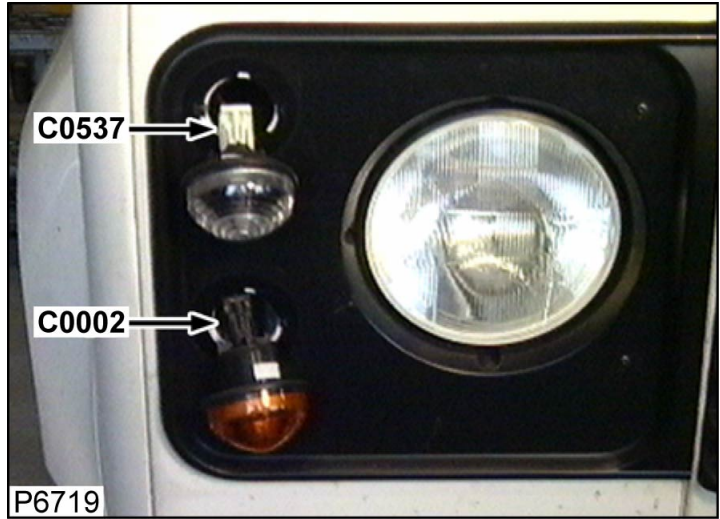
Description: **Turn signal indicator/ hazard warning lamp-Front RH**

Cavities: **2WY**

Harness: **WING RH HARNESS**

CAV	TERMINAL	CSA	COL	CCT	DESTN
1	AFU3802	1.0D	B	107	CTAP
1	AFU3802	1.0D	B	896	CTAP
1	YPL10062	0.5D	B	897	CTAP
1	AFU3802	1.0D	B	898	CTAP
2	AFU3802	0.75D	GW	499	CI267

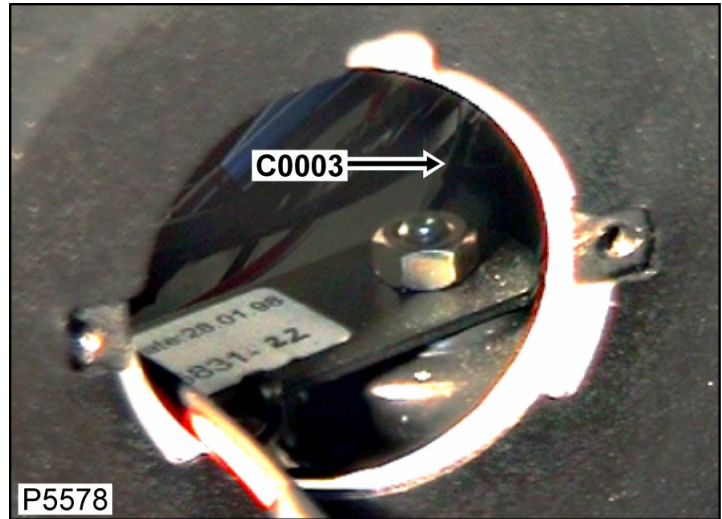
Cavities: **2WY**

Harness: **WING LH HARNESS**

CAV	TERMINAL	CSA	COL	CCT	DESTN
1	YPL101510	0.75D	B	896	C0013
2	YPL101510	0.75D	PB	896	C1265

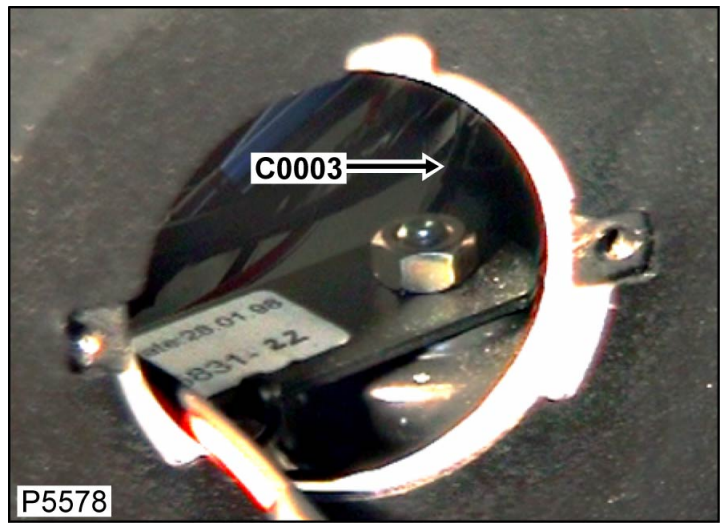
**Harness: WING LH HARNESS**

CAV	TERMINAL	CSA	COL	CCT	DESTN
1	YPL101510	0.75D	B	896	C0013
2	YPL101510	0.75D	PB	896	C1265

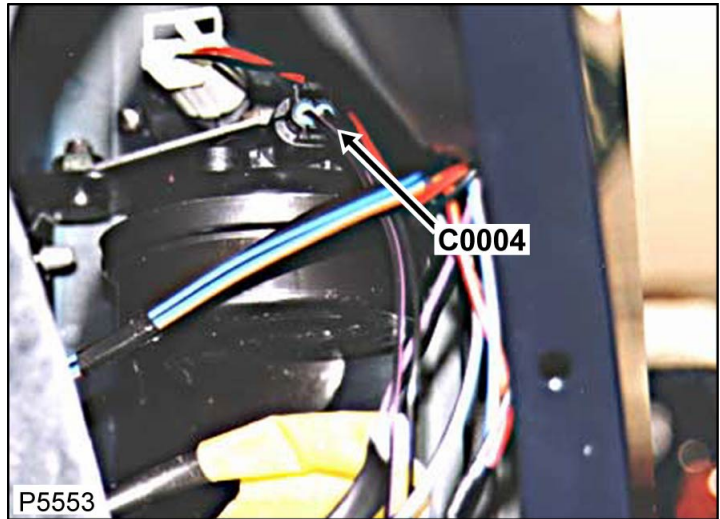
Cavities: **2WY**

Harness: **WING RH HARNESS**

CAV	TERMINAL	CSA	COL	CCT	DESTN
1	YPL101510	0.75D	B	107	C0012
1	YPL101510	0.75D	B	896	C0012
1	YPL101510	0.75D	B	898	C0012
2	YPL101510	0.75D	PB	899	CI267

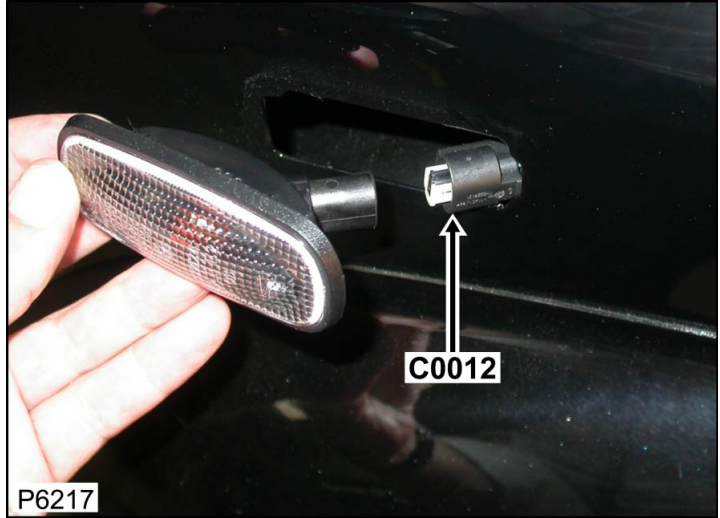
Cavities: **2WY**

Harness: **WING RH HARNESS**

CAV	TERMINAL	CSA	COL	CCT	DESTN
1	YPL101510	0.75D	GW	499	CTAP
2	YPL101510	0.75D	B	107	C0004
2	YPL101510	0.75D	B	896	C0004
2	YPL101500	0.5D	B	897	CTAP
2	YPL101510	0.75D	B	898	C0004

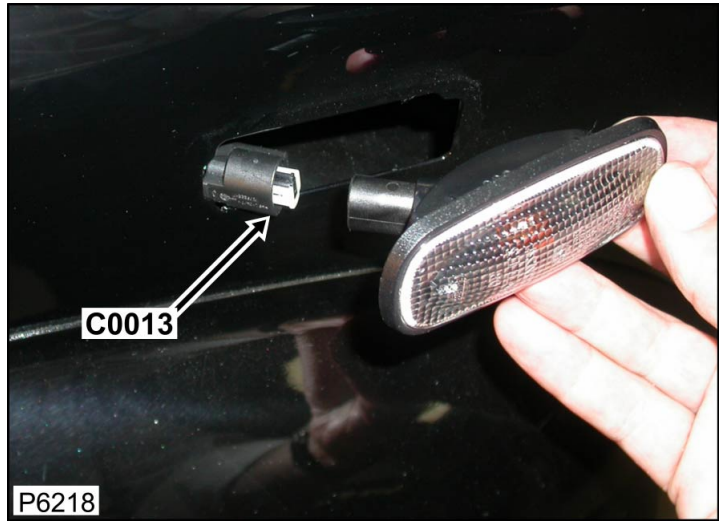
Cavities: **2WY**

Harness: **WING LH HARNESS**

CAV	TERMINAL	CSA	COL	CCT	DESTN
1	YPL101510	0.75D	GR	499	S/JOINT CTAP A104
2	YPL101510	0.75D	B	896	C0003
2	YPL101510	0.75D	B	897	C1873

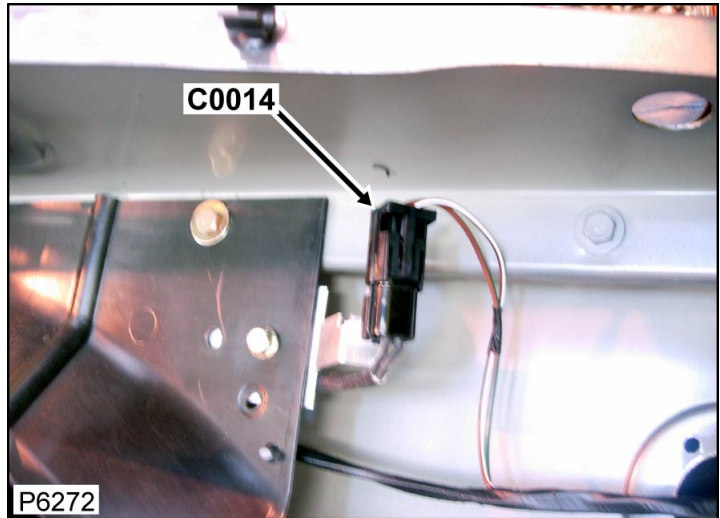
Cavità: **2WY**

Cablaggio: **WING RH HARNESS**

CAV	TERMINAL	CSA	COL	CCT	DESTN
1	AFU3802	1.5D	NW	765	C1267
2	AFU3802	1.5D	NG	765	C1267

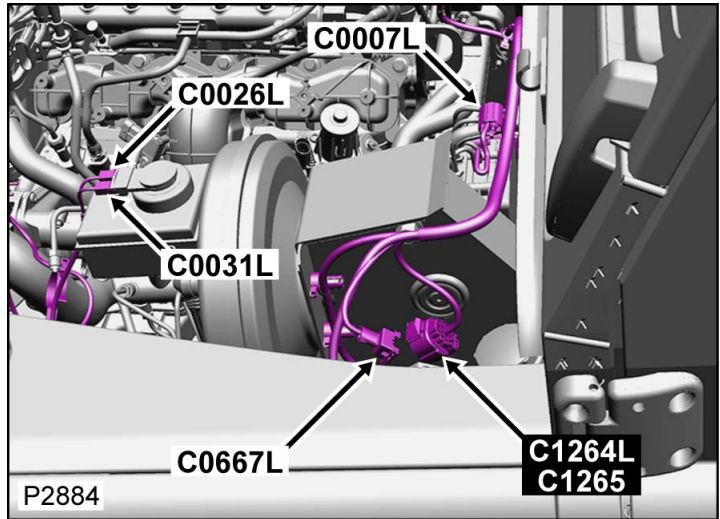
Location: **Rear LH side of engine compartment**

Qualifier: **LHD condition illustrated**

Part No.: **ADU8339**

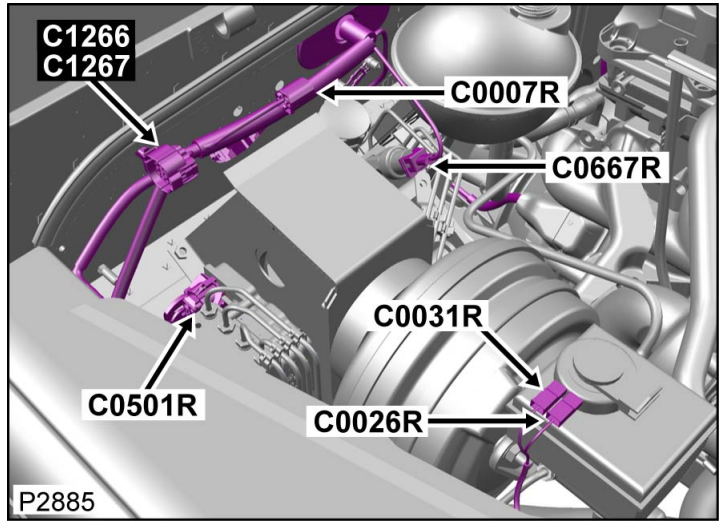
Location: **Rear RH side of engine compartment**

Qualifier: **RHD condition illustrated**

Part No.: **ADU8339**

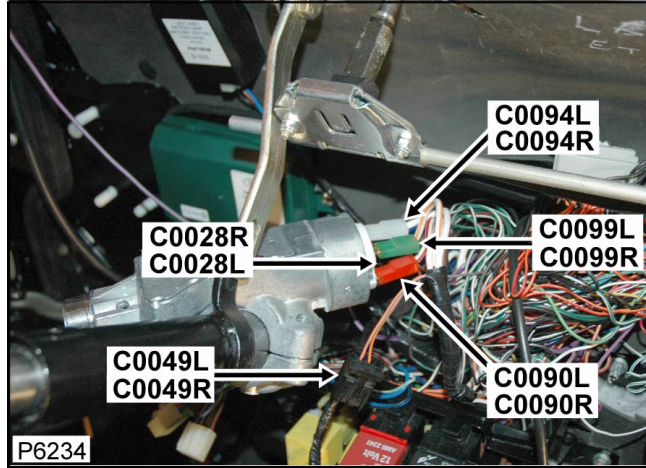
Cavities: **IWY**

Harness: **MAIN LH + RH HARNESS**

CAV	TERMINAL	CSA	COL	CCT	DESTN
I	YPLI0096	6.0D	NW	I39L	C3762

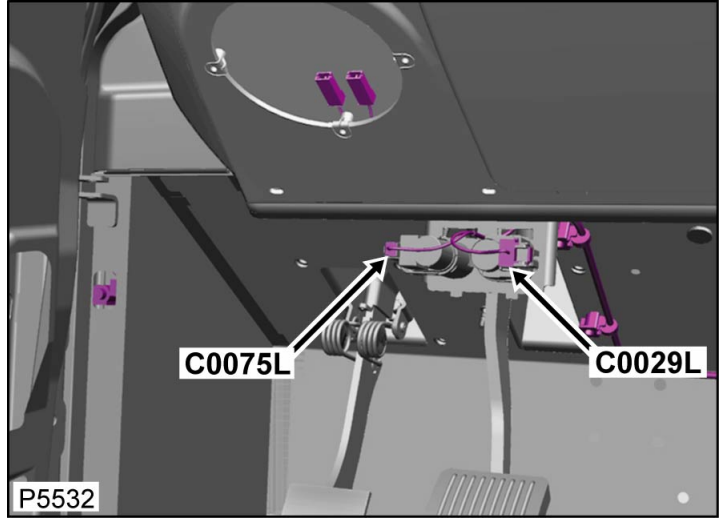
Cavities: **2WY**

Harness: **MAIN LH + RH HARNESS**

CAV	TERMINAL	CSA	COL	CCT	DESTN
1	YPL10036	0.5D	B	139L	S/JOINT SJ18
2	YPL10036	0.5D	BR	139L	C0872

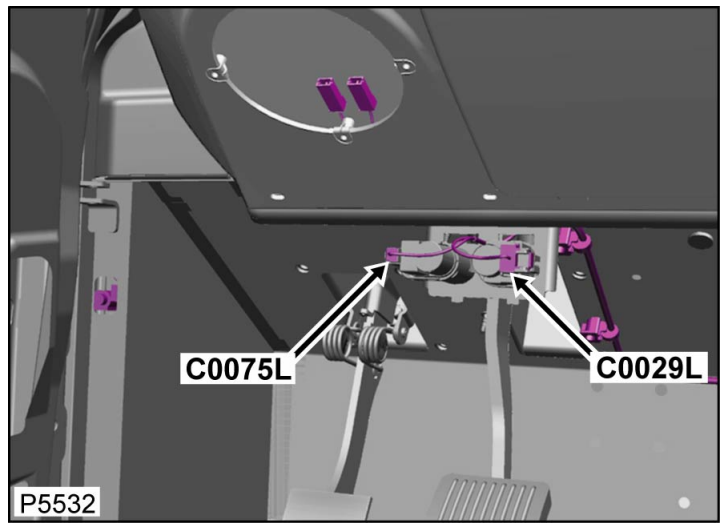
**Harness: MAIN LH + RH HARNESS**

CAV	TERMINAL	CSA	COL	CCT	DESTN
1	YPL10036	0.5D	B	139L	S/JOINT SJ18
2	YPL10036	0.5D	BR	139L	C0872

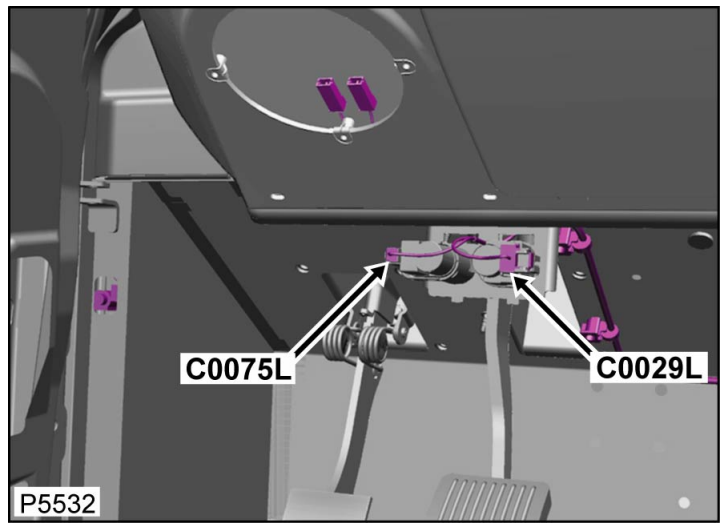
**Harness: MAIN LH + RH HARNESS**

CAV	TERMINAL	CSA	COL	CCT	DESTN
1	YPL10036	0.5D	B	139L	S/JOINT SJ18
2	YPL10036	0.5D	BR	139L	C0872

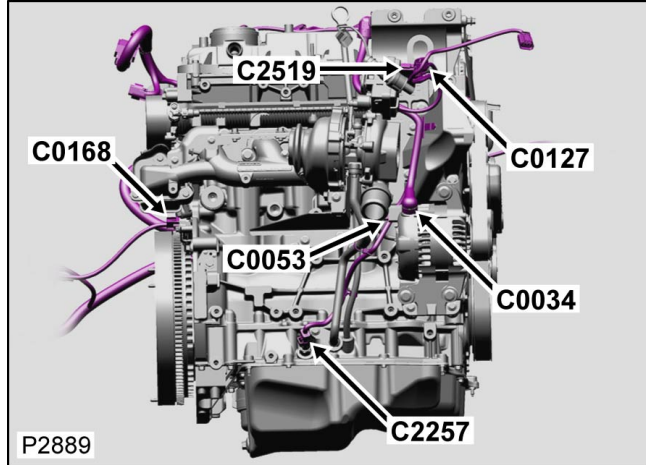
Cavities: **IWY**

Harness: **ENGINE DIESEL HARNESS**

CAV	TERMINAL	CSA	COL	CCT	DESTN
I	-	25.0	R	254	C0178

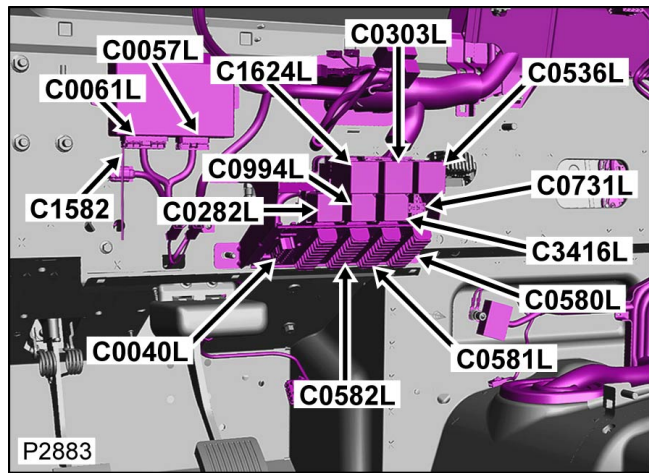
Cavities: **16WY**

**Harness: MAIN LH + RH HARNESS**

CAV	TERMINAL	CSA	COL	CCT	DESTN
4	YPLI0108	0.5D	B	139L	S/JOINT SJ46
5	YPLI0108	0.5D	B	139L	S/JOINT SJ46
6	YPLI0108	0.5D	UB	151L	S/JOINT SJ6
6	YPLI0108	0.5D	UB	9	S/JOINT SJ6
8	YPLI0108	0.5D	OLG	22L	C0061L
14	YPLI0108	0.5D	GB	151L	S/JOINT SJ5
14	YPLI0108	0.5D	GB	9	S/JOINT SJ5
16	YPLI0108	0.5D	PN	22L	C0287

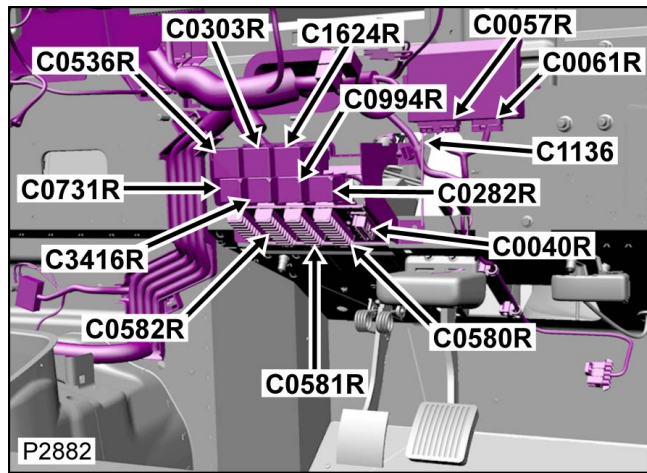
Cavities: **16WY**

**Harness: MAIN LH + RH HARNESS**

CAV	TERMINAL	CSA	COL	CCT	DESTN
4	YPLI0108	0.5D	B	200R	S/JOINT SJ66
5	YPLI0108	0.5D	B	200R	S/JOINT SJ66
6	YPLI0108	0.5D	UB	151R	S/JOINT SJ9
6	YPLI0108	0.5D	UB	10	S/JOINT SJ9
8	YPLI0108	0.5D	OLG	22R	C0061R
14	YPLI0108	0.5D	GB	151R	S/JOINT SJ10
14	YPLI0108	0.5D	GB	10	S/JOINT SJ10
16	YPLI0108	0.5D	PN	22R	C0287

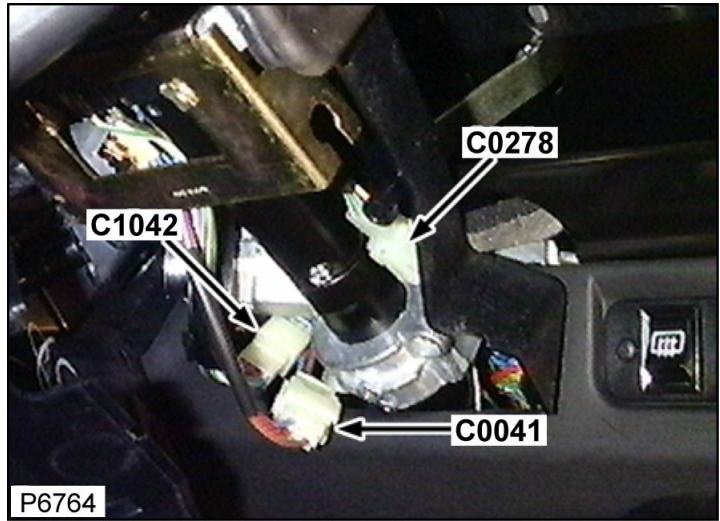
Location: **Underside of steering column**

CAV	TERMINAL	CSA	COL	CCT	DESTN
1	AFU3725	2.5D	NU	200R	C3764
2	AFU3567	1.5D	R	200R	C0581R
4	AFU3725	2.5D	U	200R	C3764

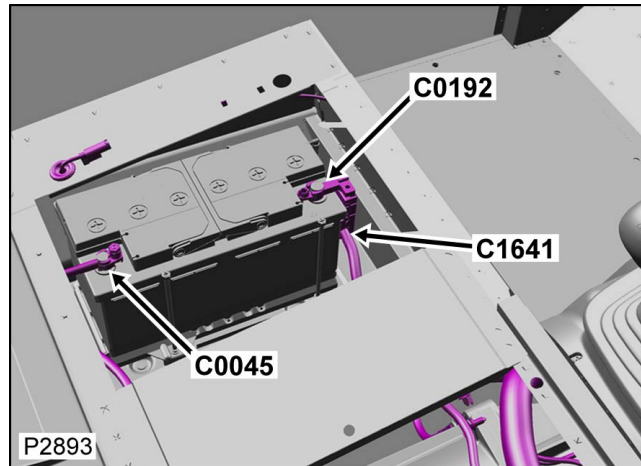
Location: **Beneath LH Front seat**

CAV	TERMINAL	CSA	COL	CCT	DESTN
I	-	50.0D	B	499	CI66I

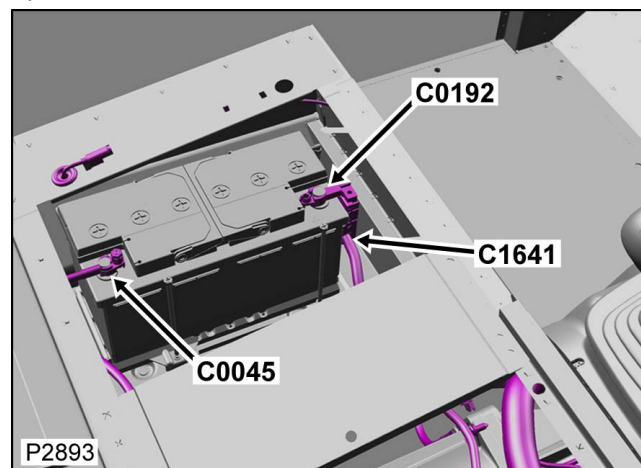
Location: **Beneath LH Front seat**

CAV	TERMINAL	CSA	COL	CCT	DESTN
I	-	50.0D	B	499	CI66I

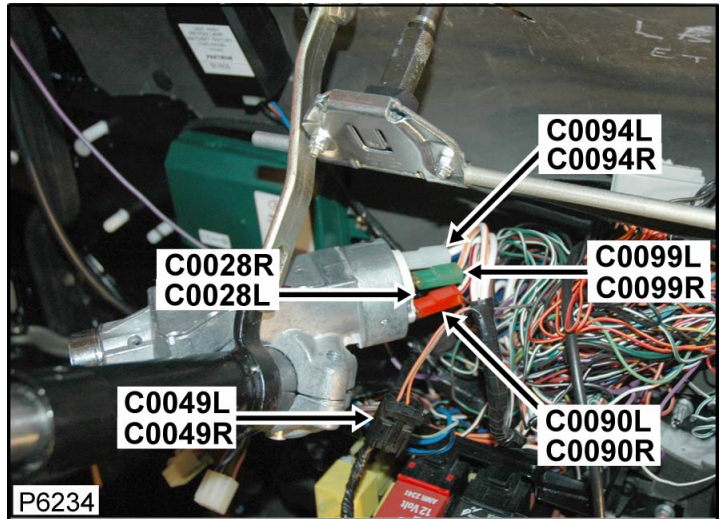
Cavities: **2WY**

Harness: **MAIN LH + RH HARNESS**

CAV	TERMINAL	CSA	COL	CCT	DESTN
1	YPL10062	0.5D	OG	22L	C0057L
2	YPL10062	0.5D	OP	22L	C0057L

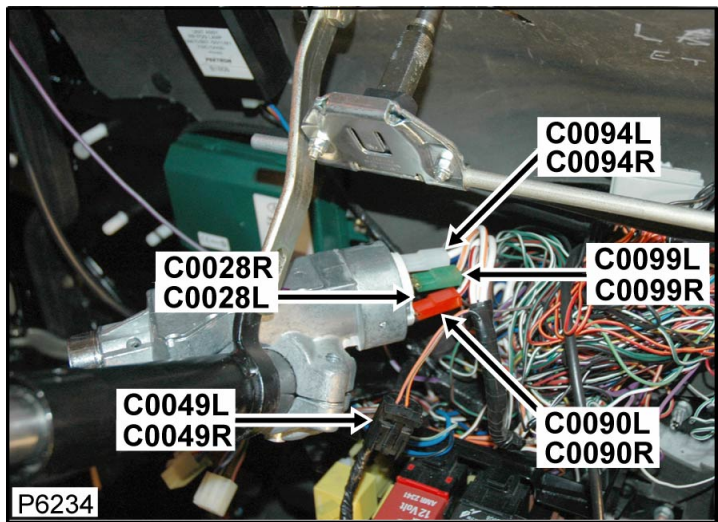
Cavities: **2WY**

Harness: **MAIN LH + RH HARNESS**

CAV	TERMINAL	CSA	COL	CCT	DESTN
1	YPL10062	0.5D	OG	22L	C0057L
2	YPL10062	0.5D	OP	22L	C0057L

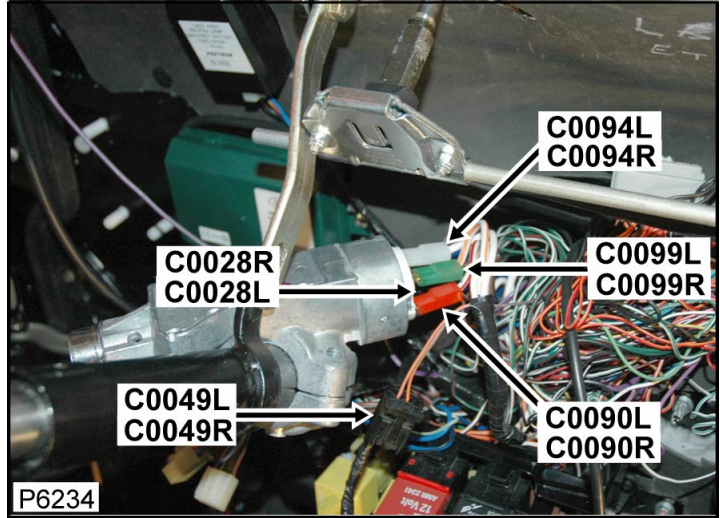
Cavities: **2WY**

Harness: **MAIN LH + RH HARNESS**

CAV	TERMINAL	CSA	COL	CCT	DESTN
1	YPL10062	0.5D	OG	22R	C0057R
2	YPL10062	0.5D	OP	22R	C0057R

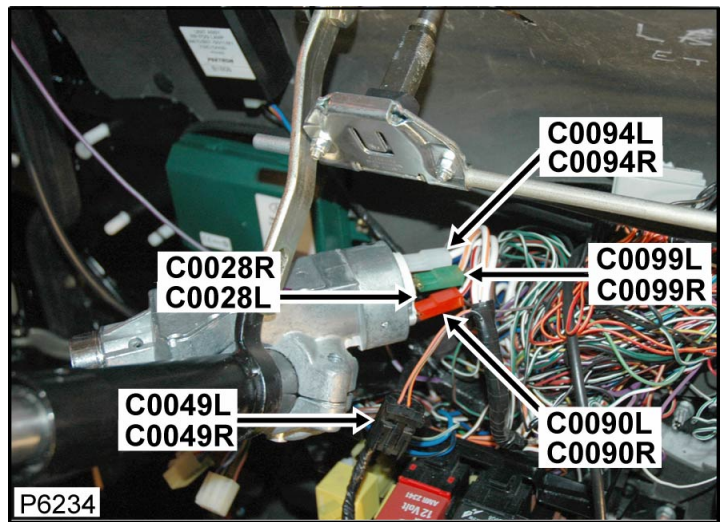
Cavities: **2WY**

Harness: **MAIN LH + RH HARNESS**

CAV	TERMINAL	CSA	COL	CCT	DESTN
1	YPL10062	0.5D	OG	22R	C0057R
2	YPL10062	0.5D	OP	22R	C0057R

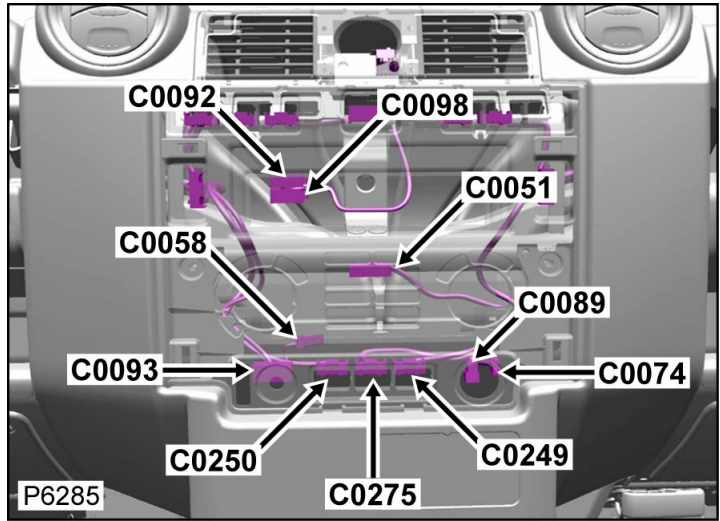
Location: **Instrument panel-Center**

CAV	TERMINAL	CSA	COL	CCT	DESTN
1	AFU3752	0.5D	B	499	S/JOINT SJ13
2	AFU3752	0.5D	RO	499	S/JOINT SJ68

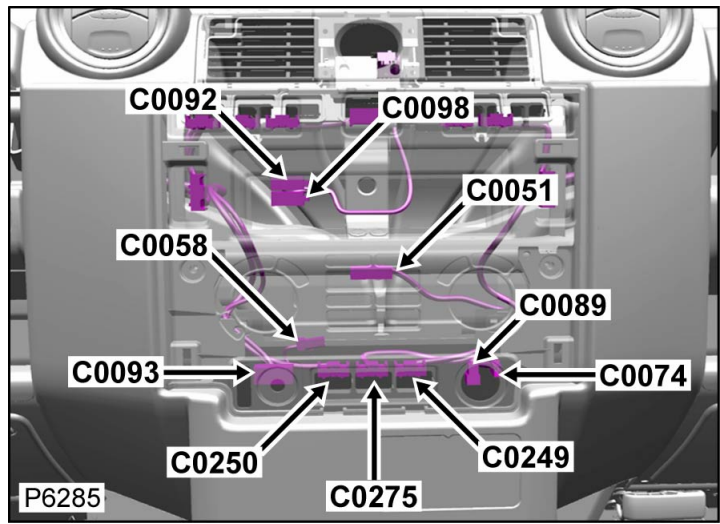
Cavities: **2WY**

Harness: **MAIN LH + RH HARNESS**

CAV	TERMINAL	CSA	COL	CCT	DESTN
1	AFU3752	0.5D	B	499	S/JOINT SJ13
2	AFU3752	0.5D	RO	499	S/JOINT SJ68

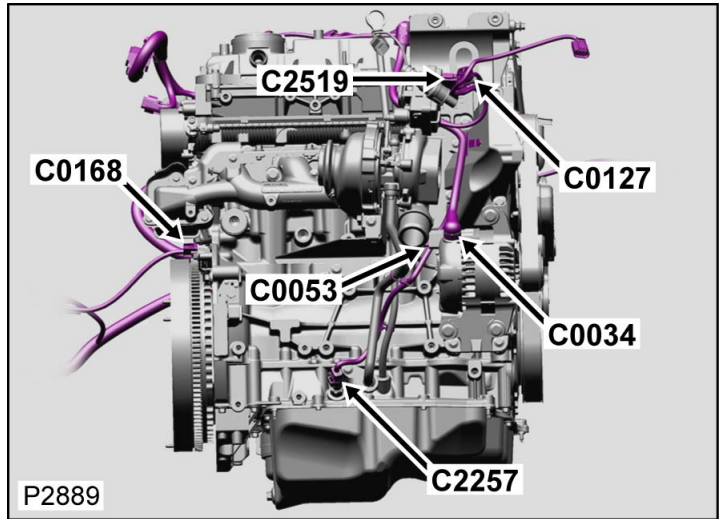
Cavities: **2WY**

Harness: **ENGINE DIESEL HARNESS**

CAV	TERMINAL	CSA	COL	CCT	DESTN
1	YPL102200	0.5	G	254	C0411

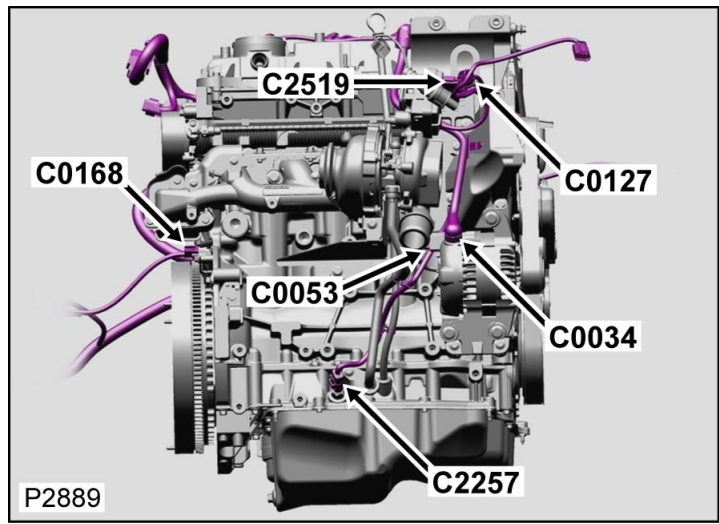
**Cavities: 2WY**

**Harness: ENGINE DIESEL HARNESS**

CAV	TERMINAL	CSA	COL	CCT	DESTN
I	YPL102200	0.5	G	254	C0411

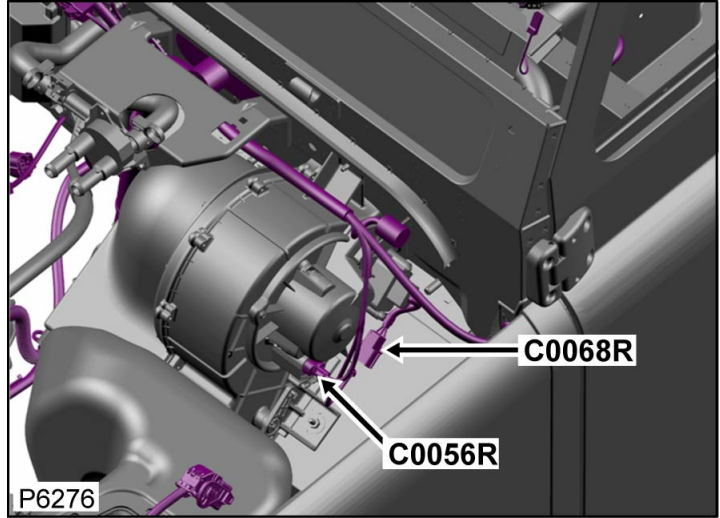
Cavities: **2WY**

Harness: **MAIN LH + RH HARNESS**

CAV	TERMINAL	CSA	COL	CCT	DESTN
1	YPJ900040	2.5D	NR	200R	S/JOINT SJ25
2	YPJ900040	2.5D	O	200R	C0582R

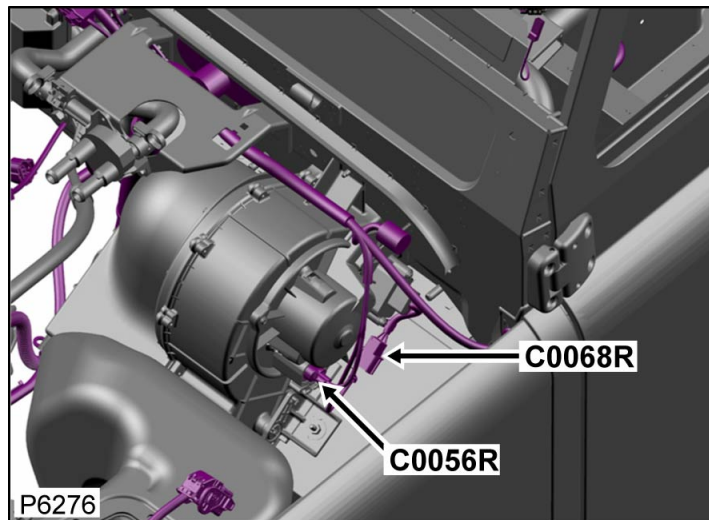
**Cavities: 2WY**

**Harness: MAIN LH + RH HARNESS**

CAV	TERMINAL	CSA	COL	CCT	DESTN
1	YPJ900040	2.5D	NR	200R	S/JOINT SJ25
2	YPJ900040	2.5D	O	200R	C0582R

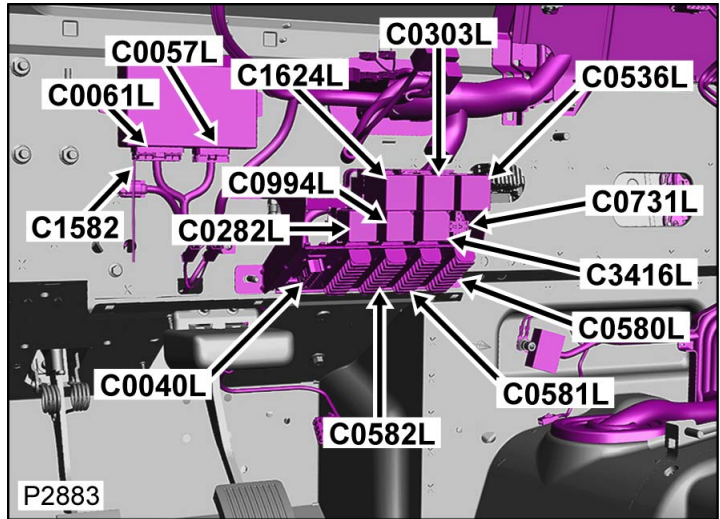
Cavities: **12WY**

Harness: **MAIN LH + RH HARNESS**

CAV	TERMINAL	CSA	COL	CCT	DESTN
1	AFU3752	0.5D	GW	139L	C0287
2	AFU3753	1.0D	O	767L	S/JOINT SJ77
3	AFU3753	1.0D	K	767L	S/JOINT SJ78
4	AFU3752	0.5D	K	22L	C1040L
5	AFU3752	0.5D	OW	22L	C0286
6	AFU3752	0.5D	GR	22L	C0287
7	AFU3752	0.5D	OG	22L	C0049L
8	AFU3753	1.0D	PN	139L	S/JOINT SJ77A
11	AFU3753	1.0D	B	768L	C0807
12	AFU3752	0.5D	OP	22L	C0049L

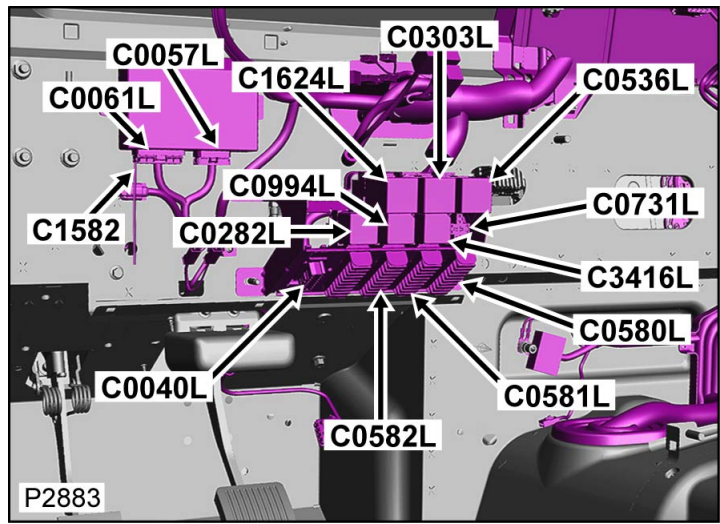
**Cavities: 12WY**

**Harness: MAIN LH + RH HARNESS**

CAV	TERMINAL	CSA	COL	CCT	DESTN
1	AFU3752	0.5D	GW	139L	C0287
2	AFU3753	1.0D	O	767L	S/JOINT SJ77
3	AFU3753	1.0D	K	767L	S/JOINT SJ78
4	AFU3752	0.5D	K	22L	C1040L
5	AFU3752	0.5D	OW	22L	C0286
6	AFU3752	0.5D	GR	22L	C0287
7	AFU3752	0.5D	OG	22L	C0049L
8	AFU3753	1.0D	PN	139L	S/JOINT SJ77A
11	AFU3753	1.0D	B	768L	C0807
12	AFU3752	0.5D	OP	22L	C0049L

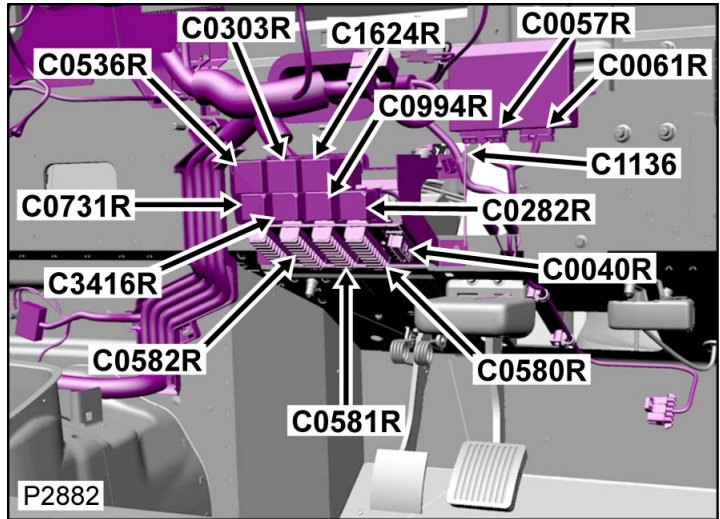
Location: **Behind RH side of Instrument panel**

Qualifier: **RHD condition illustrated**

Part No.: **YPCI0531**

Colour: **GREEN**

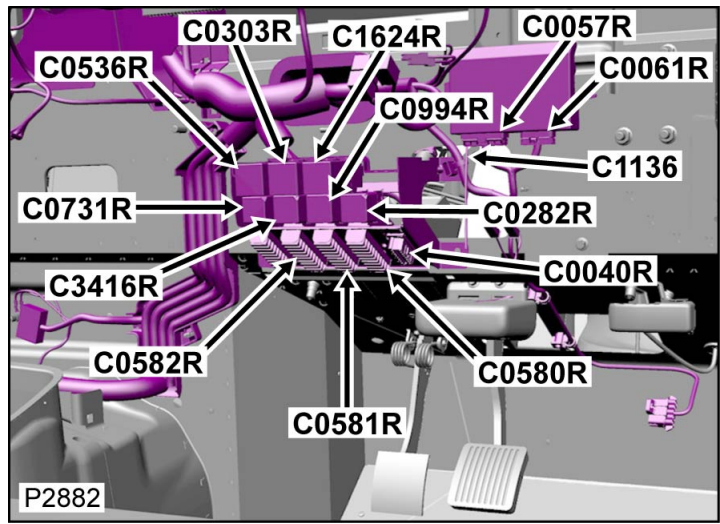
**Cavities: 12WY**

**Harness: MAIN LH + RH HARNESS**

CAV	TERMINAL	CSA	COL	CCT	DESTN
1	AFU3752	0.5D	GW	22R	C0287
2	AFU3753	0.75D	O	767R	S/JOINT SJ77
3	AFU3753	0.75D	K	767R	S/JOINT SJ78
4	AFU3752	0.5D	K	22R	C1040R
5	AFU3752	0.5D	OW	22R	C0286
6	AFU3752	0.5D	GR	22R	C0287
7	AFU3752	0.5D	OG	22R	C0049R
8	AFU3753	1.0D	PN	200R	S/JOINT SJ126
11	AFU3753	1.0D	B	768R	C0807
12	AFU3752	0.5D	OP	22R	C0049R

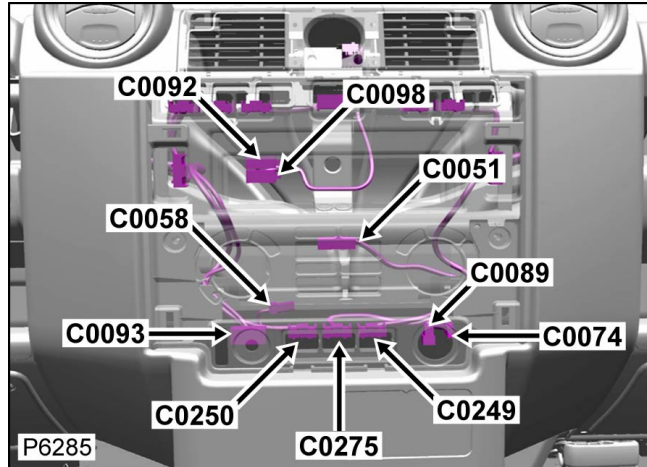
Cavities: **5WY**

Harness: **MAIN LH + RH HARNESS**

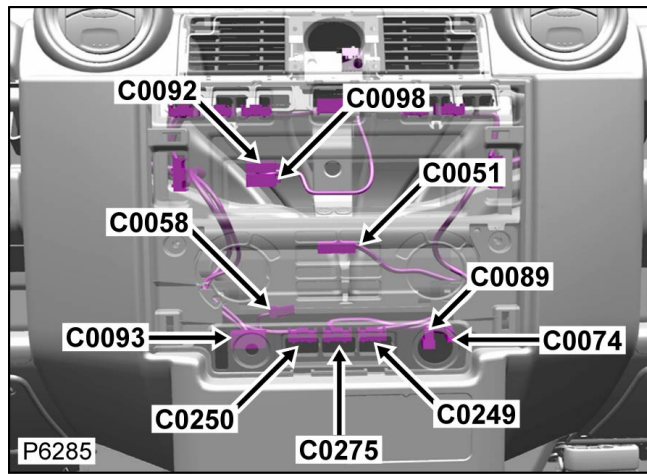
Cavities: **5WY**

**Harness: MAIN LH + RH HARNESS**

CAV	TERMINAL	CSA	COL	CCT	DESTN
1	YPL801750	2.0D	B	499	S/JOINT SJ13
2	YPL801740	1.0D	NR	14L	S/JOINT SJ26
2	YPL801740	1.0D	NR	14R	S/JOINT SJ27
2	YPL801740	1.0D	U	153R	C0068R
2	YPL801740	1.0D	U	153L	C0068L
4	YPL801750	1.5D	BN	139L	C0068L
4	YPL801750	1.5D	BN	200R	C0068R
5	YPL801750	2.5D	NR	139L	S/JOINT SJ24
5	YPL801750	2.5D	NR	200R	S/JOINT SJ25

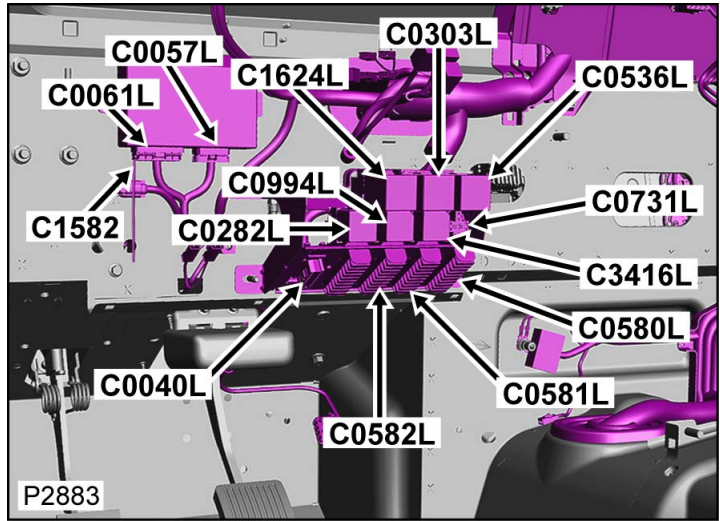
Cavities: **26WY**

Harness: **MAIN LH + RH HARNESS**

CAV	TERMINAL	CSA	COL	CCT	DESTN
1	AFU3752	0.5D	PW	22L	C0488
3	YPL10036	0.5D	WB	22L	C0488
5	YPL10036	0.5H	SW	22L	C0266L
7	YPL10036	0.5D	YK	767L	C0459
9	YPL10036	0.5D	OU	22L	C0007L
10	YPL10036	0.5D	WG	768L	C0285
13	AFU3752	0.5D	SCR	22L	C1582
14	AFU3752	0.5D	LGS	254L	C0872
16	YPL10036	0.5D	PU	22L	S/JOINT SJ54
17	YPL10036	0.5D	OLG	22L	C0040L
20	YPL10036	0.5D	BN	22L	C0488
25	AFU3753	1.5D	PN	768L	C0580L
26	AFU3752	0.5D	W	22L	C1136

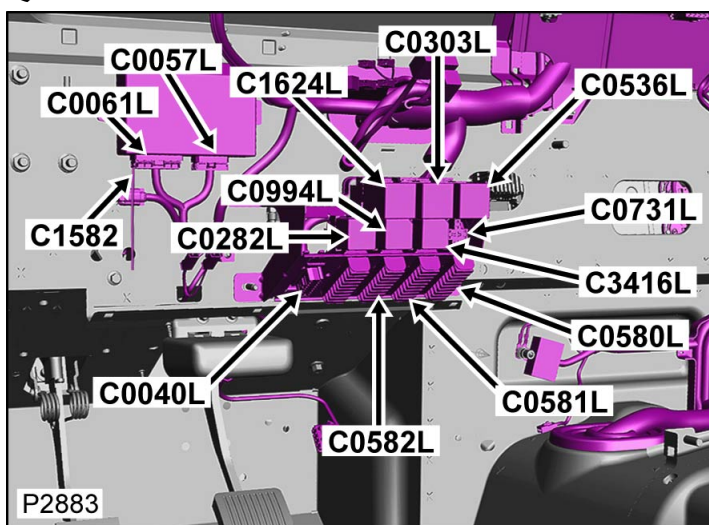
**Qualifier: LHD condition illustrated**

CAV	TERMINAL	CSA	COL	CCT	DESTN
1	AFU3752	0.5D	PW	22L	C0488
3	YPL10036	0.5D	WB	22L	C0488
5	YPL10036	0.5H	SW	22L	C0266L
7	YPL10036	0.5D	YK	767L	C0459
9	YPL10036	0.5D	OU	22L	C0007L
10	YPL10036	0.5D	WG	768L	C0285
13	AFU3752	0.5D	SCR	22L	C1582
14	AFU3752	0.5D	LGS	254L	C0872
16	YPL10036	0.5D	PU	22L	S/JOINT SJ54

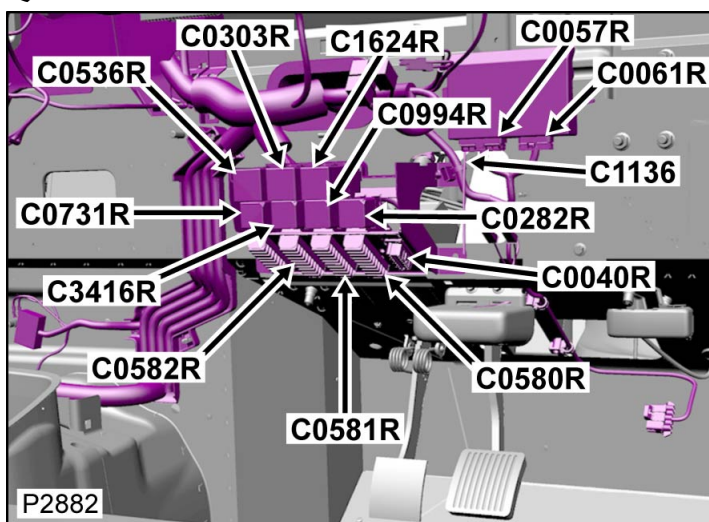
**Qualifier: RHD condition illustrated**

CAV	TERMINAL	CSA	COL	CCT	DESTN
1	AFU3752	0.5D	PW	22R	C0488
3	YPL10036	0.5D	WB	22R	C0488
5	YPL10036	0.5H	SW	22R	C2007
7	YPL10036	0.5D	YK	767R	C0460
9	YPL10036	0.5D	OU	22R	C0007R
10	YPL10036	0.5D	WG	768R	C0285
13	AFU3752	0.5D	SCR	22R	C1582
14	AFU3752	0.5D	LGS	254R	C0872
16	YPL10036	0.5D	PU	22R	S/JOINT SJ54

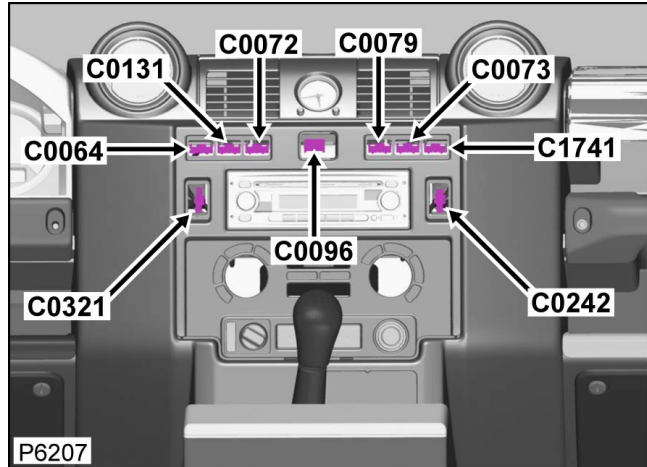
Location: **Instrument panel-Center**

CAV	TERMINAL	CSA	COL	CCT	DESTN
1	AFU3752	0.5D	BS	I39L	C0543
2	AFU3752	0.5D	RO	I39L	C0286
4	AFU3752	0.5D	B	I39L	C0289
5	AFU3752	0.5D	RY	I39L	S/JOINT SJ47

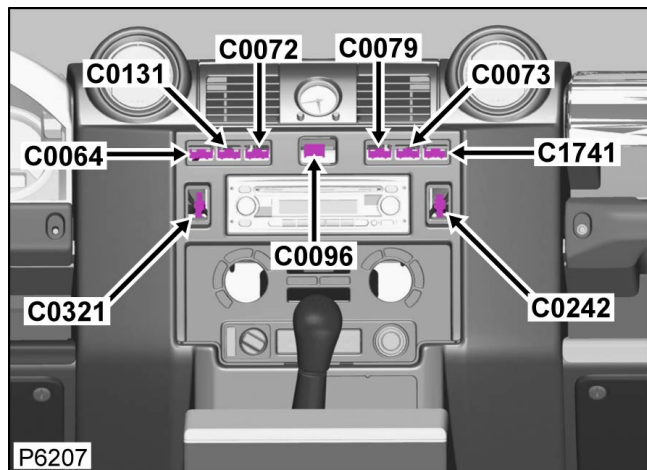
Location: **Instrument panel-Center**

CAV	TERMINAL	CSA	COL	CCT	DESTN
1	AFU3752	0.5D	BS	I39L	C0543
2	AFU3752	0.5D	RO	I39L	C0286

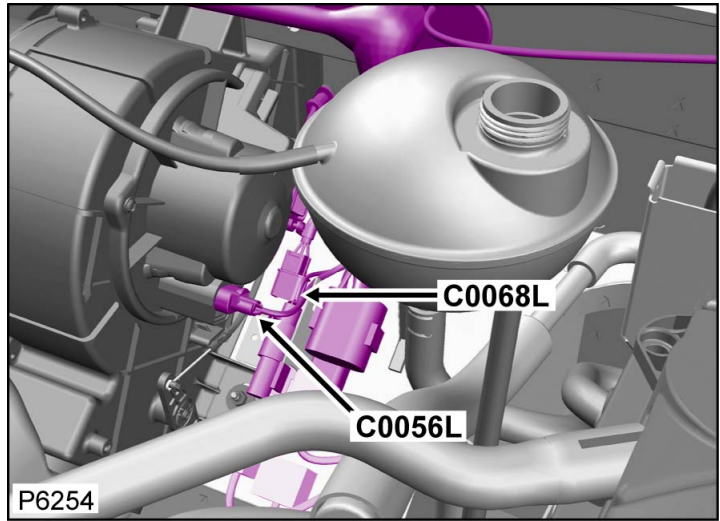
Cavities: **3WY**

Harness: **MAIN LH + RH HARNESS**

CAV	TERMINAL	CSA	COL	CCT	DESTN
1	DBP8548	1.0D	U	14L	S/JOINT SJ26
1	DBP8548	1.0D	U	153L	C0058
2	YPL10027	1.5D	BN	139L	C0058
3	YPL10027	1.5D	NR	139L	S/JOINT SJ24

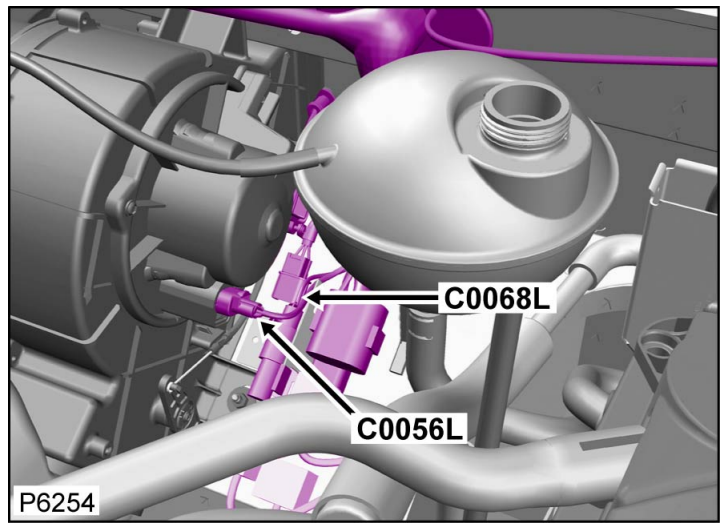
**Cavities: 3WY**

**Harness: MAIN LH + RH HARNESS**

CAV	TERMINAL	CSA	COL	CCT	DESTN
1	DBP8548	1.0D	U	14L	S/JOINT SJ26
1	DBP8548	1.0D	U	153L	C0058
2	YPL10027	1.5D	BN	139L	C0058
3	YPL10027	1.5D	NR	139L	S/JOINT SJ24

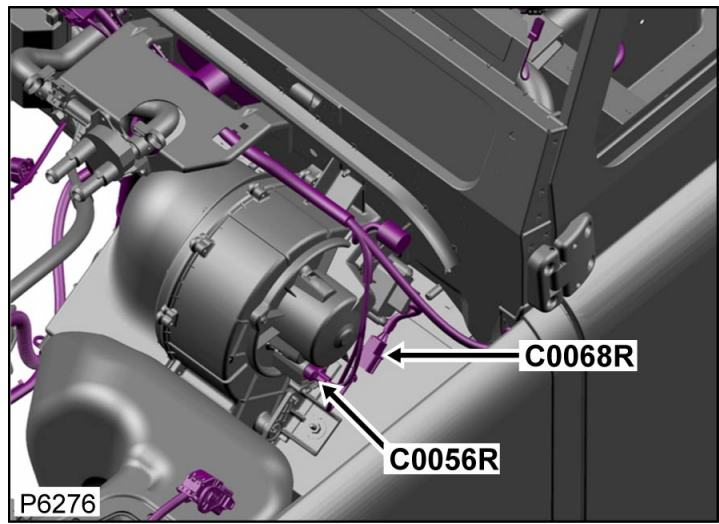
**Cavities: 3WY**

**Harness: MAIN LH + RH HARNESS**

CAV	TERMINAL	CSA	COL	CCT	DESTN
1	DBP8548	1.0D	U	14R	S/JOINT SJ27
1	DBP8548	1.0D	U	153R	C0058
2	YPL10027	1.5D	BN	200R	C0058
3	YPL10027	1.5D	NR	200R	S/JOINT SJ25

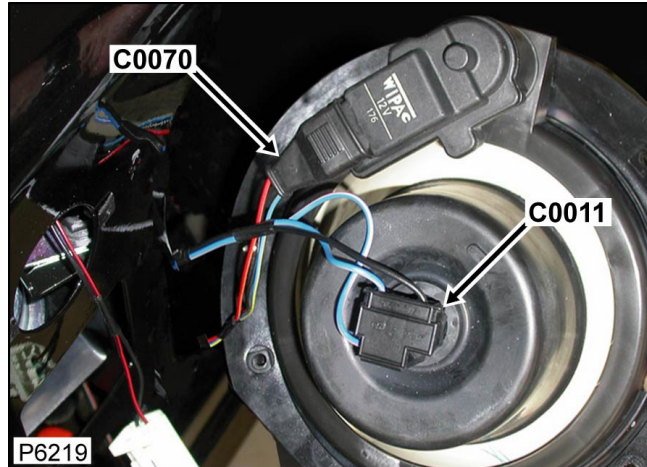
Location: **Behind RH headlamp**

CAV	TERMINAL	CSA	COL	CCT	DESTN
1	YPLI0073	0.5D	UY	I07	CI267
2	YPLI0073	0.5D	B	I07	CTAP
3	YPLI0073	0.5D	RO	I07	CI267

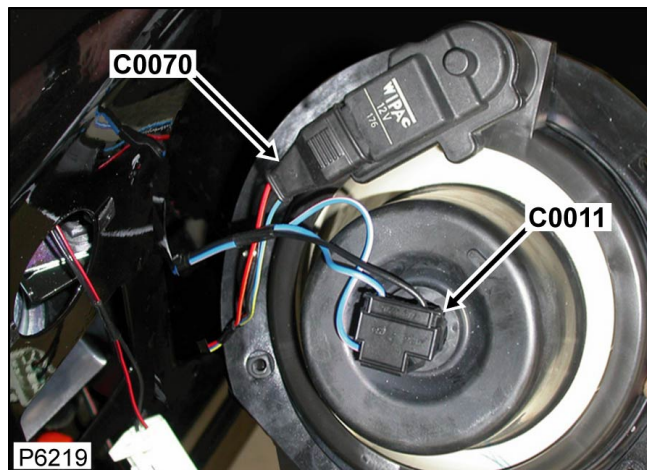
Location: **Behind RH headlamp**

CAV	TERMINAL	CSA	COL	CCT	DESTN
1	YPLI0073	0.5D	UY	I07	CI267
2	YPLI0073	0.5D	B	I07	CTAP

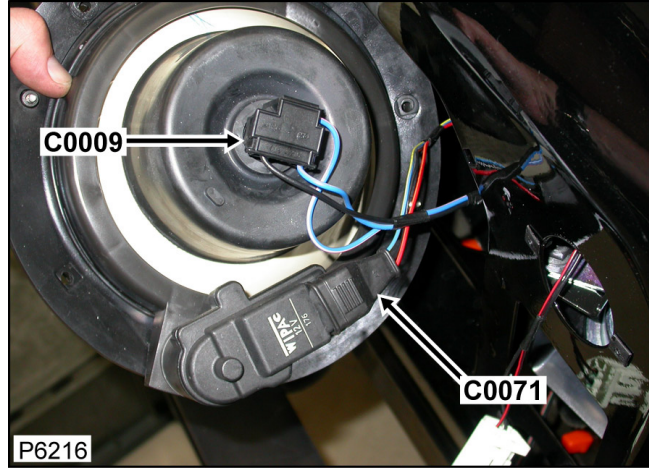
Location: **Behind LH headlamp**

CAV	TERMINAL	CSA	COL	CCT	DESTN
1	YPLI0073	0.5D	UY	107	CI265
2	YPLI0073	0.5D	B	107	CTAP
3	YPLI0073	0.5D	RO	107	CI265

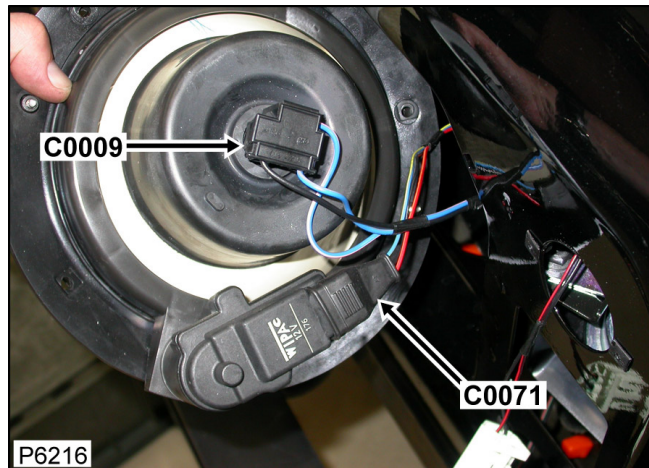
Location: **Behind LH headlamp**

CAV	TERMINAL	CSA	COL	CCT	DESTN
1	YPLI0073	0.5D	UY	107	CI265
2	YPLI0073	0.5D	B	107	CTAP

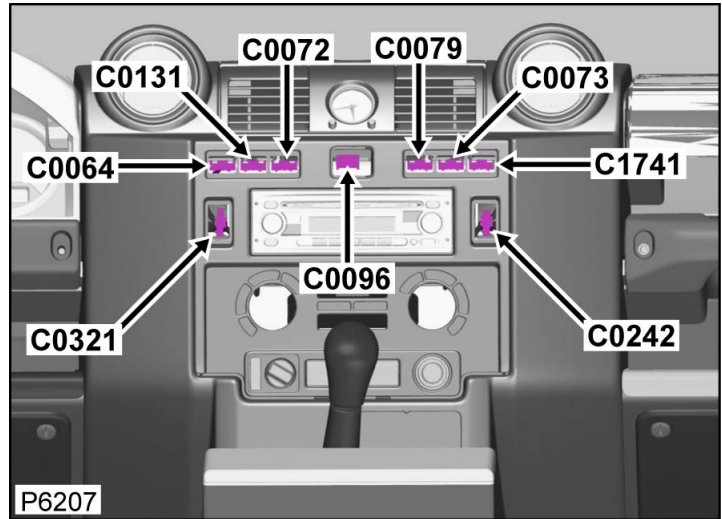
Location: **Instrument panel-Center**

CAV	TERMINAL	CSA	COL	CCT	DESTN
1	AFU3752	0.5D	WG	499	C0285
2	AFU3752	0.5D	RO	499	S/JOINT SJ68
4	AFU3752	0.5D	WB	499	C0285
5	AFU3752	0.5D	B	499	S/JOINT SJ13

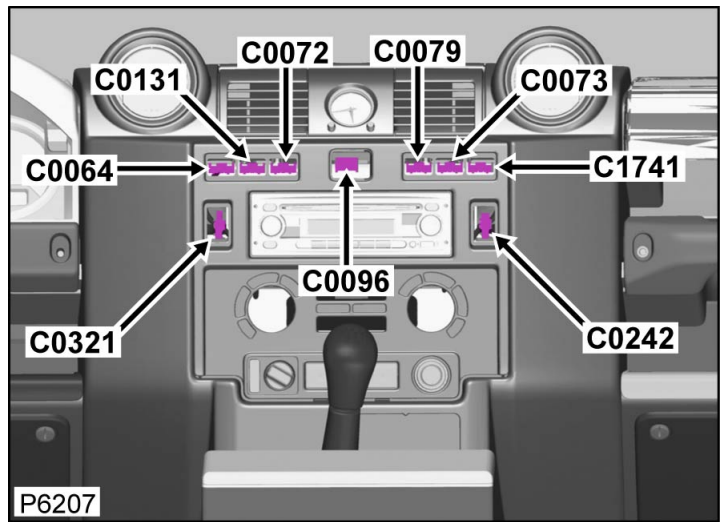
**Cavities: 5WY**

**Harness: MAIN LH + RH HARNESS**

CAV	TERMINAL	CSA	COL	CCT	DESTN
1	AFU3752	0.5D	WG	499	C0285
2	AFU3752	0.5D	RO	499	S/JOINT SJ68
4	AFU3752	0.5D	WB	499	C0285
5	AFU3752	0.5D	B	499	S/JOINT SJ13

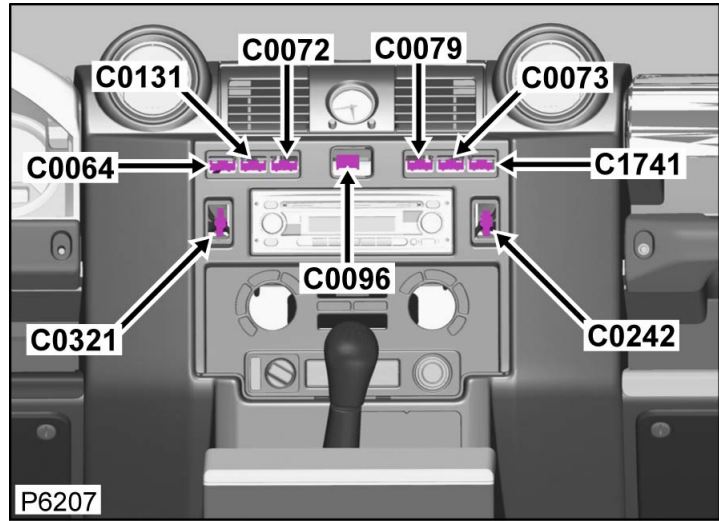
Location: **Instrument panel-Center**

CAV	TERMINAL	CSA	COL	CCT	DESTN
1	AFU3752	0.5D	WG	499	S/JOINT SJ33
2	AFU3752	0.5D	B	499	S/JOINT SJ13
4	AFU3752	0.5D	BLG	139L	C1264L
4	AFU3752	0.5D	BLG	200R	C1264R
5	AFU3752	0.5D	RO	499	S/JOINT SJ68

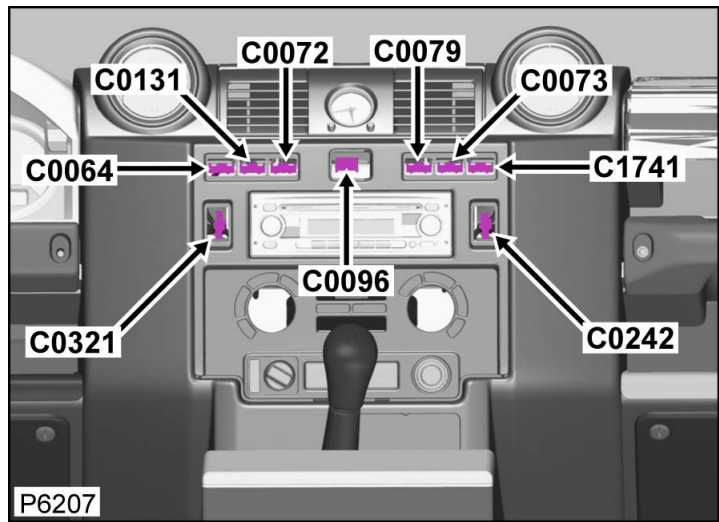
**Cavities: 5WY**

**Harness: MAIN LH + RH HARNESS**

CAV	TERMINAL	CSA	COL	CCT	DESTN
1	AFU3752	0.5D	WG	499	S/JOINT SJ33
2	AFU3752	0.5D	B	499	S/JOINT SJ13
4	AFU3752	0.5D	BLG	139L	C1264L
4	AFU3752	0.5D	BLG	200R	C1264R
5	AFU3752	0.5D	RO	499	S/JOINT SJ68

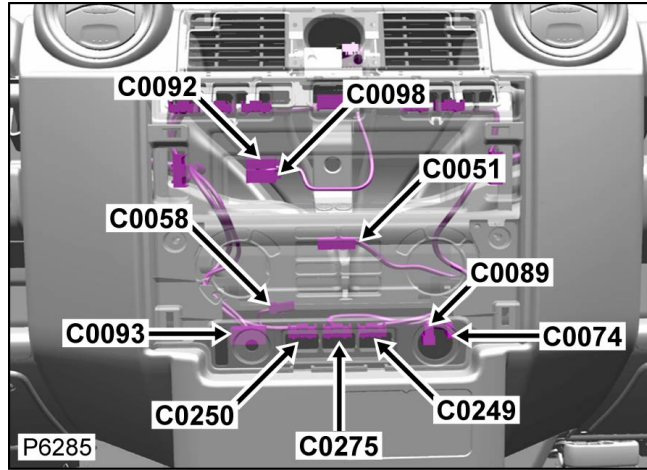
Location: **Instrument panel-Center**

CAV	TERMINAL	CSA	COL	CCT	DESTN
I	AFU4522	0.5D	RO	499	S/JOINT SJ67

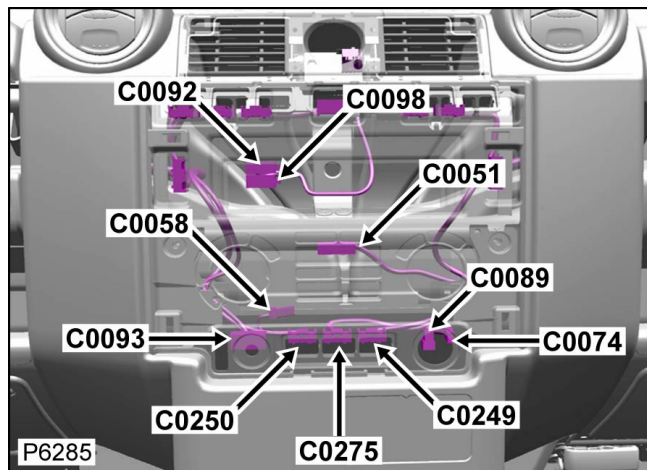
Location: **Instrument panel-Center**

CAV	TERMINAL	CSA	COL	CCT	DESTN
I	AFU4522	0.5D	RO	499	S/JOINT SJ67

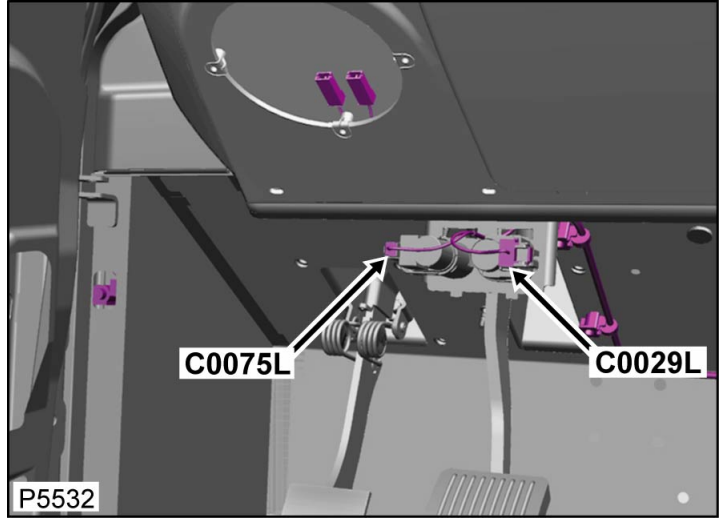
Cavities: **2WY**

Harness: **MAIN LH + RH HARNESS**

CAV	TERMINAL	CSA	COL	CCT	DESTN
1	YPL500450	1.5D	GO	I39L	C0580L
2	YPL500450	1.5D	GP	I39L	C0288

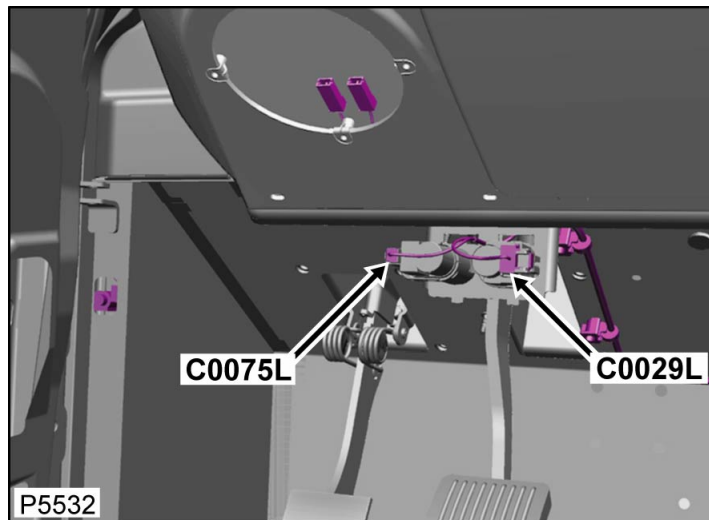
**Cavities: 2WY**

**Harness: MAIN LH + RH HARNESS**

CAV	TERMINAL	CSA	COL	CCT	DESTN
1	YPL500450	1.5D	GO	I39L	C0580L
2	YPL500450	1.5D	GP	I39L	C0288
