DEFENDER - VIN: 412051 >

Electrical Reference Library (1a)

JLR 16 25 21\_IE

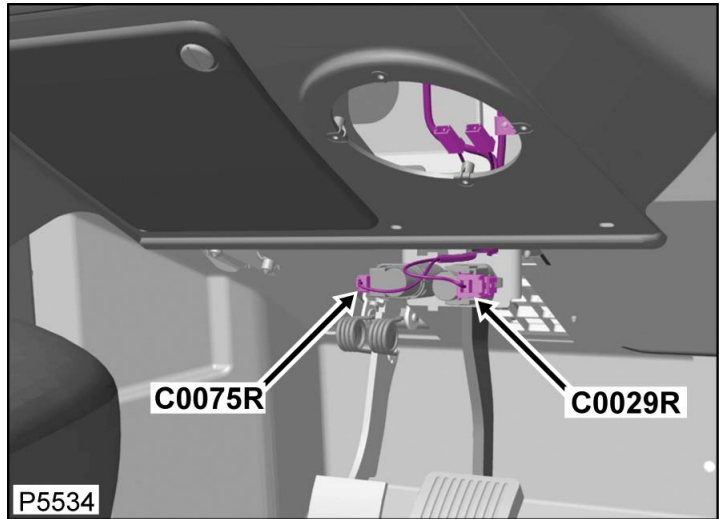
Cavities: **2WY**

Harness: **MAIN LH + RH HARNESS**

CAV	TERMINAL	CSA	COL	CCT	DESTN
1	YPL500450	1.5D	GO	200R	C0580R
2	YPL500450	1.5D	GP	200R	C0288

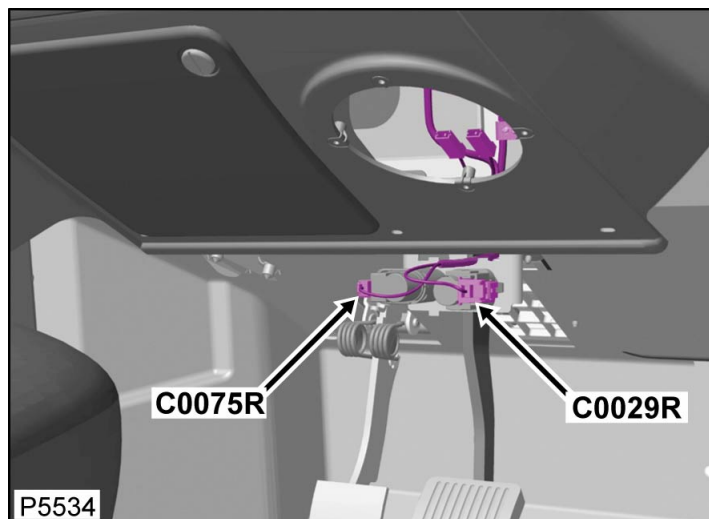
**Cavities: 2WY**

**Harness: MAIN LH + RH HARNESS**

CAV	TERMINAL	CSA	COL	CCT	DESTN
1	YPL500450	1.5D	GO	200R	C0580R
2	YPL500450	1.5D	GP	200R	C0288

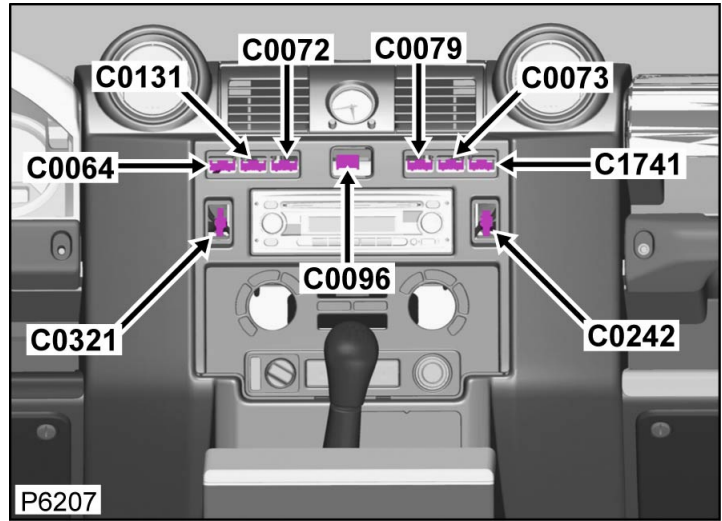
Location: **Instrument panel-Center**

CAV	TERMINAL	CSA	COL	CCT	DESTN
1	AFU3752	0.5D	BG	499	C0376
2	AFU3752	0.5D	RO	499	S/JOINT SJ68
4	AFU3752	0.5D	B	499	S/JOINT SJ13

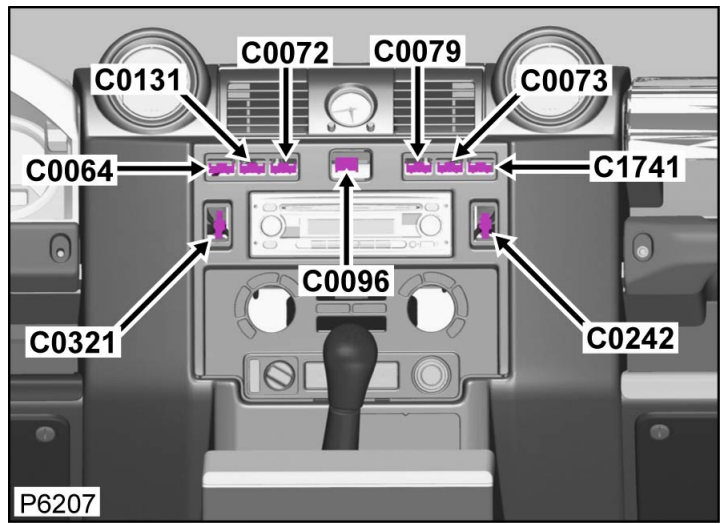
Cavities: **5WY**

Harness: **MAIN LH + RH HARNESS**

CAV	TERMINAL	CSA	COL	CCT	DESTN
1	AFU3752	0.5D	BG	499	C0376
2	AFU3752	0.5D	RO	499	S/JOINT SJ68
4	AFU3752	0.5D	B	499	S/JOINT SJ13

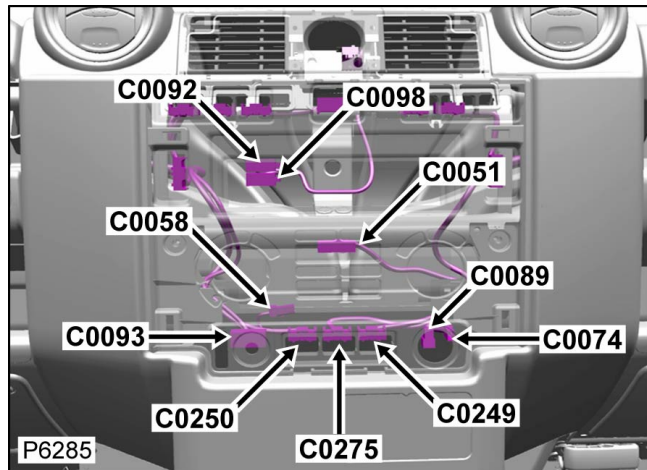
Location: **Instrument panel-Center**

CAV	TERMINAL	CSA	COL	CCT	DESTN
1	YPL902180	1.0D	B	499	C0289
2	YPL902180	1.0D	PG	200R	C0582R
2	YPL902180	1.0D	PG	139L	C0582L

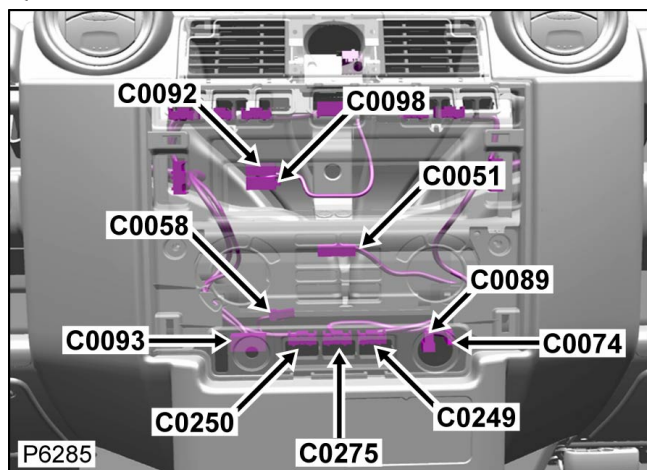
Location: **Instrument panel-Center**

CAV	TERMINAL	CSA	COL	CCT	DESTN
1	YPL902180	1.0D	B	499	C0289
2	YPL902180	1.0D	PG	200R	C0582R

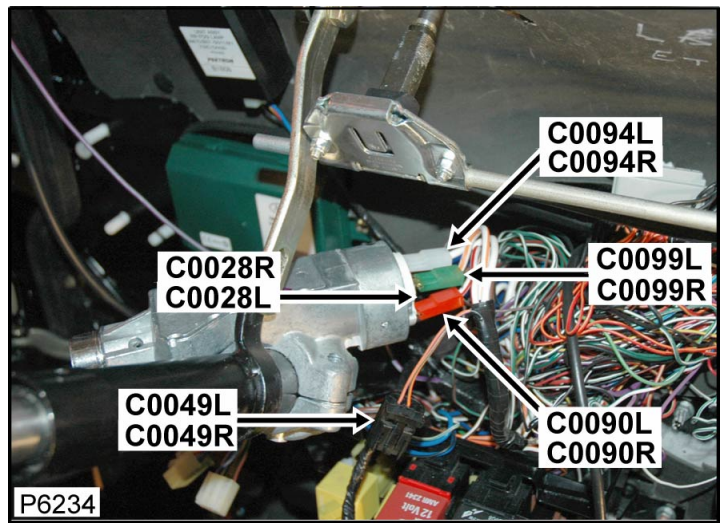
**Harness: MAIN LH + RH HARNESS**

**Colour: RED**  
**Cavities: I WY**

CAV	TERMINAL	CSA	COL	CCT	DESTN
I	ADU9568	4.0D	WR	I39L	C3768

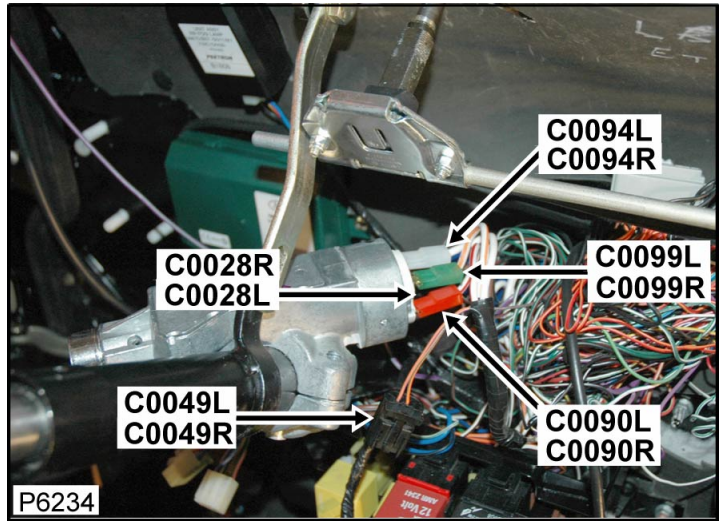
Location: **Behind steering column cowl**

Part No.: **YPCI0245**

Colour: **RED**

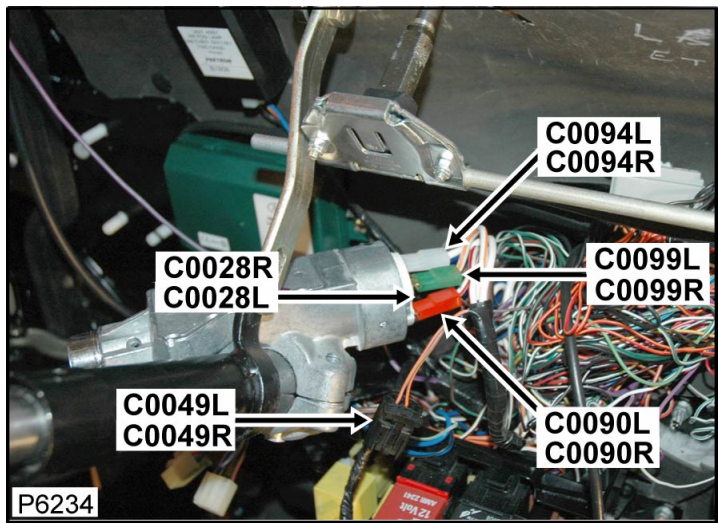
**Harness: MAIN LH + RH HARNESS**

**Colour: RED**  
**Cavities: IWY**

CAV	TERMINAL	CSA	COL	CCT	DESTN
I	ADU9568	4.0D	WR	200R	C3768

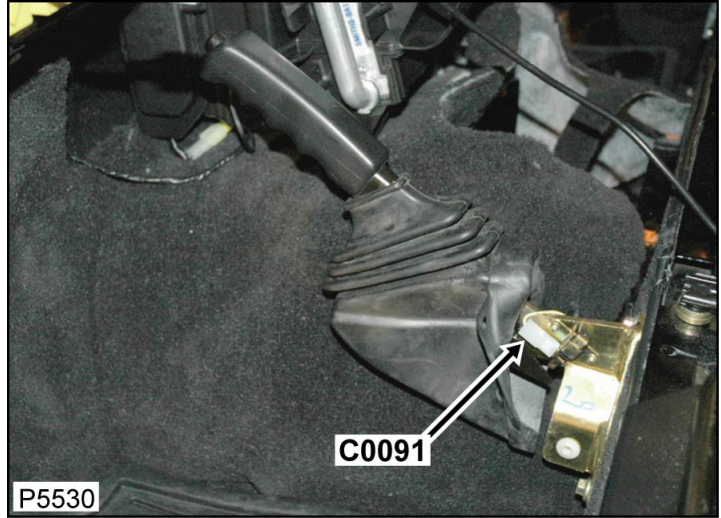
Location: **Base of handbrake lever**

Part No.: **ADU8339**

Colour: **NATURAL**

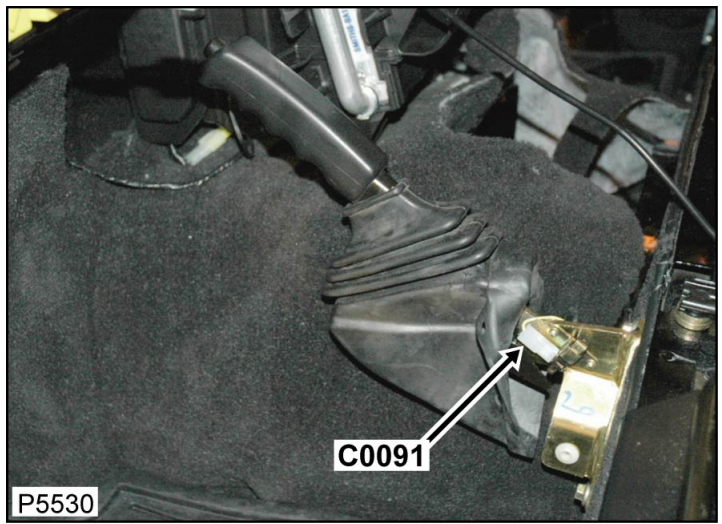
Harness: **MAIN LH + RH HARNESS**

Cavities: **IWY**

CAV	TERMINAL	CSA	COL	CCT	DESTN
I	AFU3262	0.5D	WY	499	C0288

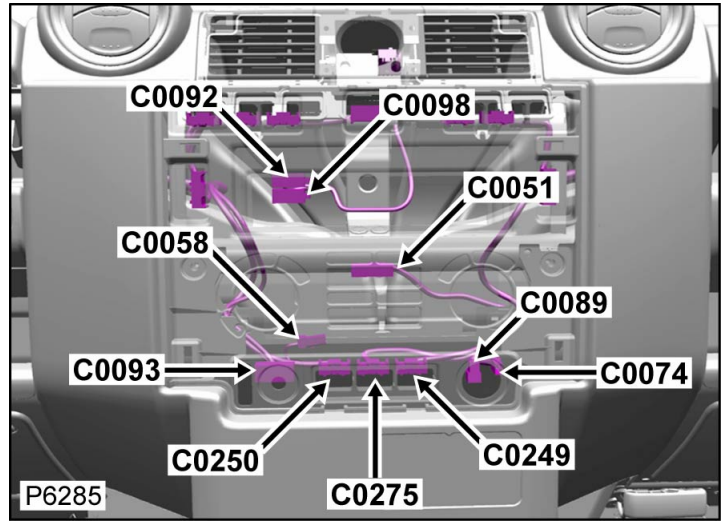
Harness: **MAIN LH + RH HARNESS**

Cavities: **8WY**

CAV	TERMINAL	CSA	COL	CCT	DESTN
1	ALUI033	0.5D	BG	192	C0376
2	ALUI033	0.5D	BU	192	C0376
3	ALUI033	0.5D	BK	769	C1577
4	ALUI033	0.5D	BR	769	C0369
5	ALUI033	0.5D	BW	769	C0340
6	ALUI033	0.5D	BN	769	C1492
7	ALUI033	0.5D	BY	192	C0376
8	ALUI033	0.5D	BO	192	C0376

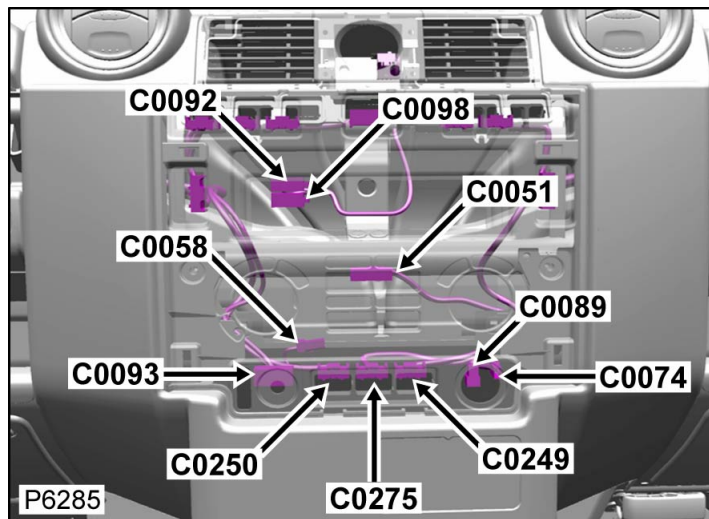
**Location: Instrument panel-Center**

**Part No.: YPCI0191**

**Colour: BROWN**

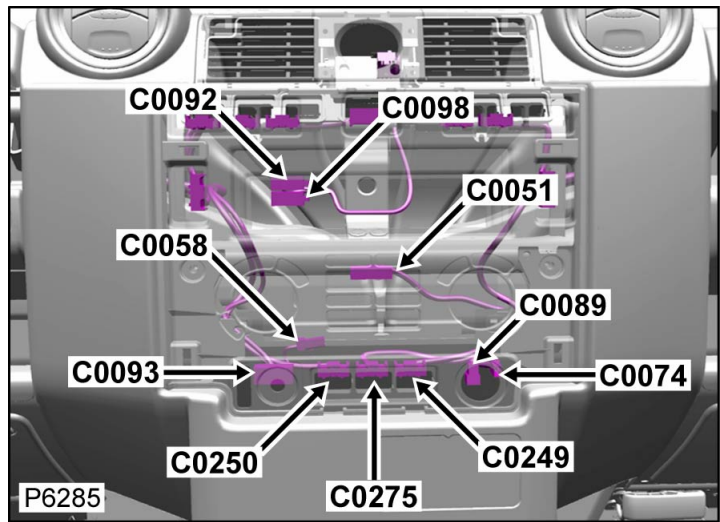
**Harness: MAIN LH + RH HARNESS**

**Cavities: 6WY**

CAV	TERMINAL	CSA	COL	CCT	DESTN
2	AFU3567	1.0D	UY	107	S/JOINT SJ56
3	AFU3726	0.5D	B	107	C0289
4	AFU3726	0.5D	RO	107	C0286
5	AFU3726	0.5D	RO	107	C0286

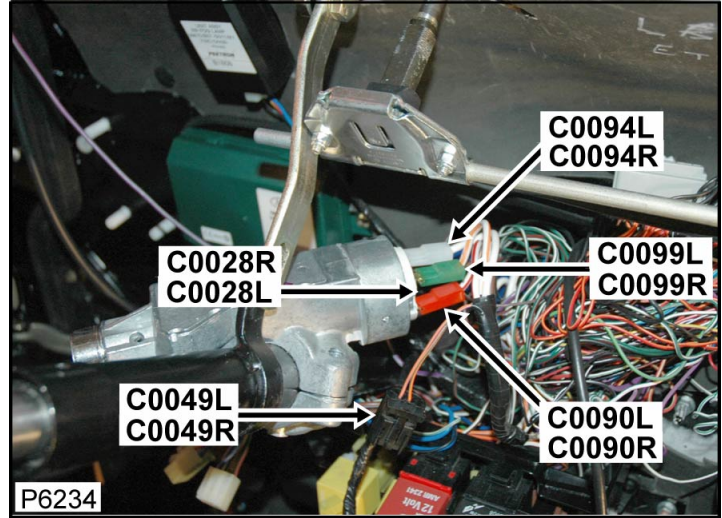
Harness: **MAIN LH + RH HARNESS**

Cavities: **IWY**

CAV	TERMINAL	CSA	COL	CCT	DESTN
I	ADU9568	4.0D	W	I39L	S/JOINT SJ3

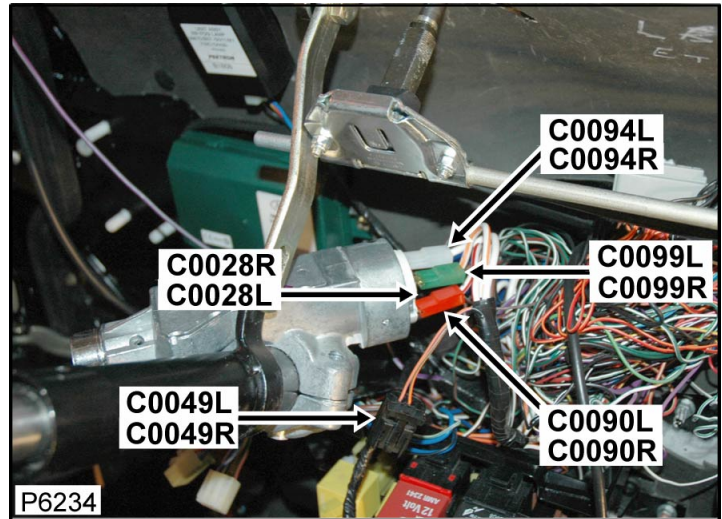
Location: **Behind steering column cowl**

Part No.: **ADU8339**

Colour: **NATURAL**

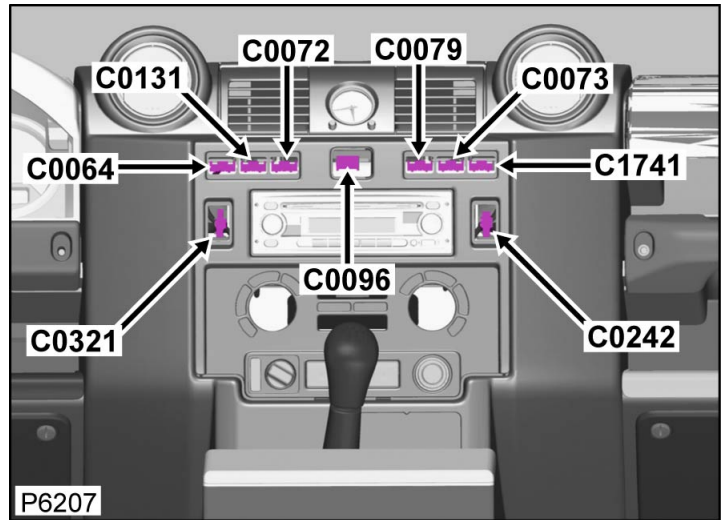
**Description: Switch-Hazard-warning**  
**Location: Instrument panel-Center**  
**Qualifier:**

CAV	TERMINAL	CSA	COL	CCT	DESTN
1	AFU3560	1.0D	WG	139L	C0580L
1	AFU3560	1.0D	WG	200R	C0580R
2	AFU3560	1.0D	PN	139L	S/JOINT SJ77A
2	AFU3560	1.0D	PN	200R	S/JOINT SJ126
3	YPL10002	1.5D	LG	139L	C0536L
3	YPL10002	1.5D	LG	200R	C0536R
4	AFU3572	0.5D	RO	499	S/JOINT SJ68
5	AFU3572	0.5D	B	499	S/JOINT SJ13
6	YPL10002	1.5D	LGN	139L	S/JOINT SJ79

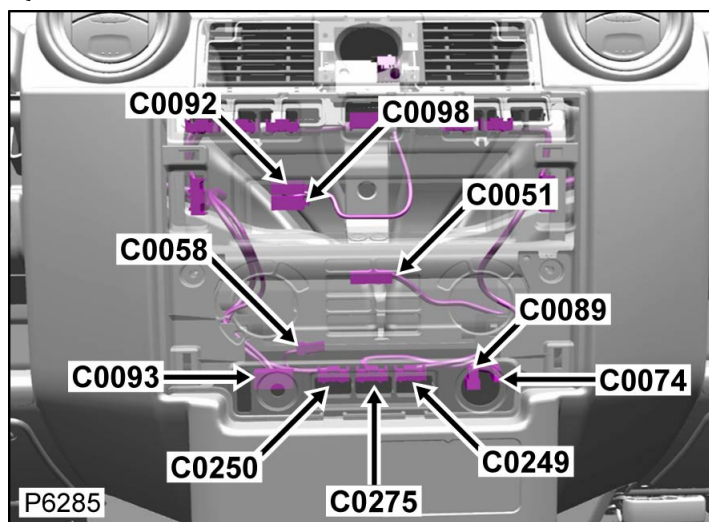
**Location: Instrument panel-Center**

**Part No.: YPCI0190**

**Colour: GREY**

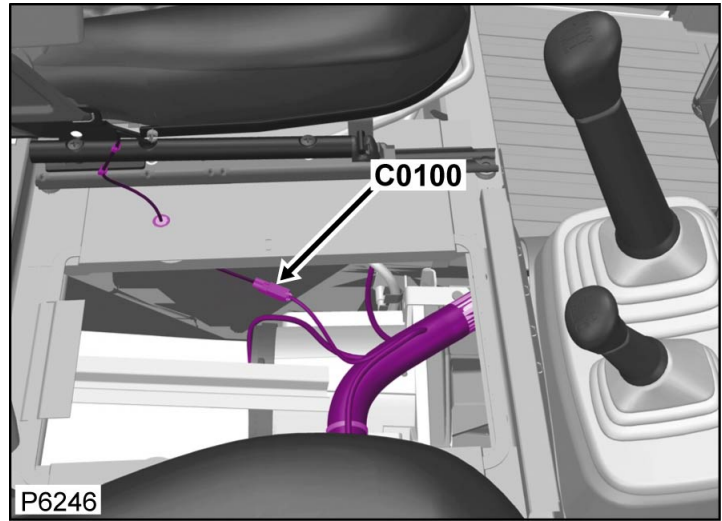
Location: **Beneath center of vehicle**

CAV	TERMINAL	CSA	COL	CCT	DESTN
1	DBP8550	0.5D	WP	I39L	C1040L
2	DBP8550	0.5D	B	I39L	C0289

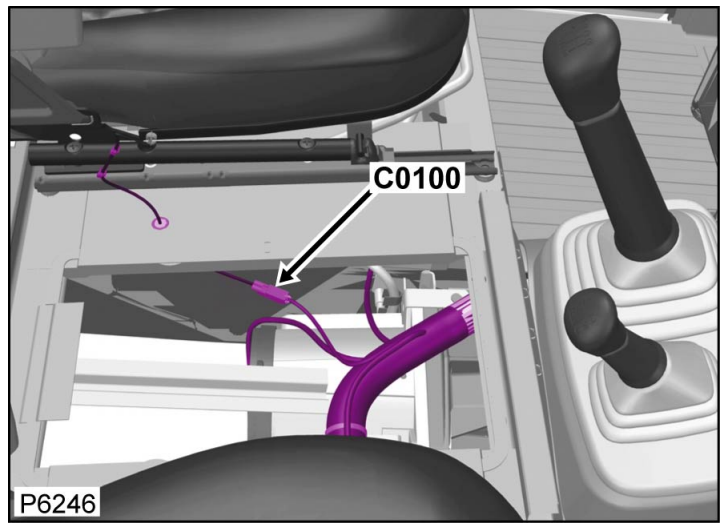
**Harness: MAIN LH + RH HARNESS**

**Cavities: 2WY**

CAV	TERMINAL	CSA	COL	CCT	DESTN
1	DBP8550	0.5D	WP	I39L	C1040L
2	DBP8550	0.5D	B	I39L	C0289

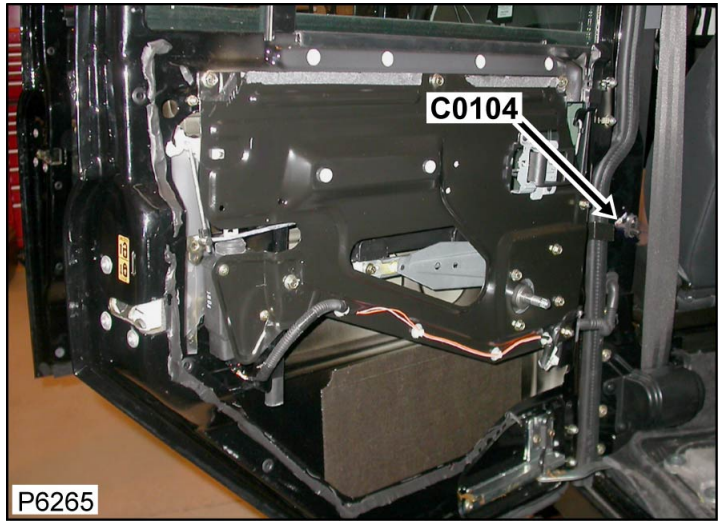
Harness: **C/POST ASSY REAR SIDE DOORS HARNESS**

Cavities: **IWY**

CAV	TERMINAL	CSA	COL	CCT	DESTN
I	AFU3262	0.75D	PU	499	S/JOINT SJI

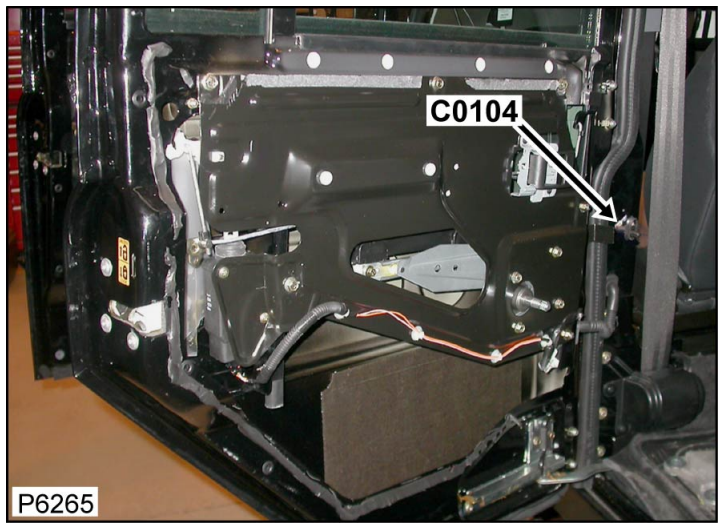
Harness: **C/POST ASSY REAR SIDE DOORS HARNESS**

Cavities: **IWY**

CAV	TERMINAL	CSA	COL	CCT	DESTN
I	AFU3262	0.75D	PU	499	S/JOINT SJI

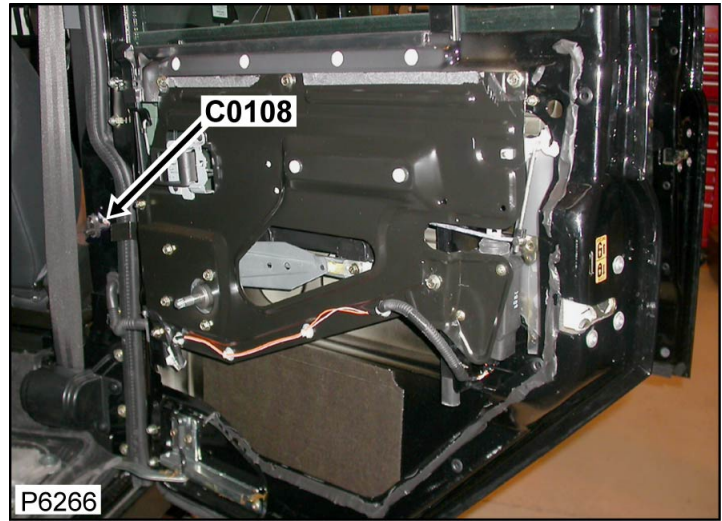
Location: **In RH 'B' post**

Part No.: **AAU1010**

Colour: **BLACK**

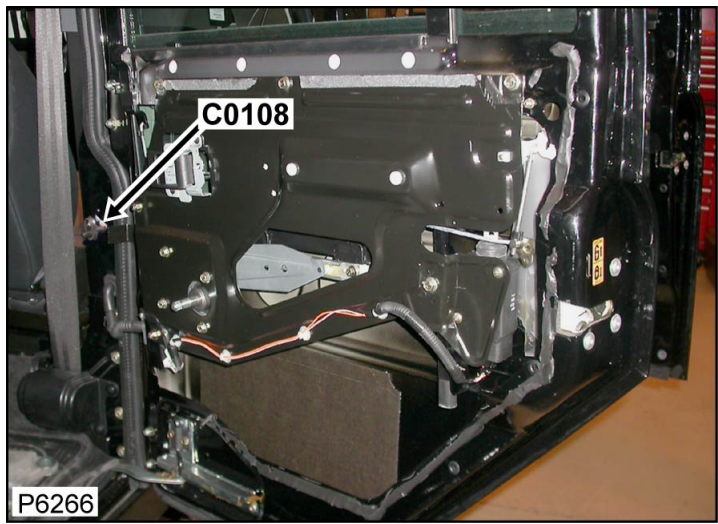
**Harness: C/POST ASSY REAR SIDE  
DOORS HARNESS**

**Cavities: IWY**

CAV	TERMINAL	CSA	COL	CCT	DESTN
I	AFU3262	0.75D	PU	499	S/JOINT SJI

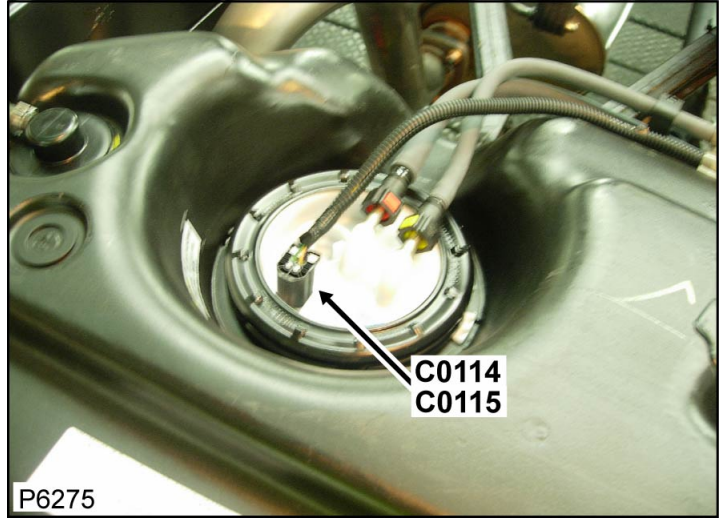
Harness: **CHASSIS HARNESS**

Cavities: **6WY**

CAV	TERMINAL	CSA	COL	CCT	DESTN
1	YPE100740	0.75D	GO	770	C0390
2	YPE100740	0.75D	YP	770	C0390
3	YPL901440	2.5D	B	770	C1964
4	YPL901440	2.5D	NS	770	C0390

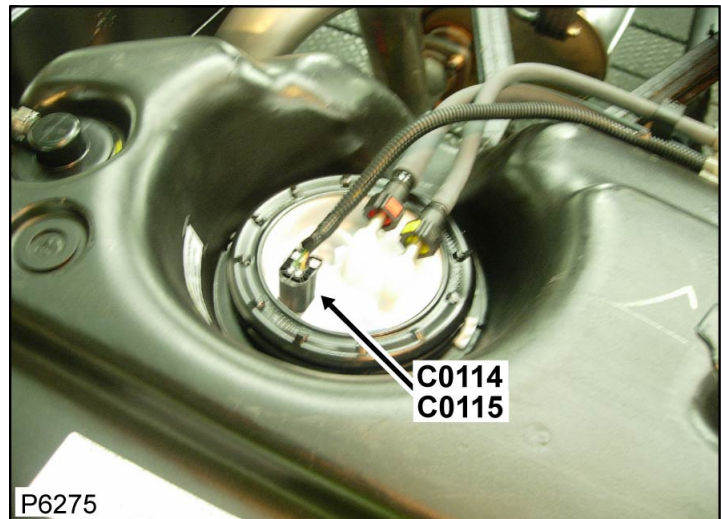
**Location: Above fuel tank**

CAV	TERMINAL	CSA	COL	CCT	DESTN
1	YPE100740	0.75D	GO	770	C0390
2	YPE100740	0.75D	YP	770	C0390
3	YPL901440	2.5D	B	770	CI964

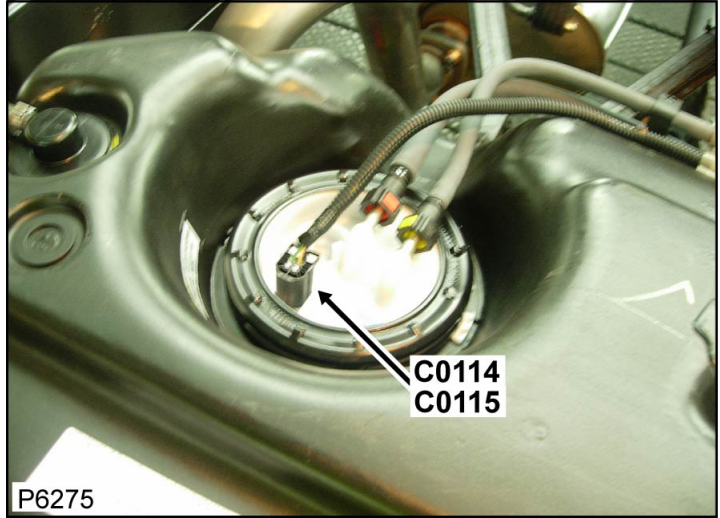
Harness: **CHASSIS HARNESS**

Cavities: **6WY**

CAV	TERMINAL	CSA	COL	CCT	DESTN
1	YPE100740	0.75D	GO	772	C1763
1	YPE100740	0.75D	GO	771	C1759
1	YPE100740	0.75D	GO	985	C1759
2	YPE100740	0.75D	YP	772	C1763
2	YPE100740	0.75D	YP	771	C1759
2	YPE100740	0.75D	YP	985	C1759
3	YPL901440	2.5D	B	771	C1967
3	YPL901440	2.5D	B	772	C1968
3	YPL901440	2.5D	B	985	C1967
4	YPL901440	2.5D	NS	771	C1759
4	YPL901440	2.5D	NS	772	C1763
4	YPL901440	2.5D	NS	985	C1759

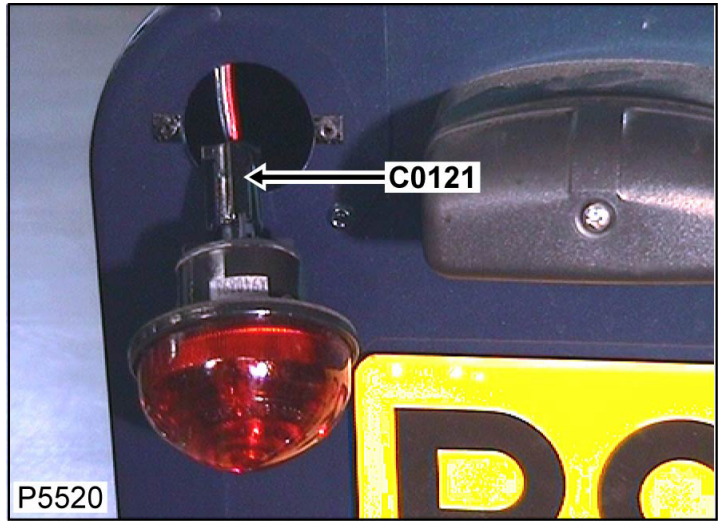
Harness: **CHASSIS HARNESS**

Cavities: **3WY**

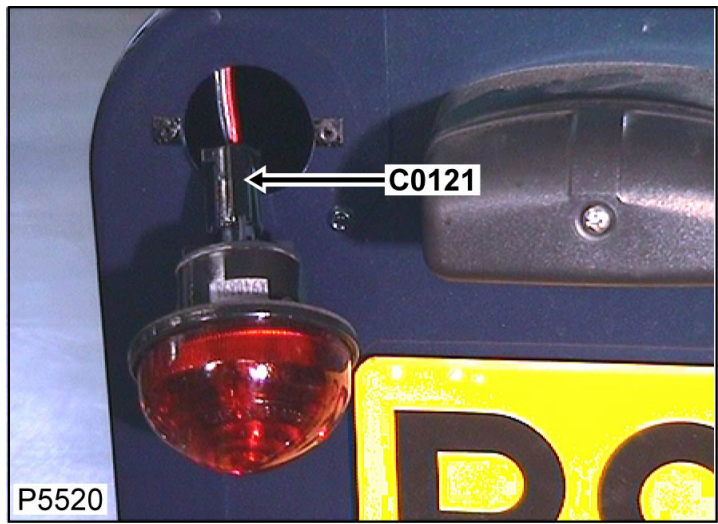
Harness: **CHASSIS HARNESS**

Cavities: **3WY**

CAV	TERMINAL	CSA	COL	CCT	DESTN
1	AFU3802	1.5D	B	770	S/JOINT SJ27
1	AFU3802	1.5D	B	771	S/JOINT SJ28
2	AFU3802	1.5D	GP	771	S/JOINT SJ20
2	AFU3802	1.5D	GP	770	S/JOINT SJ14
3	AFU3802	1.5D	RB	771	S/JOINT SJ19
3	AFU3802	1.5D	RB	770	S/JOINT SJ13

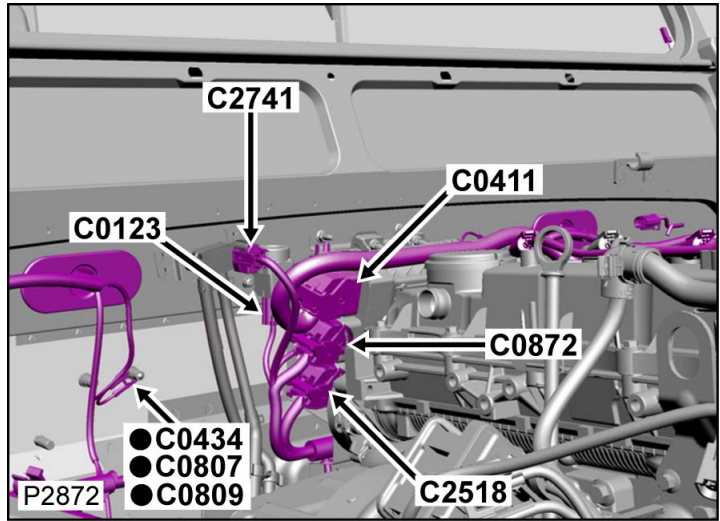
Harness: **MAIN LH + RH HARNESS**

Cavities: **3WY**

CAV	TERMINAL	CSA	COL	CCT	DESTN
1	YPL10062	0.5D	RB	254	S/JOINT SJ71
3	YPL10062	0.5D	RG	254	S/JOINT SJ70

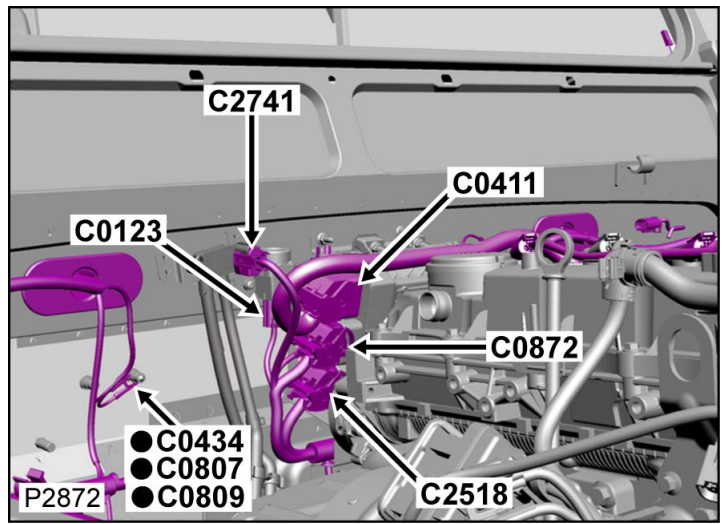
**Harness: MAIN LH + RH HARNESS**

**Cavities: 3WY**

CAV	TERMINAL	CSA	COL	CCT	DESTN
1	YPL10062	0.5D	RB	254	S/JOINT SJ71
3	YPL10062	0.5D	RG	254	S/JOINT SJ70

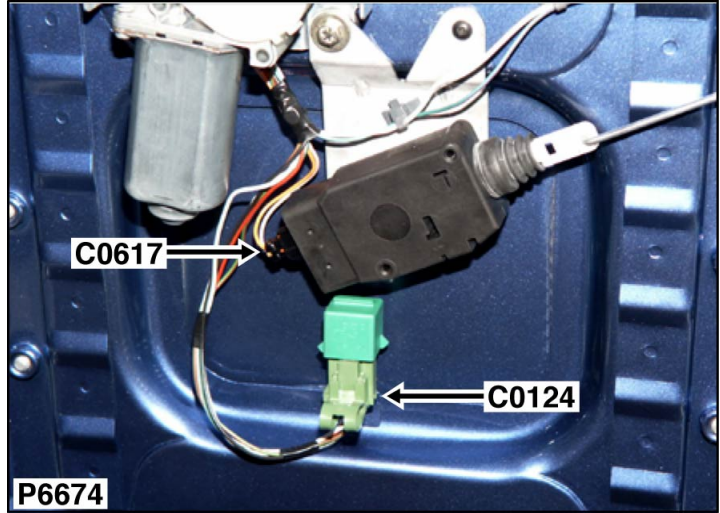
Harness: **TAILDOOR HARNESS**

Cavities: **9WY**

CAV	TERMINAL	CSA	COL	CCT	DESTN
2	AFU3228	1.0D	RLG	193	C0388
4	AFU3228	1.0D	BG	193	C1102
5	AFU3228	1.0D	NLG	193	C1105
6	AFU3228	1.0D	WG	193	S/JOINT SJ2
8	AFU3228	1.0D	WG	193	S/JOINT SJ2

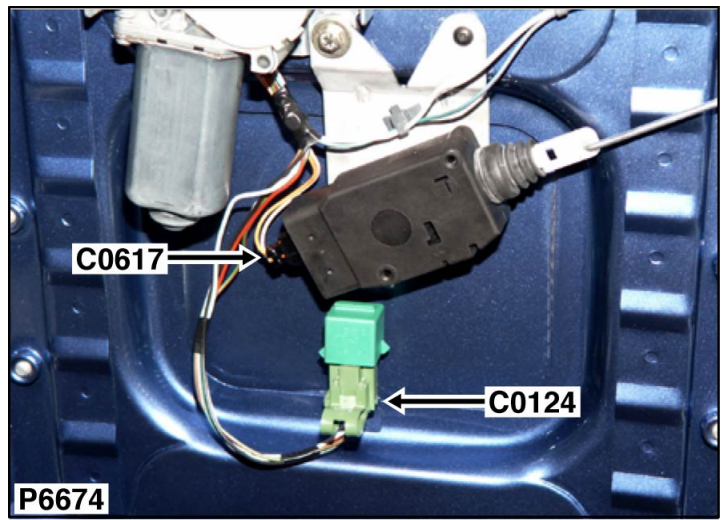
Harness: **TAILDOOR HARNESS**

Cavities: **9WY**

CAV	TERMINAL	CSA	COL	CCT	DESTN
2	AFU3228	1.0D	RLG	193	C0388
4	AFU3228	1.0D	BG	193	C1102
5	AFU3228	1.0D	NLG	193	C1105
6	AFU3228	1.0D	WG	193	S/JOINT SJ2
8	AFU3228	1.0D	WG	193	S/JOINT SJ2

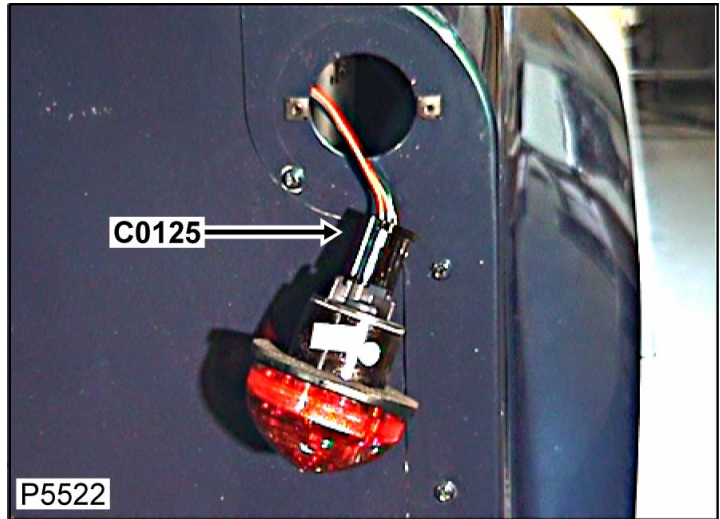
Harness: **CHASSIS HARNESS**

Cavities: **3WY**

CAV	TERMINAL	CSA	COL	CCT	DESTN
1	AFU3802	1.5D	B	770	S/JOINT SJ2
1	AFU3802	1.5D	B	771	S/JOINT SJ3
2	AFU3802	1.5D	GP	770	S/JOINT SJ14
2	AFU3802	1.5D	GP	771	S/JOINT SJ20
3	AFU3802	1.5D	RO	771	S/JOINT SJ15
3	AFU3802	1.5D	RO	770	S/JOINT SJ9

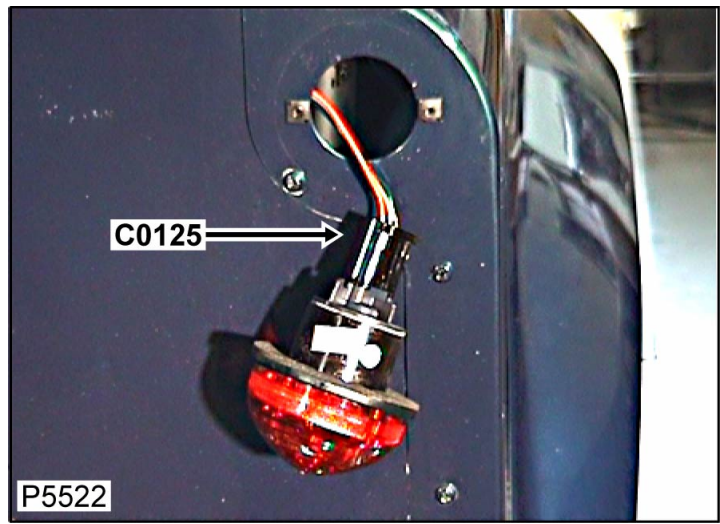
**Harness: CHASSIS HARNESS**

**Cavities: 3WY**

CAV	TERMINAL	CSA	COL	CCT	DESTN
1	AFU3802	1.5D	B	770	S/JOINT SJ2
1	AFU3802	1.5D	B	771	S/JOINT SJ3
2	AFU3802	1.5D	GP	770	S/JOINT SJ14
2	AFU3802	1.5D	GP	771	S/JOINT SJ20
3	AFU3802	1.5D	RO	771	S/JOINT SJ15
3	AFU3802	1.5D	RO	770	S/JOINT SJ9

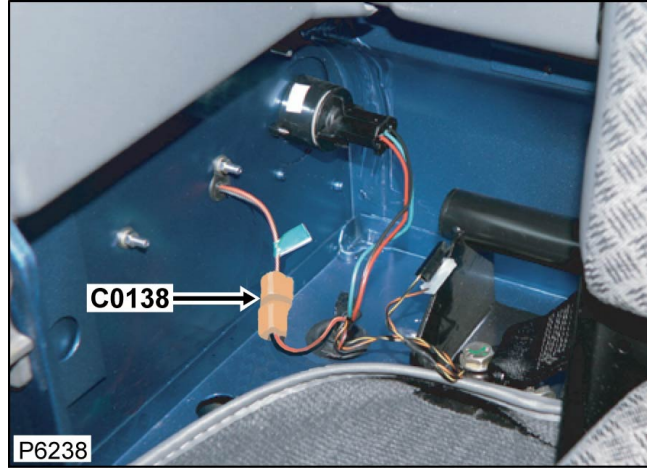
Location: **Base of 'D' post LH side**

CAV	TERMINAL	CSA	COL	CCT	DESTN
1	YPJ10008	1.5D	RB	771	S/JOINT SJ19
1	YPJ10008	1.5D	RB	770	S/JOINT SJ13
2	YPJ10008	1.5D	B	770	S/JOINT SJ27
2	YPJ10008	1.5D	B	771	S/JOINT SJ28

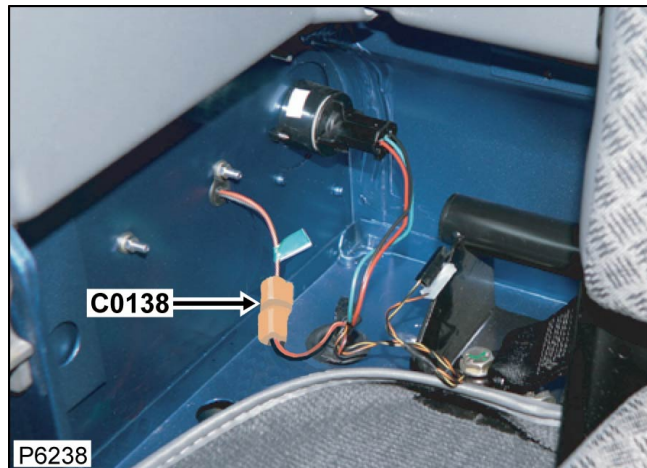
Location: **Base of 'D' post LH side**

CAV	TERMINAL	CSA	COL	CCT	DESTN
1	YPJ10008	1.5D	RB	771	S/JOINT SJ19
					S/JOINT

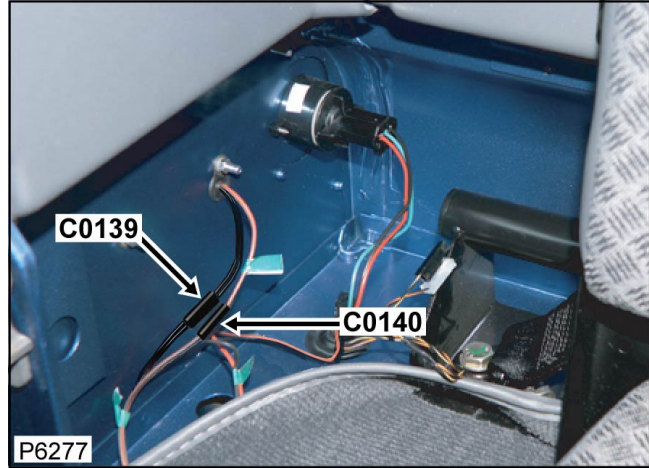
Location: **Base of 'D' post LH side**

CAV	TERMINAL	CSA	COL	CCT	DESTN
1	YPS10003	1.0D	B	772	S/JOINT SJI
1	YPS10003	1.0D	B	985	S/JOINT SJI
2	YPS10005	1.5D	B	772	C2121
2	YPS10005	1.5D	B	985	C2121

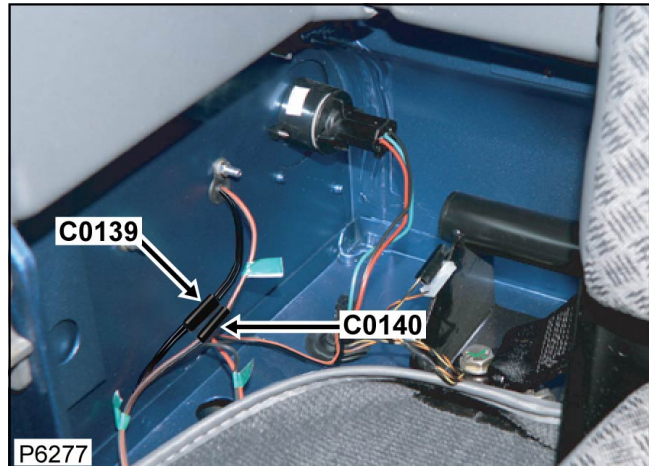
Location: **Base of 'D' post LH side**

CAV	TERMINAL	CSA	COL	CCT	DESTN
1	YPS10003	1.0D	B	772	S/JOINT SJI
					S/JOINT

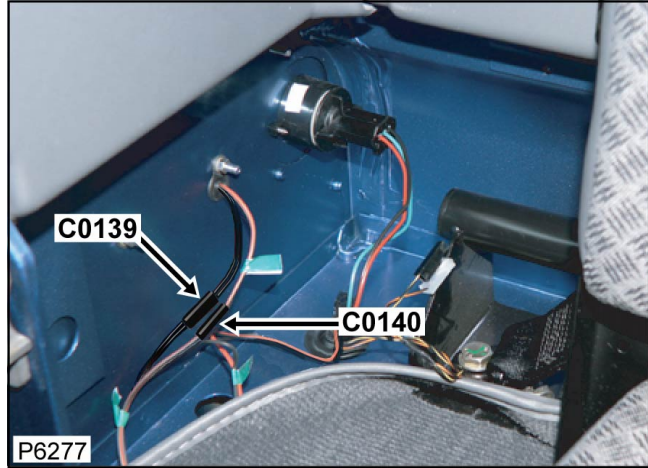
Location: **Base of 'D' post LH side**

CAV	TERMINAL	CSA	COL	CCT	DESTN
I	YPS10005	1.5D	RB	772	S/JOINT SJ23
I	YPS10005	1.5D	RB	985	CI305

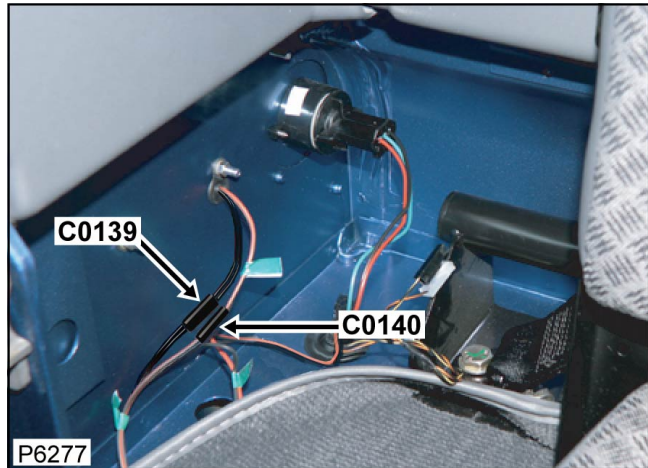
Location: **Base of 'D' post LH side**

CAV	TERMINAL	CSA	COL	CCT	DESTN
I	YPS10005	1.5D	RB	772	S/JOINT SJ23
I	YPS10005	1.5D	RR	985	CI305

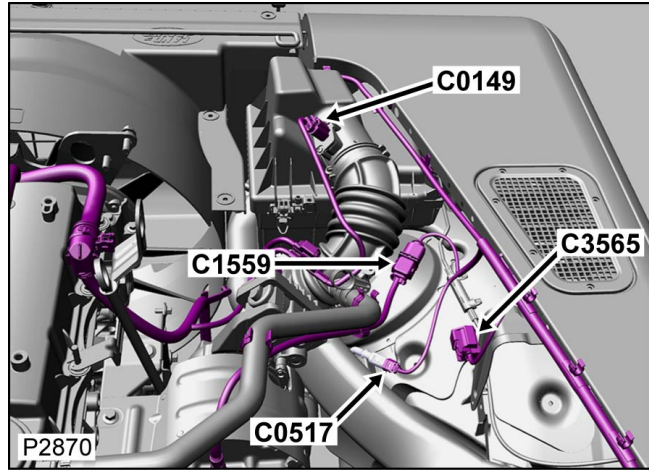
Location: **RH side of engine compartment**

CAV	TERMINAL	CSA	COL	CCT	DESTN
2	YPL802570	0.5	PS	254	C0162
3	YPL802570	0.5	SP	254	C0162
4	YPL802570	0.5	U	254	C0162
5	YPL802570	0.5	YP	254	C0162

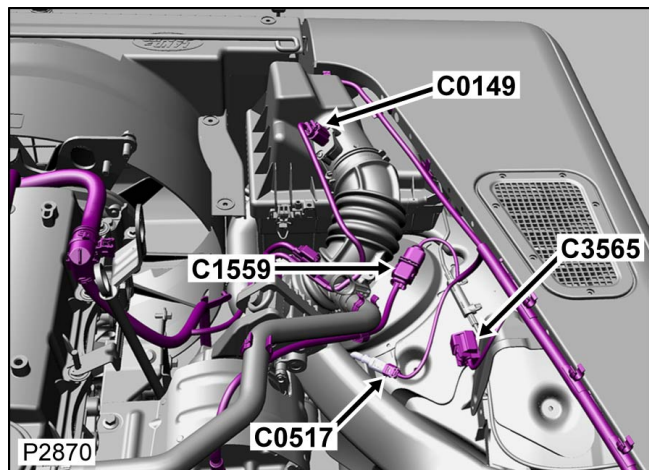
Location: **RH side of engine compartment**

CAV	TERMINAL	CSA	COL	CCT	DESTN
2	YPL802570	0.5	PS	254	C0162
3	YPL802570	0.5	SP	254	C0162

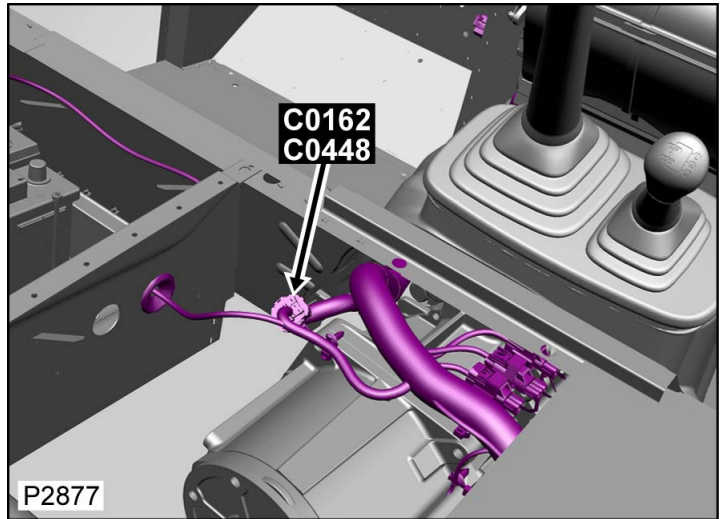
Harness: **ENGINE DIESEL HARNESS**

Cavities: **12WY**

CAV	TERMINAL	CSA	COL	CCT	DESTN
1	YPJ000020	0.5	YP	254	C0149
2	YPJ000020	0.5	GN	254	C0168
3	YPJ900240	1.0	BG	LR	C0127
4	YPJ900040	2.5	NG	254	S/JOINT SIBBI7A
5	YPJ000020	0.5	PS	254	C0149
6	YPJ000020	0.5	U	254	C0149
7	YPJ000020	0.5	SP	254	C0149
8	YPJ000020	0.5	SP	254	C0168
9	YPJ900240	1.0	PW	AC	C0127
10	YPJ900240	0.75	PN	254	C3356

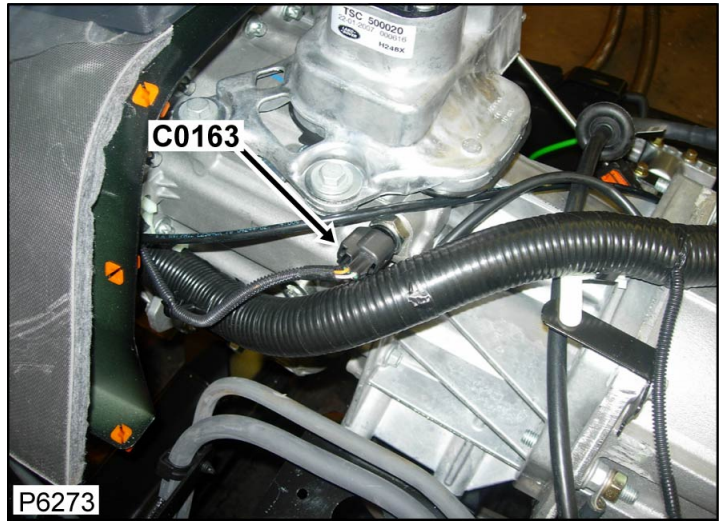
Cavities: **2WY**

Harness: **MAIN LH + RH HARNESS**

CAV	TERMINAL	CSA	COL	CCT	DESTN
1	YPL500410	1.0D	GN	499	S/JOINT SJ49
2	YPL500410	1.0D	LGP	254	C3766

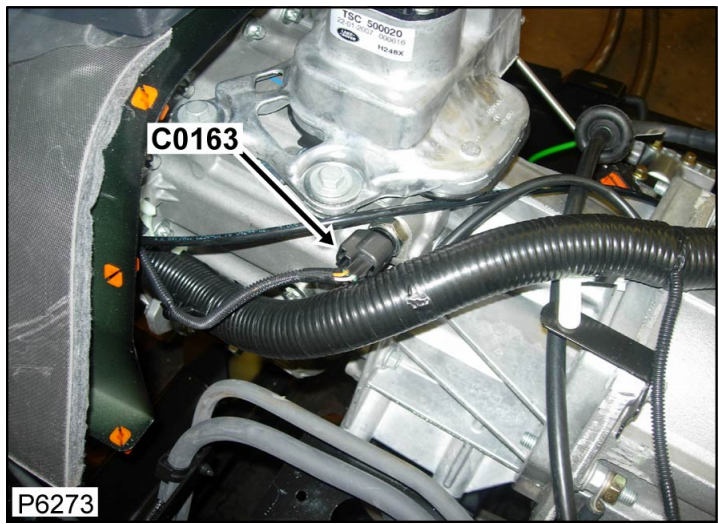
**Cavities: 2WY**

**Harness: MAIN LH + RH HARNESS**

CAV	TERMINAL	CSA	COL	CCT	DESTN
1	YPL500410	1.0D	GN	499	S/JOINT SJ49
2	YPL500410	1.0D	LGP	254	C3766

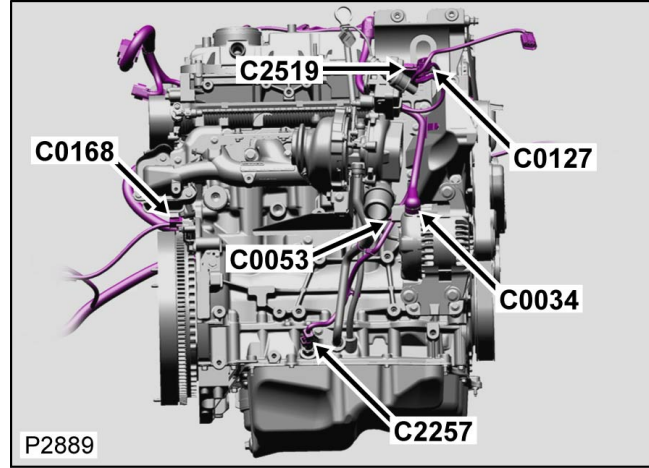
Connector: **C0168**

Location: **RH side of engine**

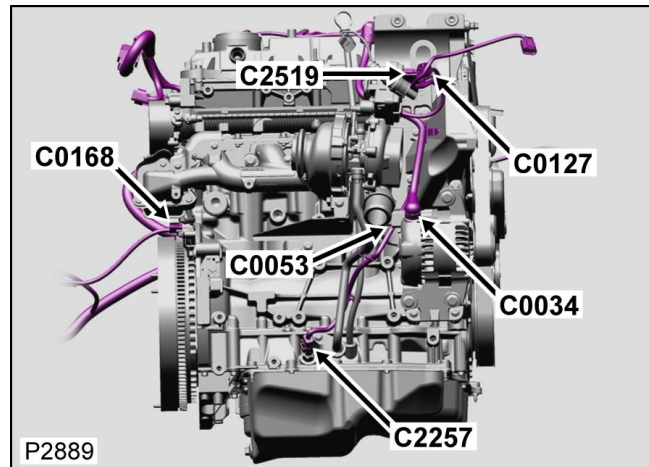
Location: **RH side of engine**

1		0.5	SP	254	C0162
2		0.5	GN	254	C0162
3		0.5	YP	254	C0411

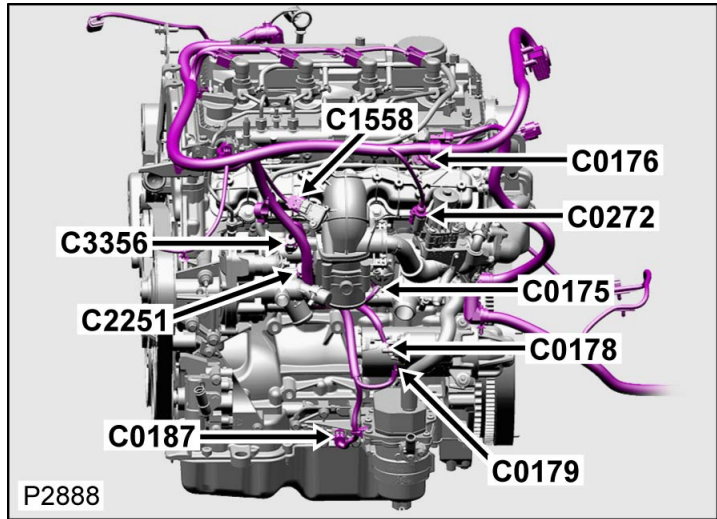
Cavities: **6WY**

Harness: **ENGINE DIESEL HARNESS**

CAV	TERMINAL	CSA	COL	CCT	DESTN
1	YPL101890	0.75	UO	254	C0411
2	YPL101880	0.5	YP	254	C0411
3	YPL101880	0.5	UW	254	C0411
4	YPL101890	0.75	Y	254	C0411
6	YPL101880	0.5	S	254	C0411

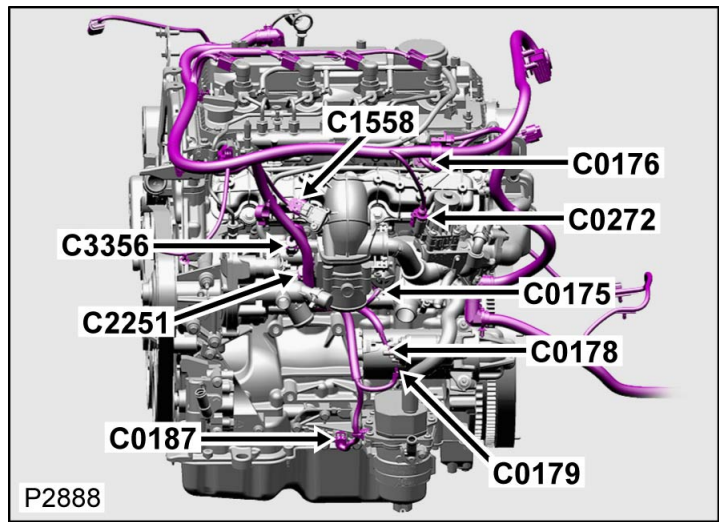
**Cavities: 6WY**

**Harness: ENGINE DIESEL HARNESS**

CAV	TERMINAL	CSA	COL	CCT	DESTN
1	YPL101890	0.75	UO	254	C0411
2	YPL101880	0.5	YP	254	C0411
3	YPL101880	0.5	UW	254	C0411
4	YPL101890	0.75	Y	254	C0411
6	YPL101880	0.5	S	254	C0411

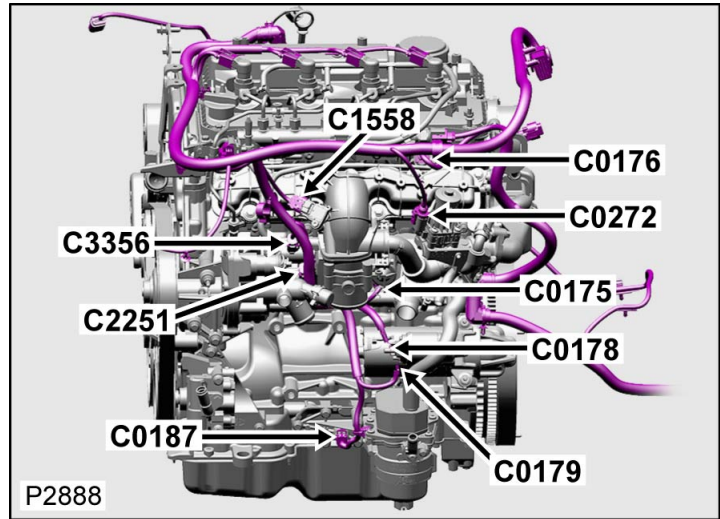
Location: **LH side of engine**

CAV	TERMINAL	CSA	COL	CCT	DESTN
1	YPL500570	0.75	OG	254	C0411
2	YPL500570	0.75	OB	254	C0411
3	YPL500560	0.5	NU	254	C0411

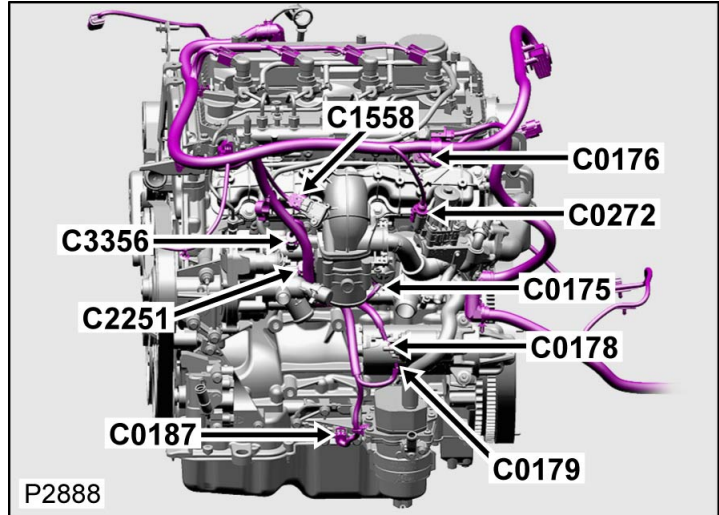
**Cavities: 3WY**

**Harness: ENGINE DIESEL HARNESS**

CAV	TERMINAL	CSA	COL	CCT	DESTN
1	YPL500570	0.75	OG	254	C0411
2	YPL500570	0.75	OB	254	C0411
3	YPL500560	0.5	NU	254	C0411

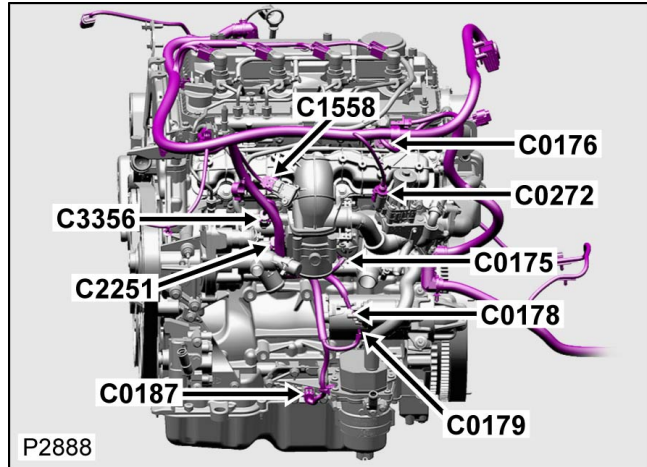
Cavities: **IWY**

Harness: **ENGINE DIESEL HARNESS**

CAV	TERMINAL	CSA	COL	CCT	DESTN
I	-	25.0	R	254	C0034

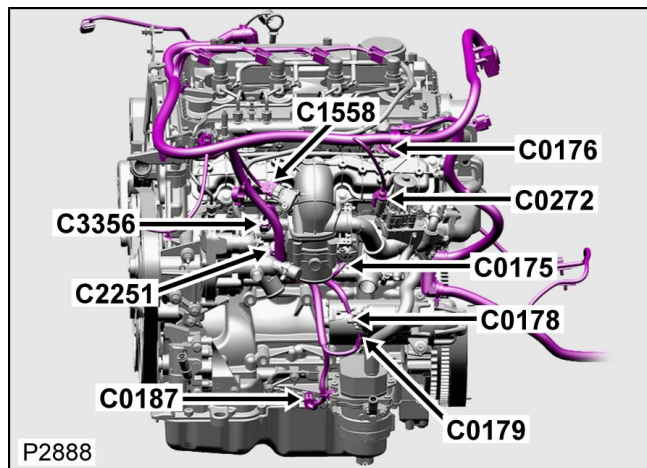
Cavities: **IWY**

Harness: **ENGINE DIESEL HARNESS**

CAV	TERMINAL	CSA	COL	CCT	DESTN
I	-	25.0	R	254	C0034

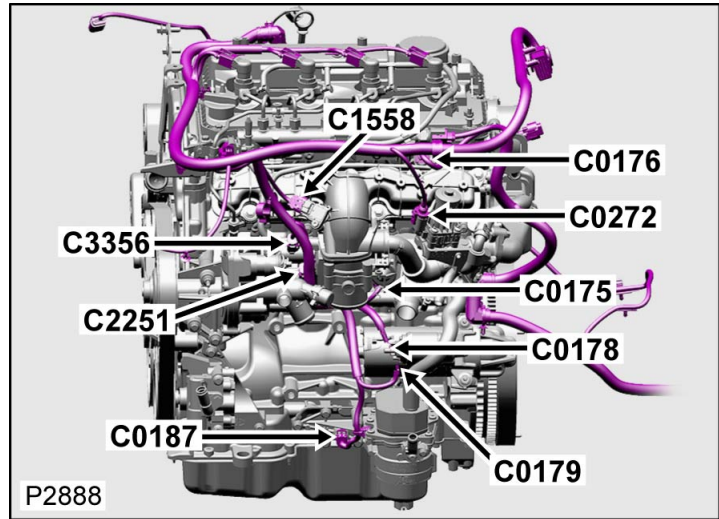
Location: **LH side of engine**

CAV	TERMINAL	CSA	COL	CCT	DESTN
I	YPL801130	0.75	S	254	C0411

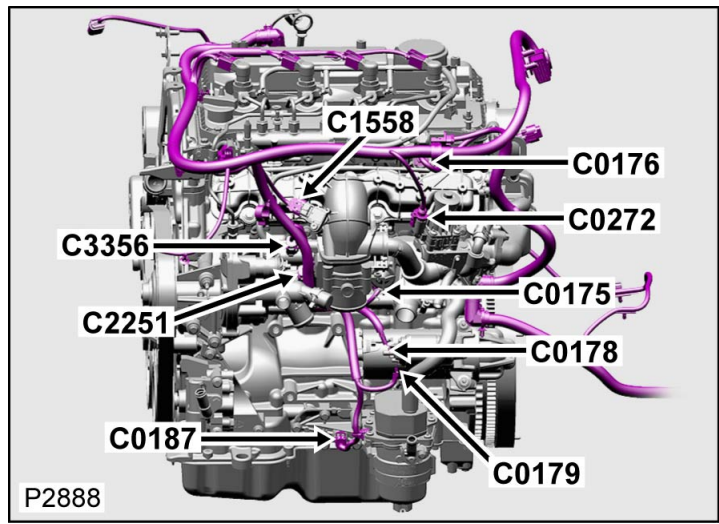
**Cavities: IWY**

**Harness: ENGINE DIESEL HARNESS**

CAV	TERMINAL	CSA	COL	CCT	DESTN
I	YPL801130	0.75	S	254	C0411

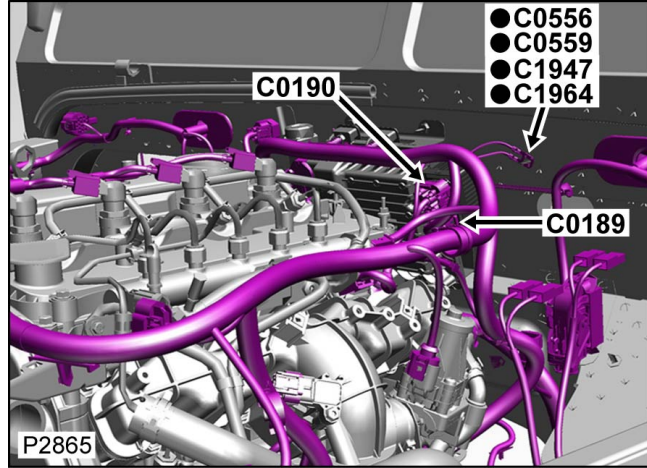
Location: **Rear LH side of engine compartment**

CAV	TERMINAL	CSA	COL	CCT	DESTN
1	ASSEMBLY	2.5	UN	254	C2583
3	ASSEMBLY	2.5	SP	254	C2583
4	ASSEMBLY	2.5	PW	254	C2583
6	ASSEMBLY	2.5	YU	254	C2583
