DEFENDER - VIN: 412051 >

Electrical Reference Library (1a)

JLR 16 25 21\_IE

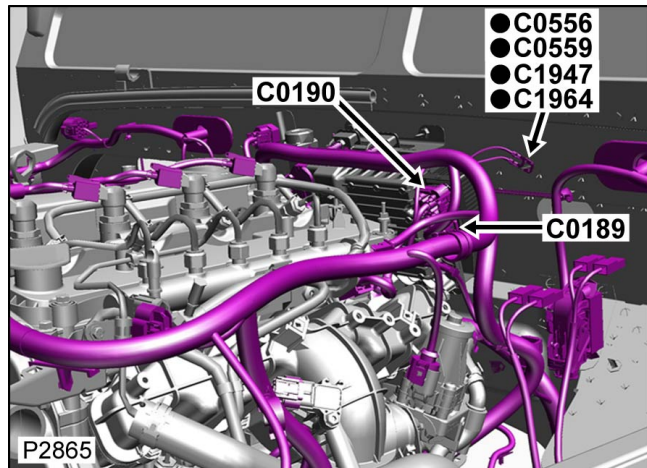
Location: **Rear LH side of engine compartment**

CAV	TERMINAL	CSA	COL	CCT	DESTN
1	ASSEMBLY	2.5	UN	254	C2583
3	ASSEMBLY	2.5	SP	254	C2583

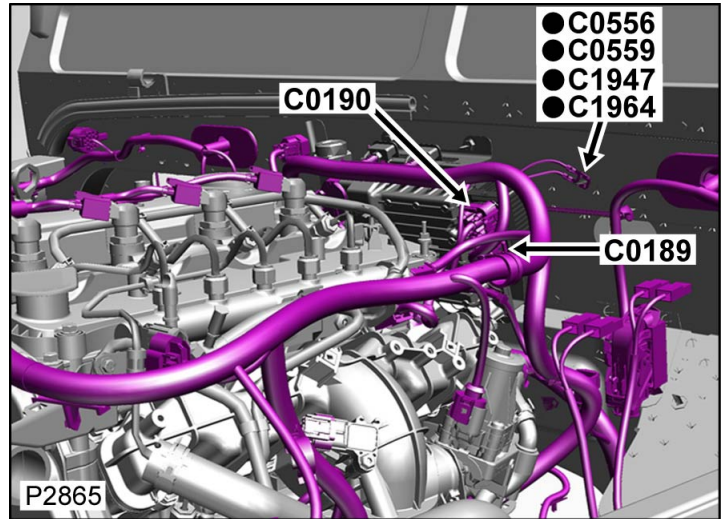
Cavities: **5WY**

Harness: **MAIN LH + RH HARNESS**

CAV	TERMINAL	CSA	COL	CCT	DESTN
1	YPL801960	0.75D	G	254	C0872
2	YPL801960	0.75D	NP	254	C0872
3	YPL801960	0.75D	B	254	C1964
4	YPL801970	0.35D	G	254	S/JOINT SJ31
5	YPL802040	6.0D	YR	499	C3762

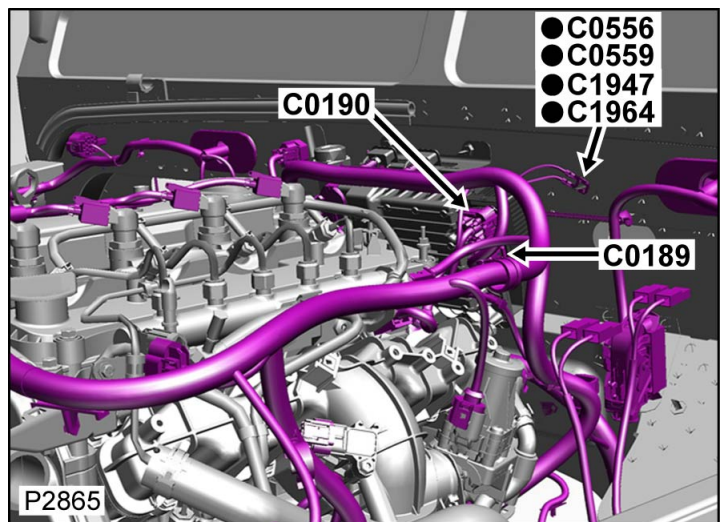
**Location: Rear LH side of engine compartment**

**Part No.: YPC804150**

**Colour: GREY**

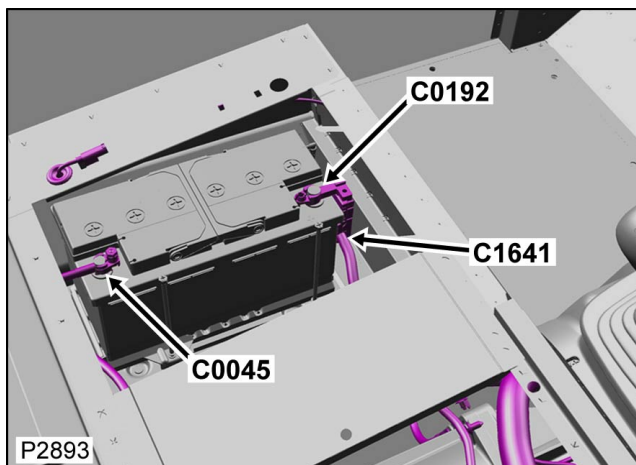
Location: **Beneath LH Front seat**

CAV	TERMINAL	CSA	COL	CCT	DESTN
I	-	10.0D	N	499	C0632

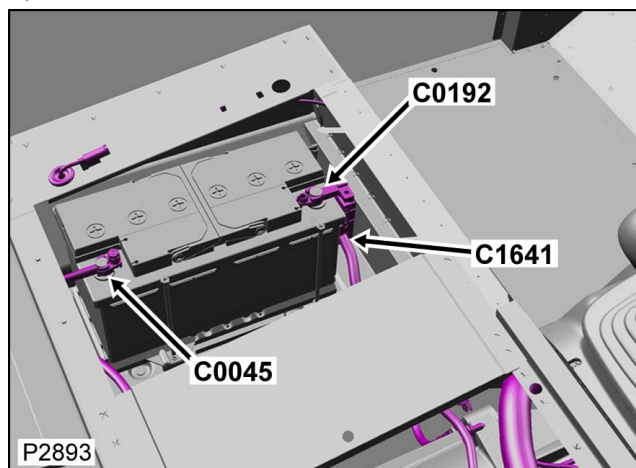
Location: **Beneath LH Front seat**

CAV	TERMINAL	CSA	COL	CCT	DESTN
I	-	10.0D	N	499	C0632

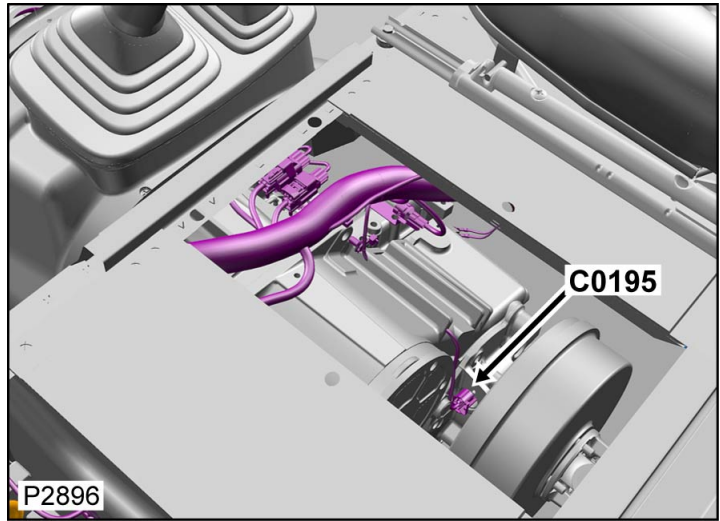
Cavities: **3WY**

Harness: **MAIN LH + RH HARNESS**

CAV	TERMINAL	CSA	COL	CCT	DESTN
1	YPL10062	0.5D	WG	254	C3766
2	YPL10062	0.5D	B	499	S/JOINT SJ11
3	YPL10062	0.5D	BR	139L	C1040L
3	YPL10062	0.5D	BR	200R	C1040R

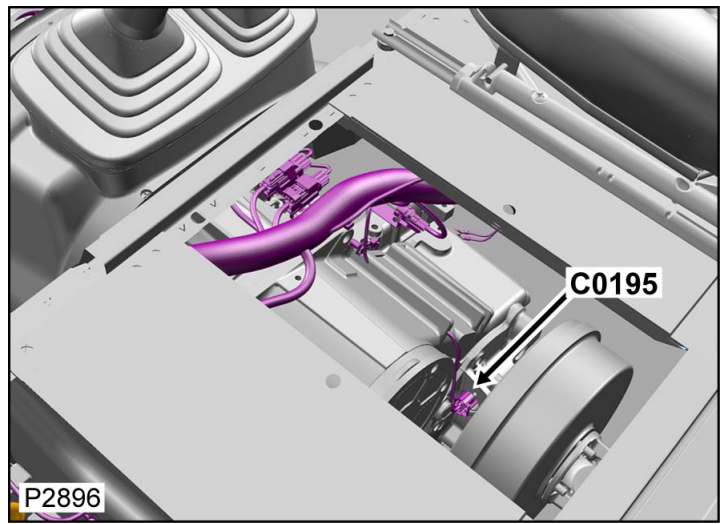
**Cavities: 3WY**

**Harness: MAIN LH + RH HARNESS**

CAV	TERMINAL	CSA	COL	CCT	DESTN
1	YPL10062	0.5D	WG	254	C3766
2	YPL10062	0.5D	B	499	S/JOINT SJ11
3	YPL10062	0.5D	BR	139L	C1040L
3	YPL10062	0.5D	BR	200R	C1040R

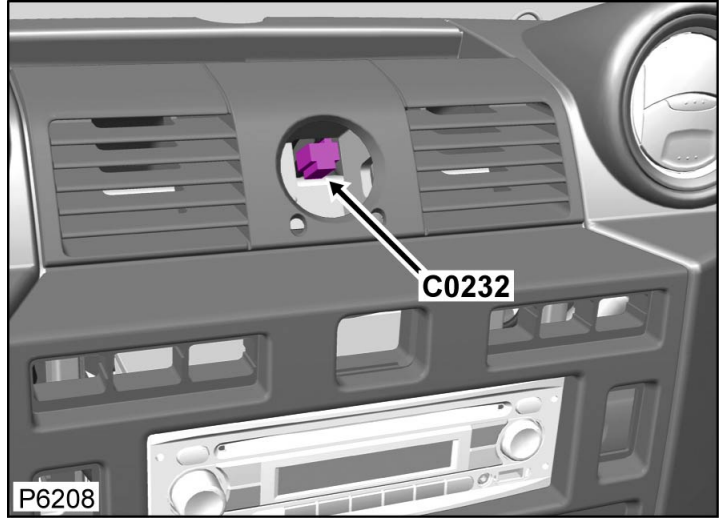
Cavities: **6WY**

Harness: **MAIN LH + RH HARNESS**

CAV	TERMINAL	CSA	COL	CCT	DESTN
2	YPL101310	0.5D	RO	499	S/JOINT SJ67
5	YPL101310	0.5D	B	499	S/JOINT SJ13
6	YPL101310	0.5D	PN	499	S/JOINT SJ60

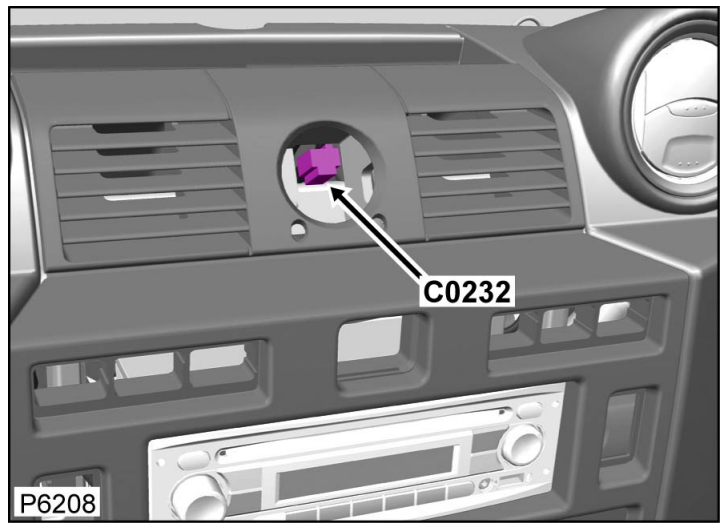
**Cavities: 6WY**

**Harness: MAIN LH + RH HARNESS**

CAV	TERMINAL	CSA	COL	CCT	DESTN
2	YPL101310	0.5D	RO	499	S/JOINT SJ67
5	YPL101310	0.5D	B	499	S/JOINT SJ13
6	YPL101310	0.5D	PN	499	S/JOINT SJ60

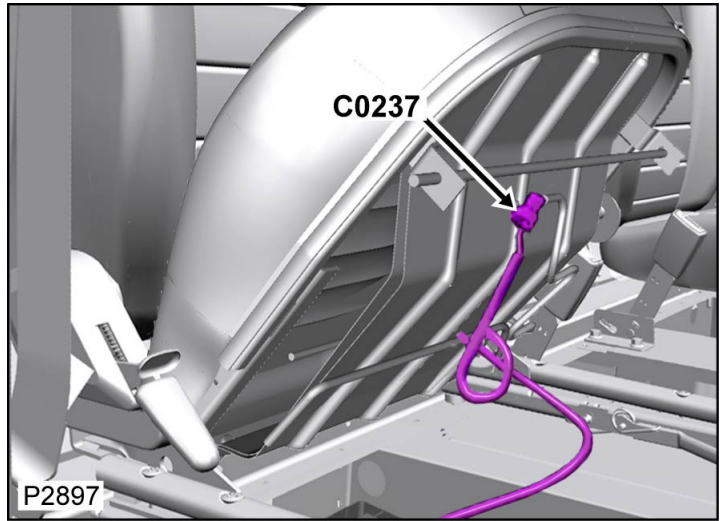
Cavities: **2WY**

Harness: **SEAT LINK HARNESS**

CAV	TERMINAL	CSA	COL	CCT	DESTN
1	YPL101910	0.75D	US	56	C0751
2	YPL101910	0.75D	B	56	C0751

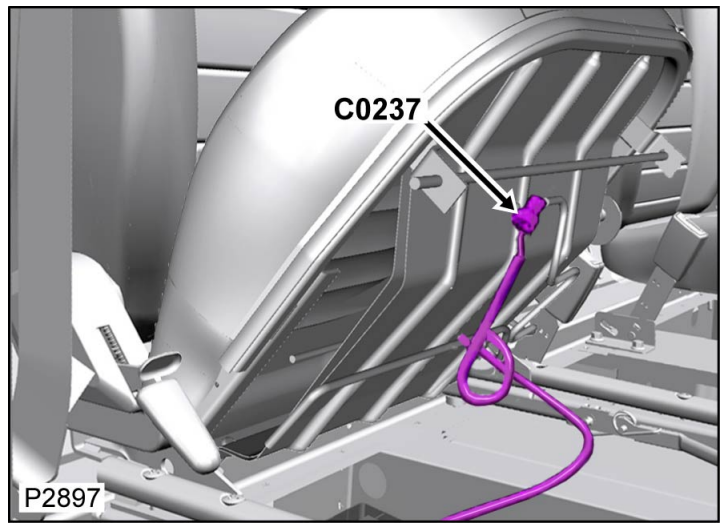
**Cavities: 2WY**

**Harness: SEAT LINK HARNESS**

CAV	TERMINAL	CSA	COL	CCT	DESTN
1	YPL101910	0.75D	US	56	C0751
2	YPL101910	0.75D	B	56	C0751

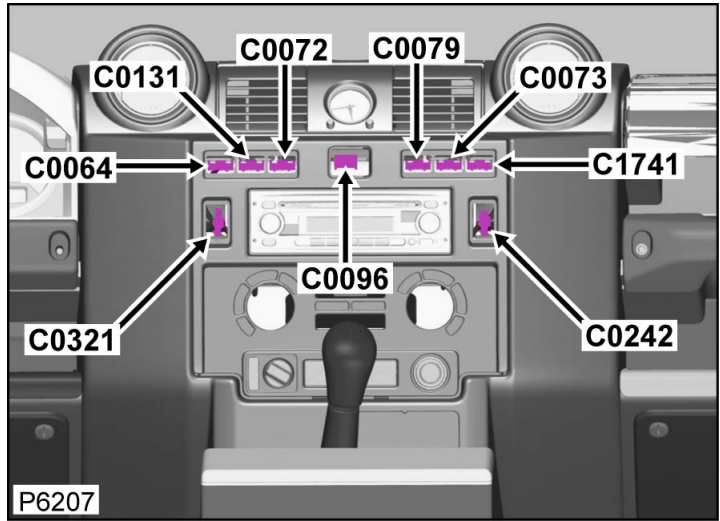
Cavities: **6WY**

Harness: **MAIN LH + RH HARNESS**

CAV	TERMINAL	CSA	COL	CCT	DESTN
1	AFU3753	1.5D	B	248	C0289
2	AFU3753	1.5D	SO	247L	C0582L
2	AFU3753	1.5D	SO	247R	C0582R
3	AFU3753	1.5D	OU	247R	C0464
3	AFU3753	1.5D	OU	247L	C0464
4	AFU3753	1.5D	OR	247R	C0464
4	AFU3753	1.5D	OR	247L	C0464
6	AFU3752	0.5D	RO	248	C0286

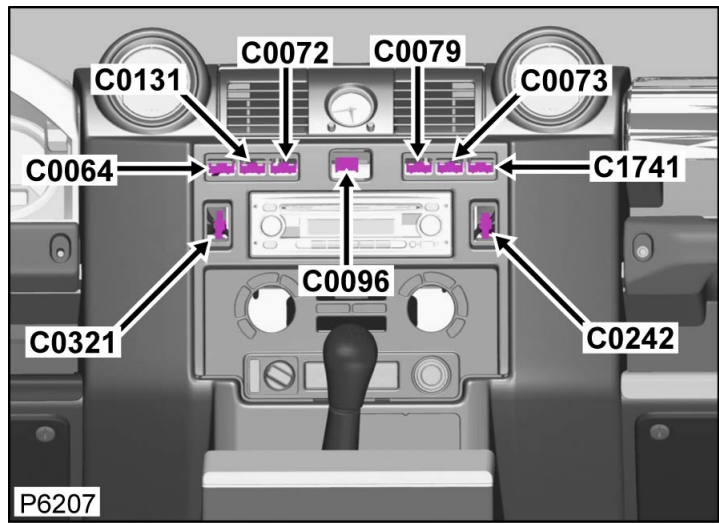
**Cavities:** 6WY

**Harness:** MAIN LH + RH HARNESS

CAV	TERMINAL	CSA	COL	CCT	DESTN
1	AFU3753	1.5D	B	248	C0289
2	AFU3753	1.5D	SO	247L	C0582L
2	AFU3753	1.5D	SO	247R	C0582R
3	AFU3753	1.5D	OU	247R	C0464
3	AFU3753	1.5D	OU	247L	C0464
4	AFU3753	1.5D	OR	247R	C0464
4	AFU3753	1.5D	OR	247L	C0464
6	AFU3752	0.5D	RO	248	C0286

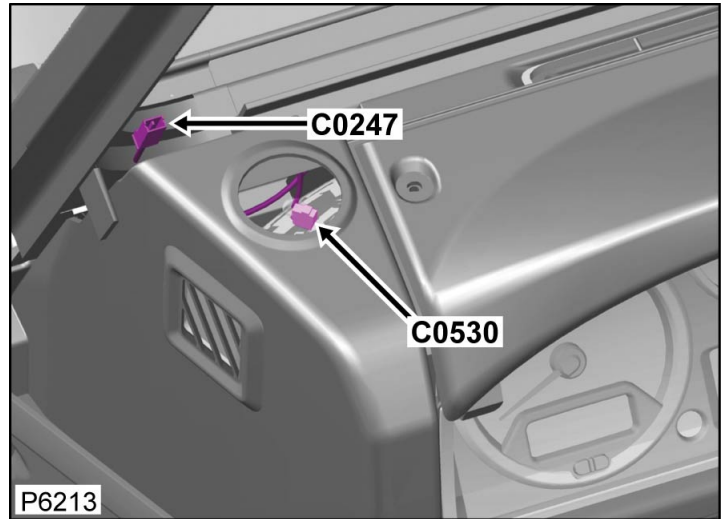
Location: **Instrument panel-left-upper**

Part No.: **AAUI010**

Colour: **BLACK**

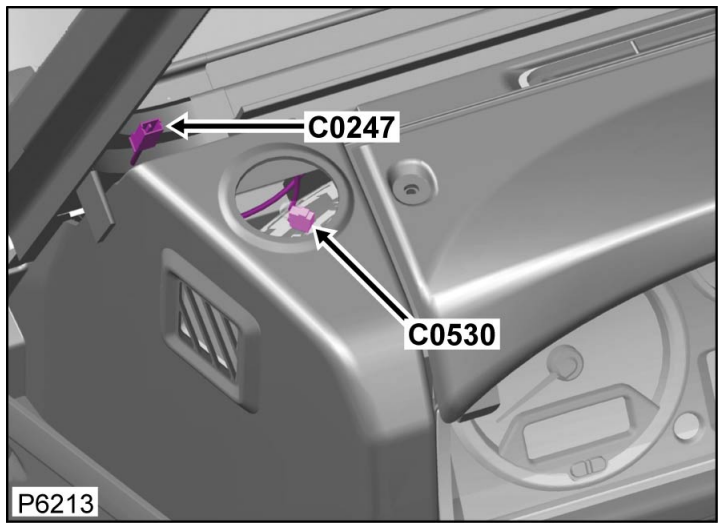
**Cavities: IWY**

**Harness: MAIN LH + RH HARNESS**

CAV	TERMINAL	CSA	COL	CCT	DESTN
I	ADU9568	2.5D	PS	766	S/JOINT SJ42

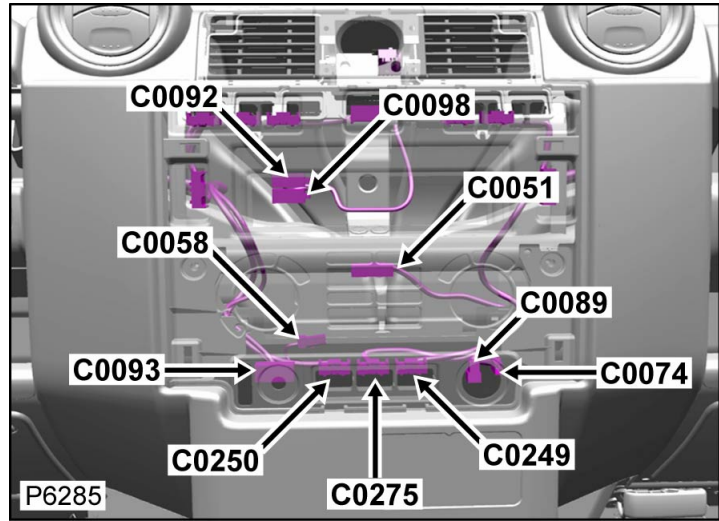
Location: **Instrument panel-Center**

CAV	TERMINAL	CSA	COL	CCT	DESTN
1	AFU3753	1.0D	LGW	766L	C0582L
1	AFU3753	1.0D	LGW	766R	C0582R
2	AFU3752	0.5D	RO	766	S/JOINT SJ76
4	AFU3753	0.75D	UK	766	CI403
5	AFU3752	0.5D	B	766	S/JOINT SJ20

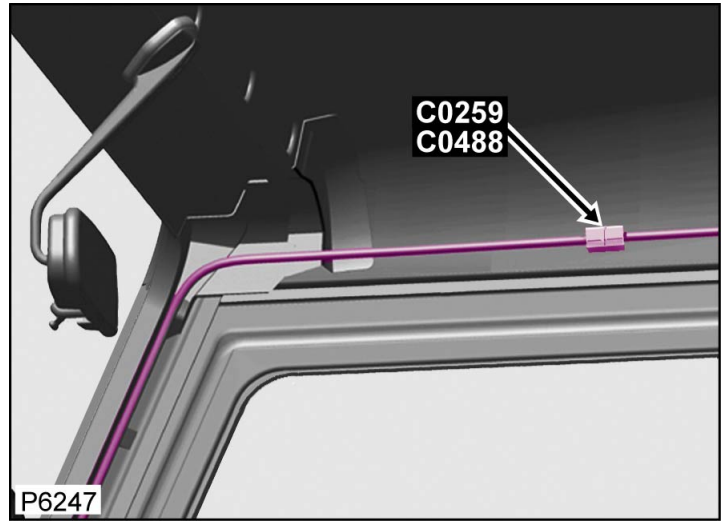
Cavities: **10WY**

Harness: **ROOF FRONT HARNESS**

CAV	TERMINAL	CSA	COL	CCT	DESTN
1	YPJ10002	0.5D	B	902	C1991
1	YPJ10002	0.5D	B	903	C1209
1	YPJ10002	0.5D	B	904	C1210
2	YPJ10001	1.0D	PW	902	C0357
2	YPJ10001	1.0D	PW	903	C0356
2	YPJ10001	1.0D	PW	904	C0355
3	YPJ10001	1.0D	PN	902	C0357
3	YPJ10001	1.0D	PN	903	C0356
3	YPJ10001	1.0D	PN	904	C0355
4	YPJ10002	0.5D	PU	902	C0615
4	YPJ10002	0.5D	PU	903	C1992
4	YPJ10002	0.5D	PU	909	C1993
4	YPJ10002	0.5D	PU	910	C1994
5	YPJ10006	1.5D	K	905	C1986
5	YPJ10006	1.5D	K	906	C1987

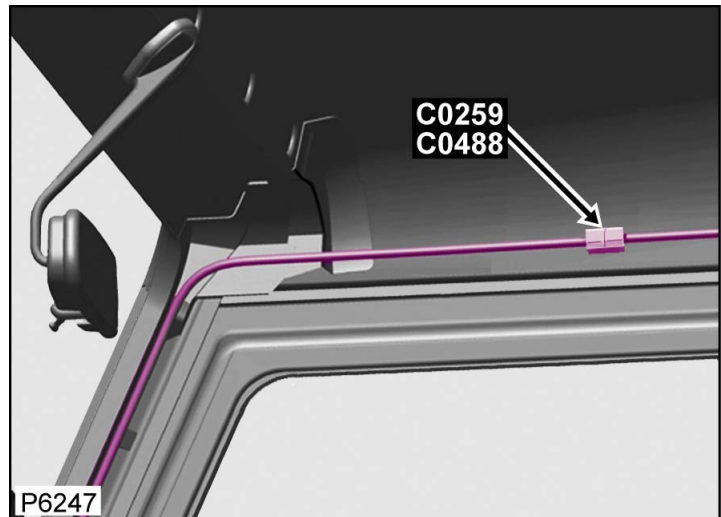
**Cavities: 10WY**

**Harness: ROOF FRONT HARNESS**

CAV	TERMINAL	CSA	COL	CCT	DESTN
1	YPJ10002	0.5D	B	902	C1991
1	YPJ10002	0.5D	B	903	C1209
1	YPJ10002	0.5D	B	904	C1210
2	YPJ10001	1.0D	PW	902	C0357

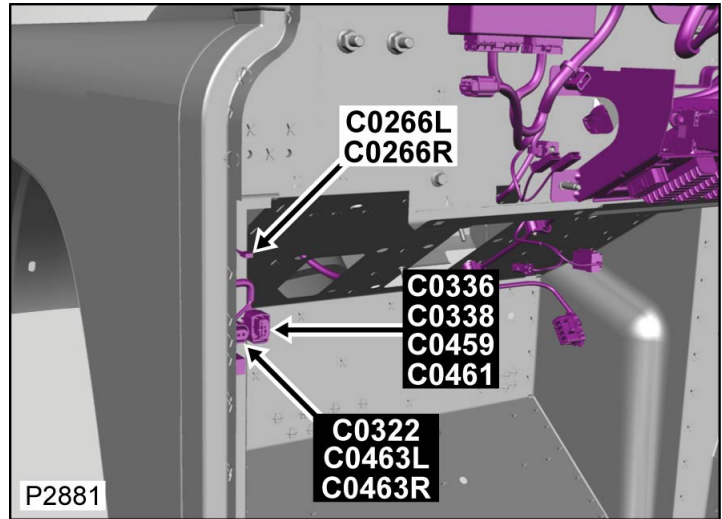
Cavities: **I WY**

Harness: **MAIN LH + RH HARNESS**

CAV	TERMINAL	CSA	COL	CCT	DESTN
I	AFU3262	0.5H	SW	22L	C0061L

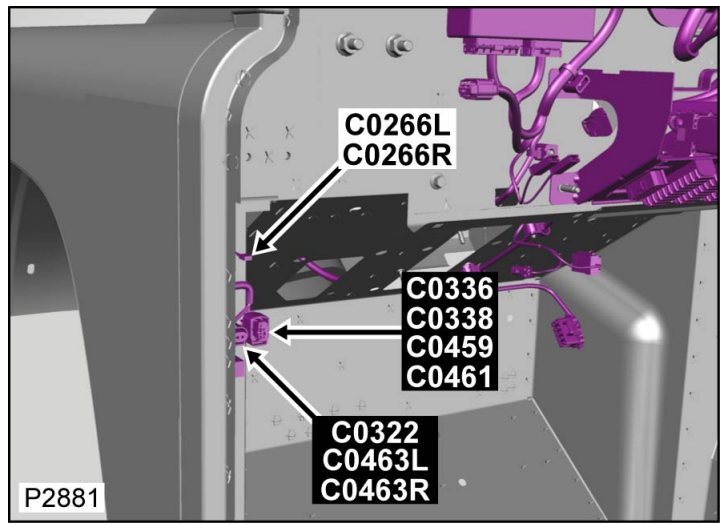
**Cavities: IWY**

**Harness: MAIN LH + RH HARNESS**

CAV	TERMINAL	CSA	COL	CCT	DESTN
I	AFU3262	0.5H	SW	22L	C0061L

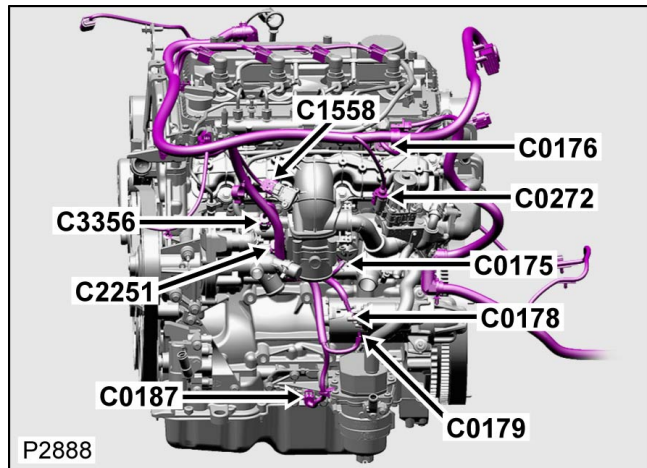
Location: **LH side of engine**

CAV	TERMINAL	CSA	COL	CCT	DESTN
1	YPL905100	0.75	WP	254	C0411
2	YPL905100	0.5	SW	254	C0411

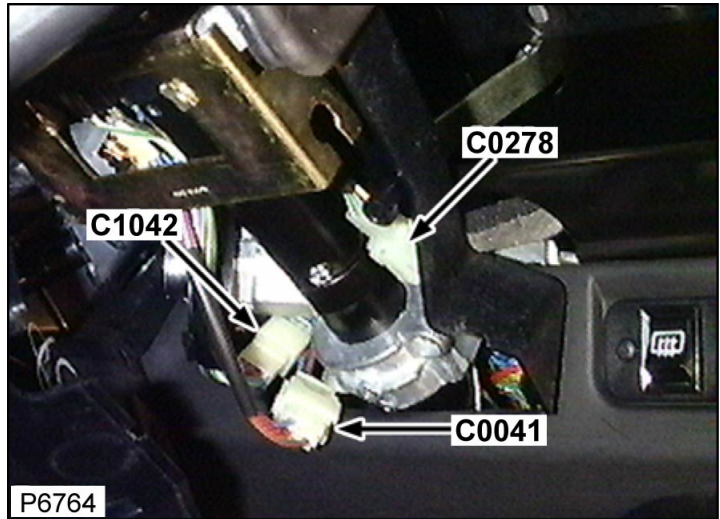
Cavities: **6WY**

Harness: **MAIN LH + RH HARNESS**

CAV	TERMINAL	CSA	COL	CCT	DESTN
1	YPL10002	2.0D	ULG	200R	C0030
2	YPL10002	1.5D	LGB	200R	C0285
3	YPL10002	1.5D	WG	200R	C0303R
4	YPL10002	2.0D	YLG	200R	C0303R
5	YPL10002	2.0D	RLG	200R	C0030
6	YPL10002	2.0D	WG	200R	S/JOINT SJ32

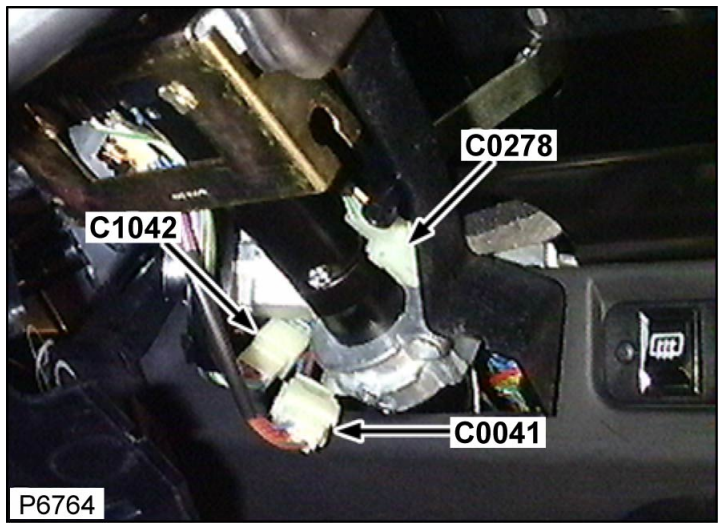
**Cavities: 6WY**

**Harness: MAIN LH + RH HARNESS**

CAV	TERMINAL	CSA	COL	CCT	DESTN
1	YPL10002	2.0D	ULG	200R	C0030
2	YPL10002	1.5D	LGB	200R	C0285
3	YPL10002	1.5D	WG	200R	C0303R
4	YPL10002	2.0D	YLG	200R	C0303R
5	YPL10002	2.0D	RLG	200R	C0030
6	YPL10002	2.0D	WG	200R	S/JOINT SJ32

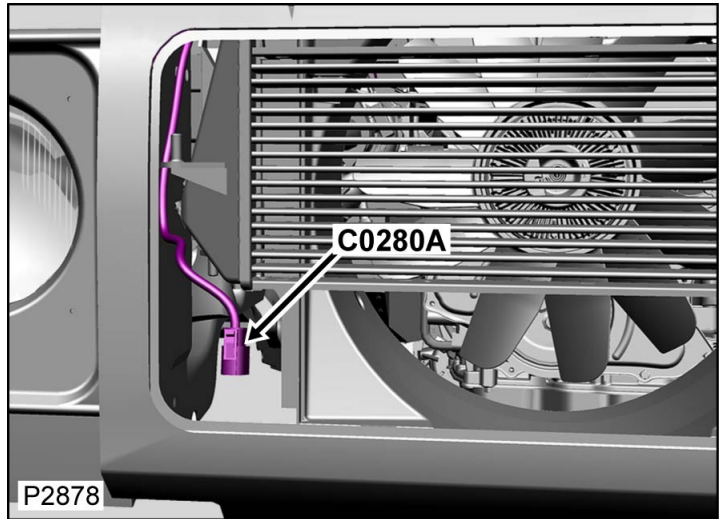
Location: **In front of the radiator**

CAV	TERMINAL	CSA	COL	CCT	DESTN
1	YPE100330	2.5D	BG	14	C3764
2	YPE100330	2.0D	B	14	C0550

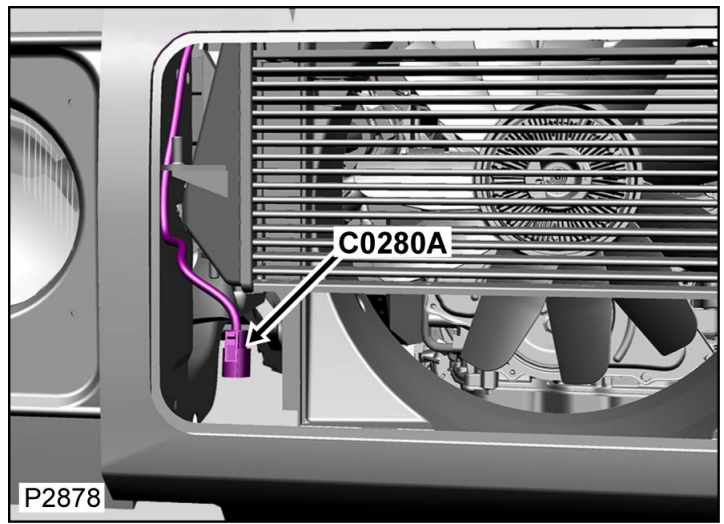
**Cavities: 2WY**

**Harness: MAIN LH + RH HARNESS**

CAV	TERMINAL	CSA	COL	CCT	DESTN
1	YPE100330	2.5D	BG	14	C3764
2	YPE100330	2.0D	B	14	C0550

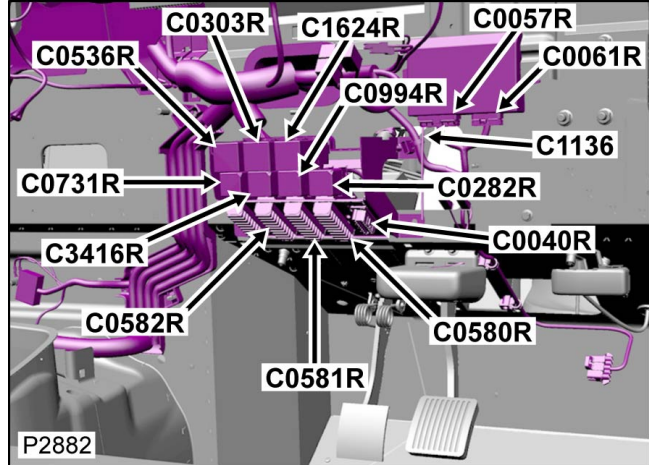
Qualifier: **RHD condition illustrated**

CAV	TERMINAL	CSA	COL	CCT	DESTN
30	YPLI0045	2.5D	UR	200R	C3764
85	AFU3119	0.5D	B	200R	C0289
86	AFU3119	0.5D	WG	200R	C0285
87	YPLI0045	2.5D	U	200R	S/JOINT Sj6I

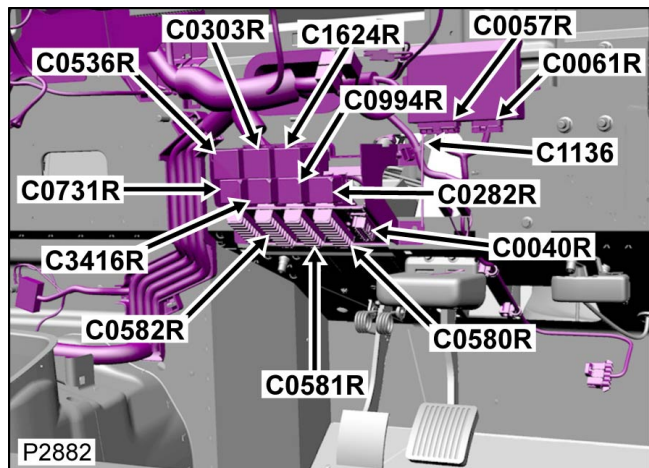
Location: **Behind RH side of Instrument panel**

Qualifier: **RHD condition illustrated**

CAV	TERMINAL	CSA	COL	CCT	DESTN
30	YPLI0045	2.5D	UR	200R	C3764
85	AFU3119	0.5D	B	200R	C0289

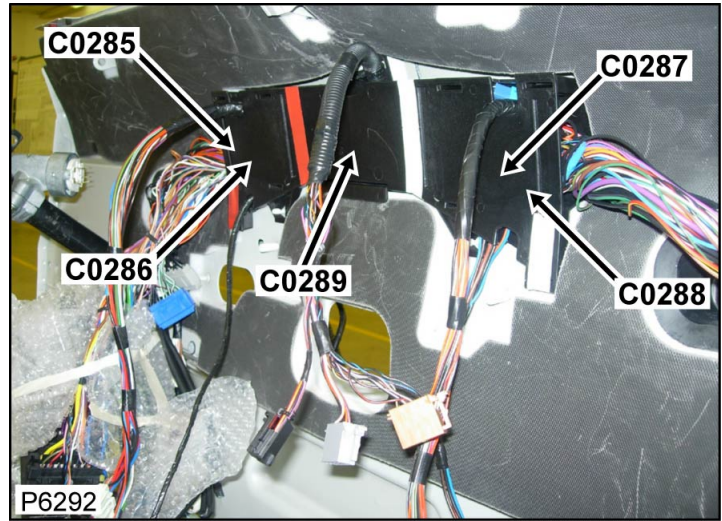
Location: **Behind center of Instrument panel**

Part No.: **YQC10004**

Colour: **YELLOW**

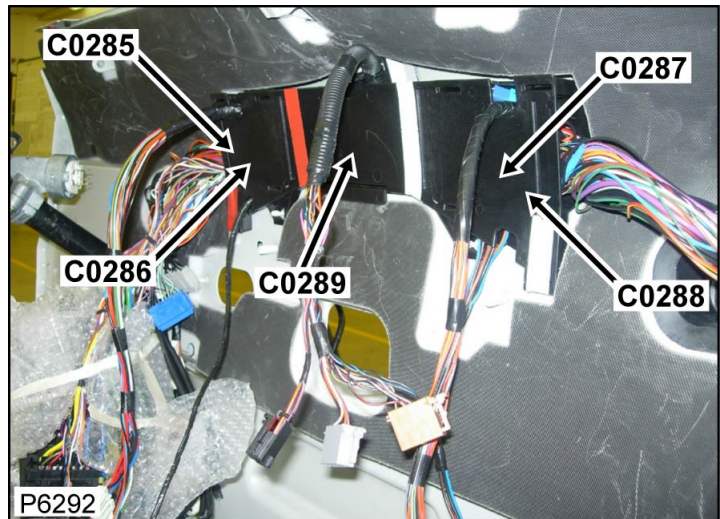
**Cavities: 20WY**

**Harness: MAIN LH + RH HARNESS**

CAV	TERMINAL	CSA	COL	CCT	DESTN
1	AFU3560	1.0D	RO	200R	C0581R
1	AFU3560	1.0D	RO	139L	C0581L
2	AFU3572	0.5D	RO	248	C0242
3	AFU3572	0.5D	RO	248	C0321
4	AFU3572	0.5D	RO	499	S/JOINT SJ67
5	AFU3572	0.5D	RO	107	C0093

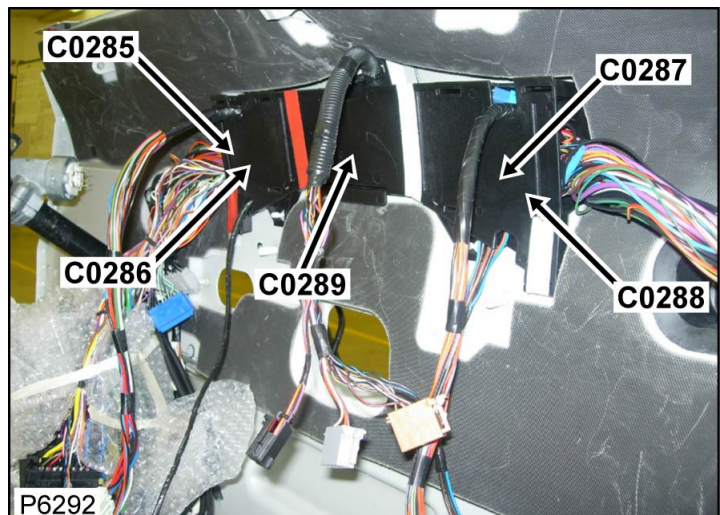
**Cavities: 20WY**

**Harness: MAIN LH + RH HARNESS**

CAV	TERMINAL	CSA	COL	CCT	DESTN
1	AFU3560	1.0D	GR	499	C0376
2	AFU3560	1.0D	GR	499	C0096
3	AFU3572	0.5D	GR	200R	CI040R
3	AFU3572	0.5D	GR	139L	CI040L
4	AFU3572	0.5D	GR	200R	CI042
4	AFU3572	0.5D	GR	139L	CI739
5	AFU3572	0.5D	GR	22R	C0057R
5	AFU3572	0.5D	GR	22L	C0057L
6	AFU3572	0.5D	GR	139L	CI264L
6	AFU3572	0.5D	GR	200R	CI264R
7	YPL10002	1.5D	PB	200R	CI042
7	YPL10002	1.5D	PB	139L	CI739
8	YPL10002	1.5D	PS	22R	C0581R
8	YPL10002	1.5D	PB	22L	C0581L
9	AFU3560	0.75D	PB	139L	CI264L
9	AFU3560	0.75D	PB	200R	CI264R
10	AFU3560	0.75D	PB	499	CI266
11	AFU3572	0.5D	PN	499	S/JOINT SJ60
12	AFU3572	0.5D	PN	200R	CI040R
12	AFU3572	0.5D	PN	139L	CI040L
13	AFU3572	0.5D	PN	22L	C0040L
13	AFU3572	0.5D	PN	22R	C0040R
14	AFU3572	0.5D	PN	769	S/JOINT SJ58

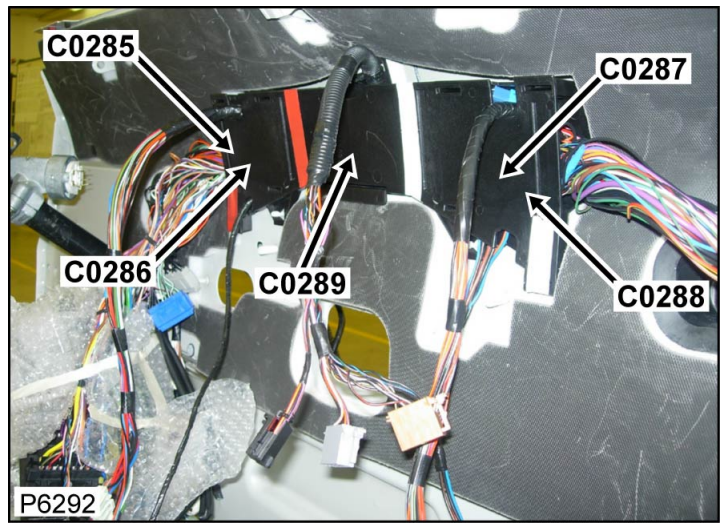
**Cavities: 20WY**

**Harness: MAIN LH + RH HARNESS**

CAV	TERMINAL	CSA	COL	CCT	DESTN
1	YPL10002	1.5D	B	248	C0321
2	YPL10002	1.5D	B	248	C0242
3	YPL10002	1.5D	B	247L	C3416L
3	YPL10002	1.5D	B	247R	C3416R
3	YPL10002	1.5D	B	95L	C3416L
3	YPL10002	1.5D	B	95R	C3416R
4	YPL10002	1.5D	B	499	C0550
5	AFU3572	0.5D	B	139L	S/JOINT SJ18
5	AFU3572	0.5D	B	200R	S/JOINT SJ19
6	AFU3572	0.5D	B	767R	C0460
6	AFU3572	0.5D	B	767L	C0459
7	AFU3572	0.5D	B	766R	C1624R
7	AFU3572	0.5D	B	766L	C1624L
8	AFU3572	0.5D	B	766L	C0994L
8	AFU3572	0.5D	B	766R	C0994R
9	AFU3560	1.0D	B	499	C0089
10	YPL10002	2.0D	B	200R	C0030

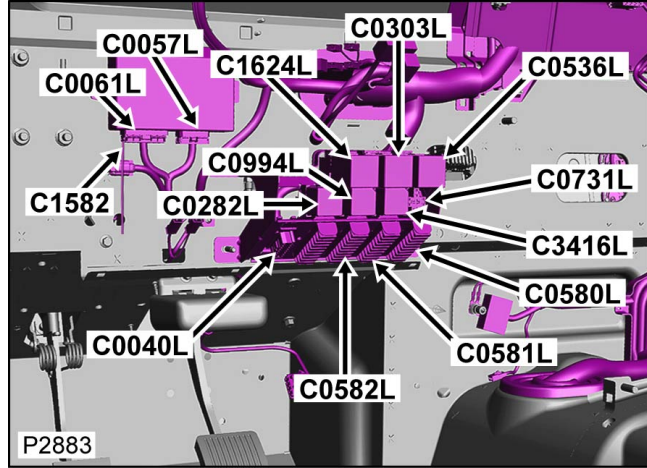
Qualifier: **LHD condition illustrated**

CAV	TERMINAL	CSA	COL	CCT	DESTN
1	AGU1113	1.5D	WG	I39L	CI740
2	AFU3173	2.0D	YLG	I39L	CI740
4	AFU3173	1.5D	B	I39L	C0289
5	AFU3173	2.0D	NLG	I39L	CI510
6	AFU3173	1.5D	LGB	I39L	C0285
8	AFU3173	2.0D	WG	I39L	S/JOINT SJ45

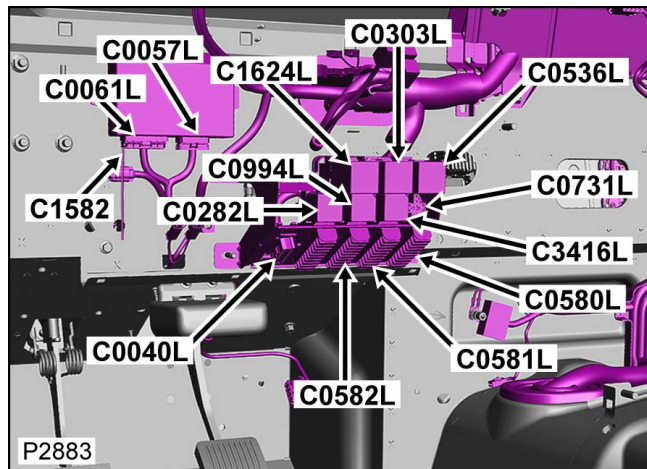
Location: **Behind LH side of Instrument panel**

Qualifier: **LHD condition illustrated**

CAV	TERMINAL	CSA	COL	CCT	DESTN
1	AGU1113	1.5D	WG	I39L	CI740
2	AFU3173	2.0D	YLG	I39L	CI740

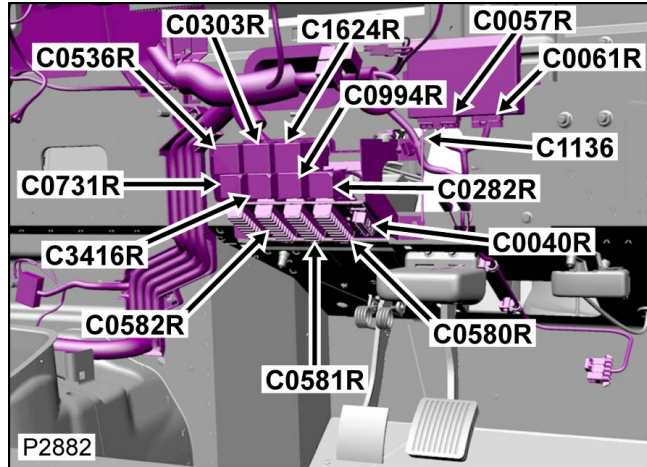
Qualifier: **RHD condition illustrated**

CAV	TERMINAL	CSA	COL	CCT	DESTN
1	AGU1113	1.5D	WG	200R	C0278
2	AFU3173	2.0D	YLG	200R	C0278
4	AFU3173	1.5D	B	200R	C0289
5	AFU3173	2.0D	NLG	200R	C0030
6	AFU3173	1.5D	LGB	200R	C0285
8	AFU3173	2.0D	WG	200R	S/JOINT SJ32

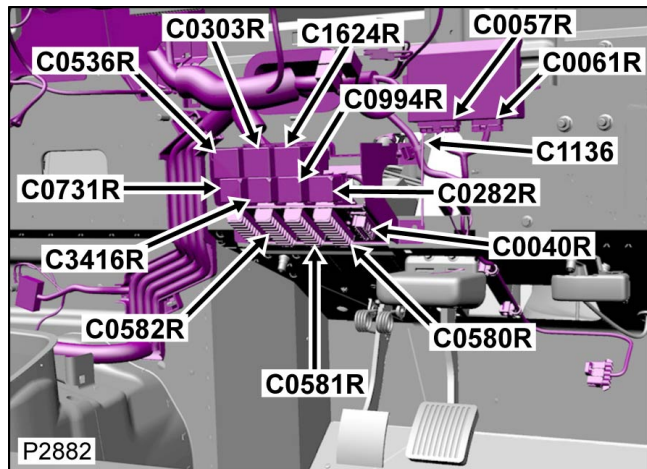
Location: **Behind RH side of Instrument panel**

Qualifier: **RHD condition illustrated**

CAV	TERMINAL	CSA	COL	CCT	DESTN
1	AGU1113	1.5D	WG	200R	C0278
2	AFU3173	2.0D	YLG	200R	C0278

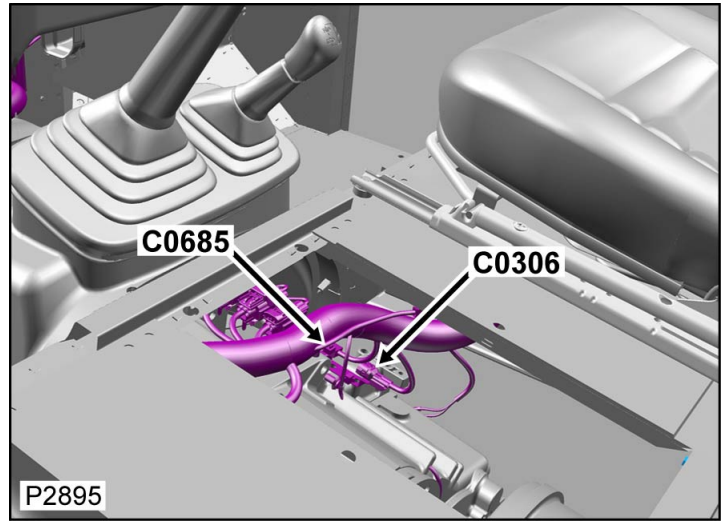
Cavities: **2WY**

Harness: **MAIN LH + RH HARNESS**

CAV	TERMINAL	CSA	COL	CCT	DESTN
1	DBP8550	0.5D	BU	151R	C1040R
1	DBP8550	0.5D	BU	151L	C1040L
1	DBP8550	0.5D	BU	9	S/JOINT SJ37
1	DBP8550	0.5D	BU	10	S/JOINT SJ53
2	DBP8550	0.5D	B	499	S/JOINT SJ11

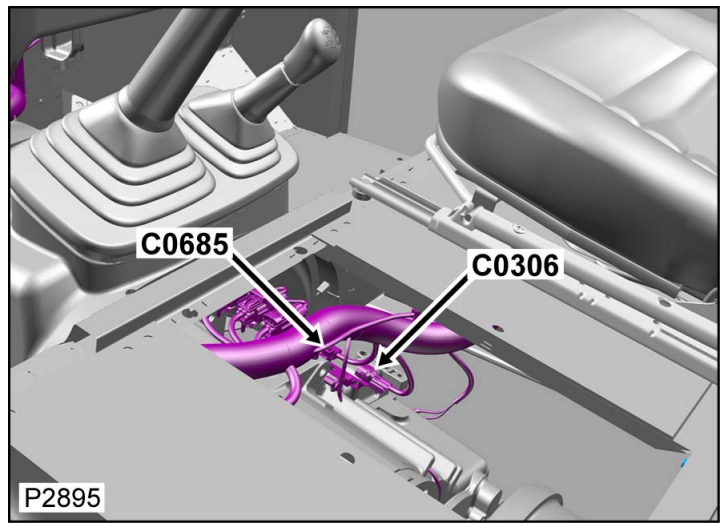
**Cavities: 2WY**

**Harness: MAIN LH + RH HARNESS**

CAV	TERMINAL	CSA	COL	CCT	DESTN
1	DBP8550	0.5D	BU	151R	C1040R
1	DBP8550	0.5D	BU	151L	C1040L
1	DBP8550	0.5D	BU	9	S/JOINT SJ37
1	DBP8550	0.5D	BU	10	S/JOINT SJ53
2	DBP8550	0.5D	B	499	S/JOINT SJ11

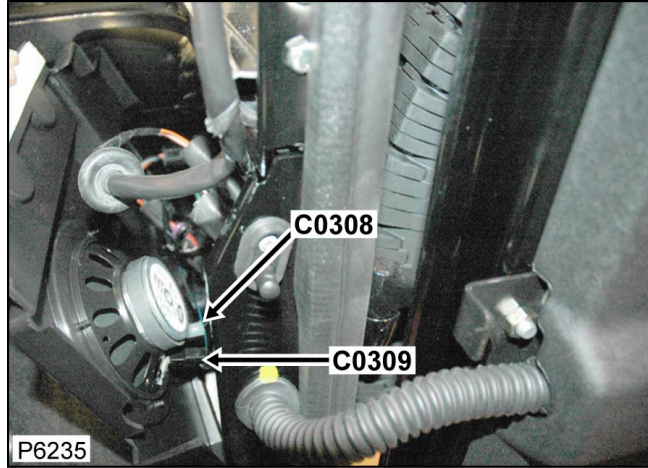
Location: **Behind RH rear trim panel**

CAV	TERMINAL	CSA	COL	CCT	DESTN
I	AFU4522	0.5D	BG	771	CI759
I	AFU4522	0.5D	BG	770	C0390

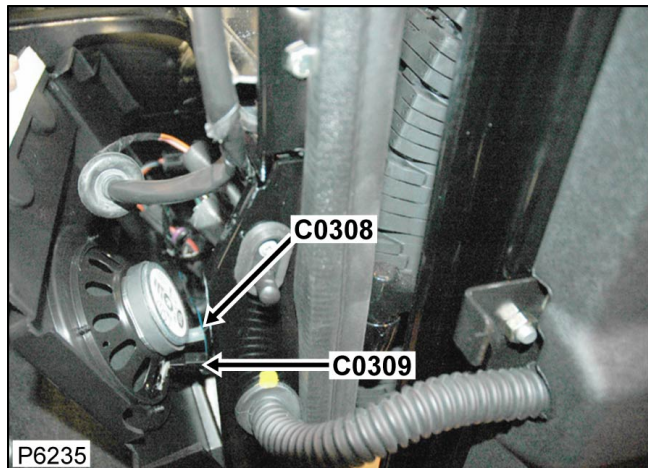
Location: **Behind RH rear trim panel**

CAV	TERMINAL	CSA	COL	CCT	DESTN
I	AFU4522	0.5D	BG	771	CI759
I	AFU4522	0.5D	BG	770	C0390

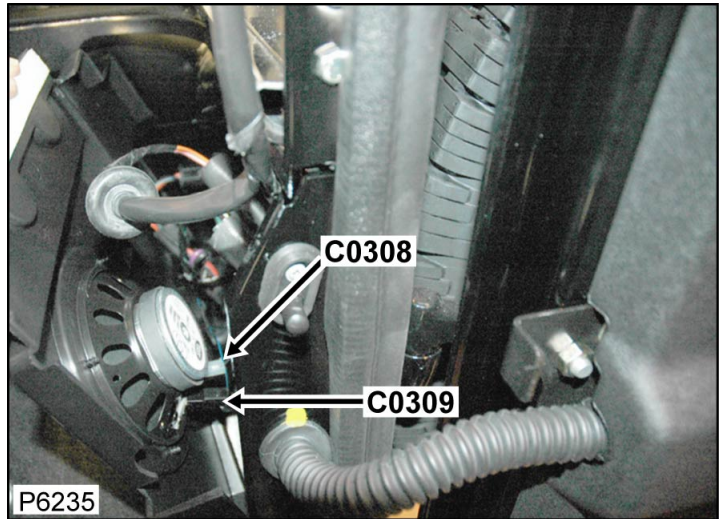
Cavities: **IWY**

Harness: **CHASSIS HARNESS**

CAV	TERMINAL	CSA	COL	CCT	DESTN
I	AFU3262	0.5D	BU	771	C1759
I	AFU3262	0.5D	BU	770	C0390

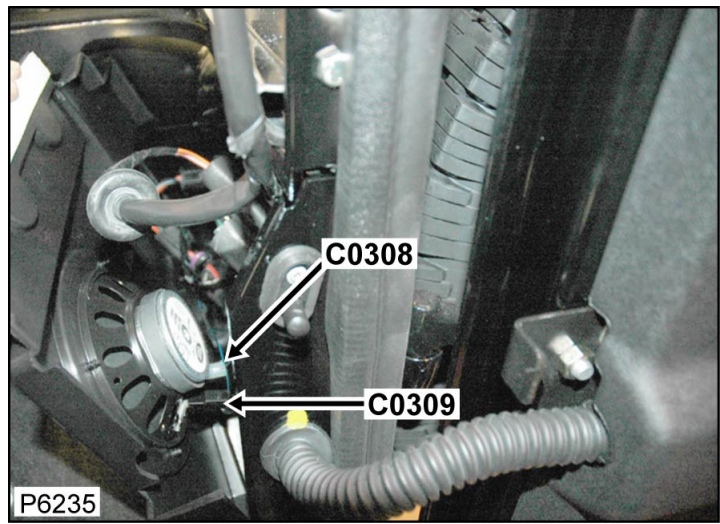
Cavities: **IWY**

Harness: **CHASSIS HARNESS**

CAV	TERMINAL	CSA	COL	CCT	DESTN
I	AFU3262	0.5D	BU	771	C1759
I	AFU3262	0.5D	BU	770	C0390

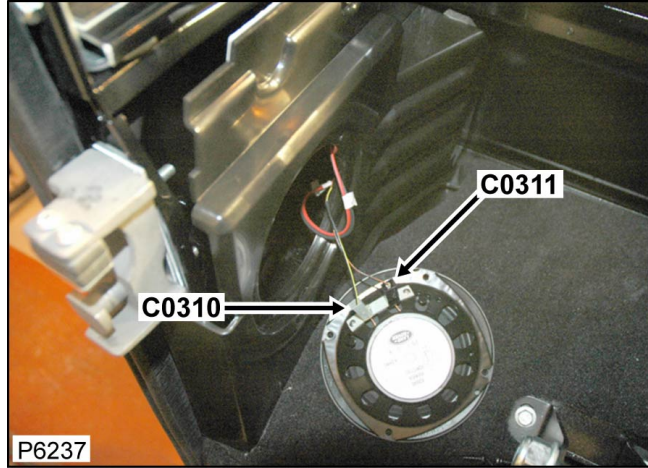
Location: **Base of 'D' post LH side**

CAV	TERMINAL	CSA	COL	CCT	DESTN
I	AFU4522	0.5D	BY	771	CI759
I	AFU4522	0.5D	BY	770	C0390

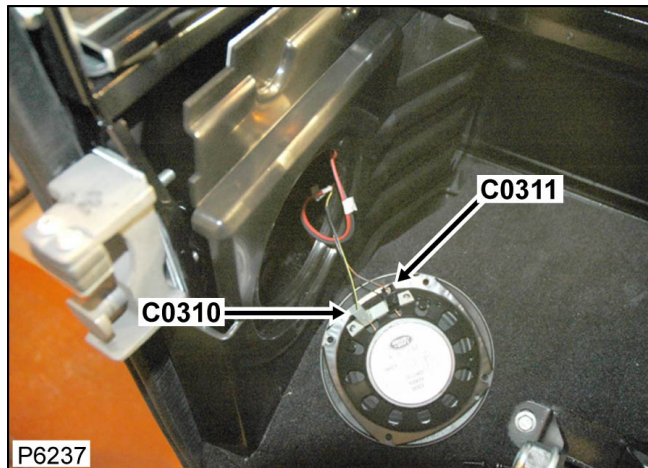
Location: **Base of 'D' post LH side**

CAV	TERMINAL	CSA	COL	CCT	DESTN
I	AFU4522	0.5D	BY	771	CI759
I	AFU4522	0.5D	BY	770	C0390

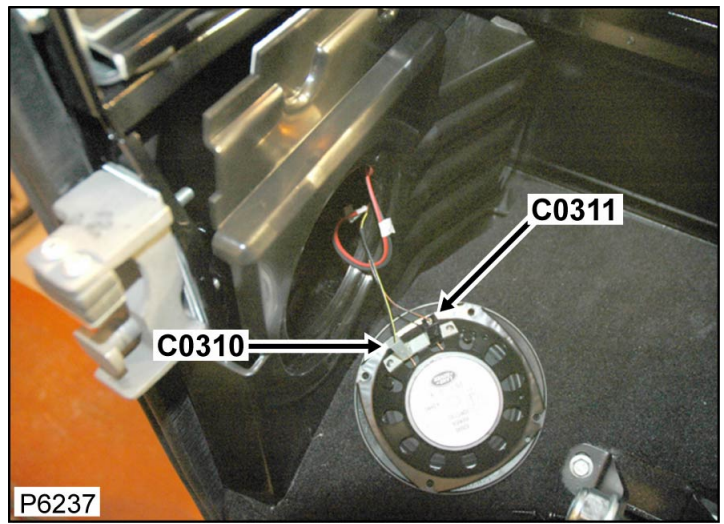
**Cavities: IWY**

**Harness: CHASSIS HARNESS**

CAV	TERMINAL	CSA	COL	CCT	DESTN
I	AFU3262	0.5D	BO	771	C1759
I	AFU3262	0.5D	BO	770	C0390

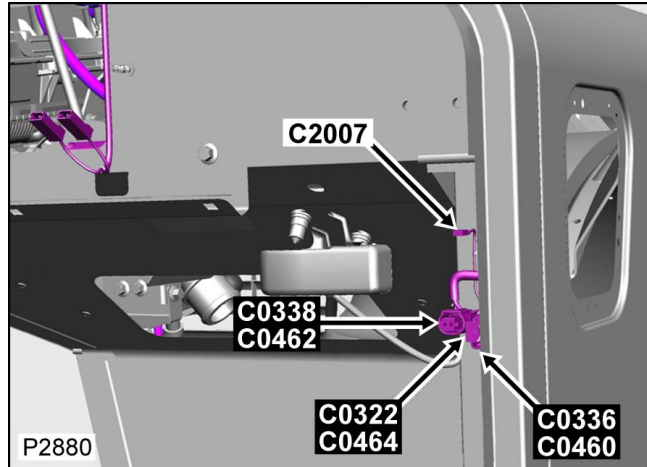
Location: **RH 'A' post**

CAV	TERMINAL	CSA	COL	CCT	DESTN
1	YPJ10008	2.0D	R	895	C0326
2	YPJ10008	2.0D	U	895	C0326

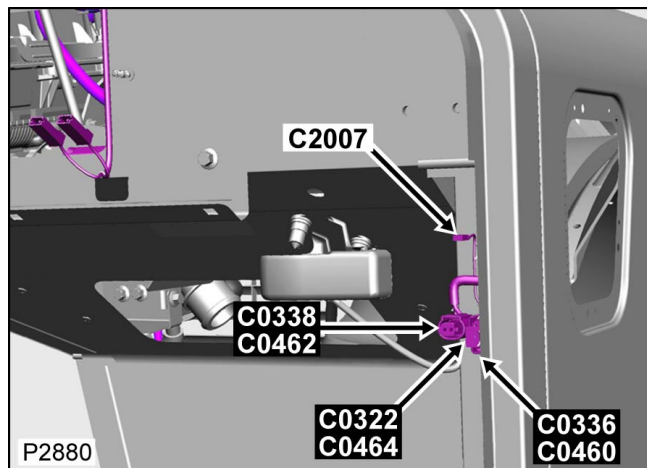
Location: **RH 'A' post**

CAV	TERMINAL	CSA	COL	CCT	DESTN
1	YPJ10008	2.0D	R	895	C0326
2	YPJ10008	2.0D	U	895	C0326

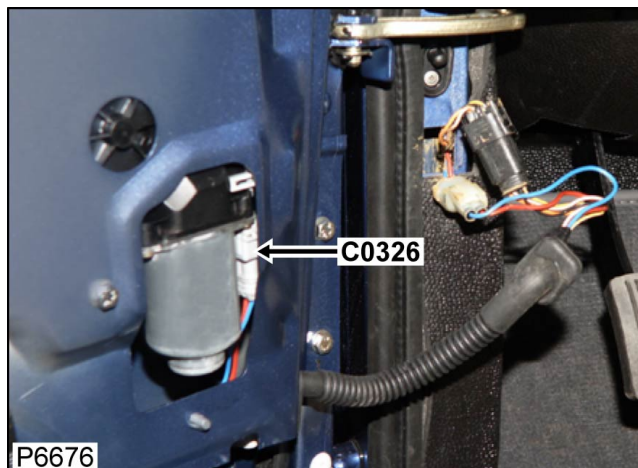
Location: **Behind front door trim panel**

CAV	TERMINAL	CSA	COL	CCT	DESTN
1	YPL500150	2.0D	U	895	C0322
2	YPL500150	2.0D	R	895	C0322

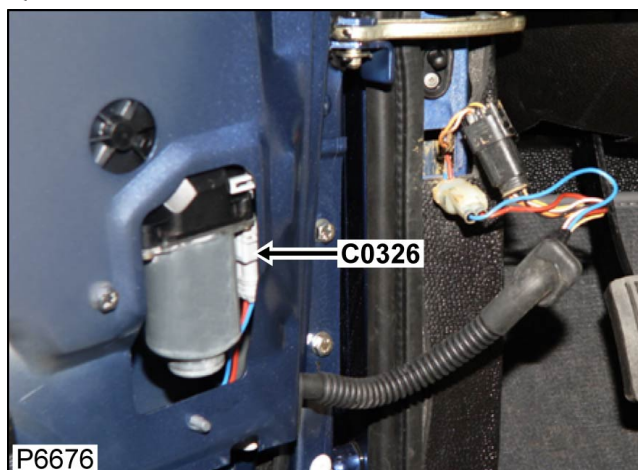
Location: **Behind front door trim panel**

CAV	TERMINAL	CSA	COL	CCT	DESTN
1	YPL500150	2.0D	U	895	C0322
2	YPL500150	2.0D	R	895	C0322

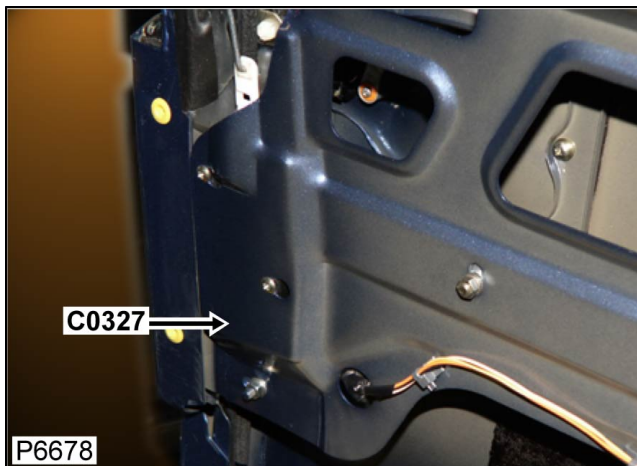
Location: **Behind passenger door trim panel**

CAV	TERMINAL	CSA	COL	CCT	DESTN
1	YPL000080	0.75D	K	893	C0338
2	YPL000080	0.75D	O	893	C0338

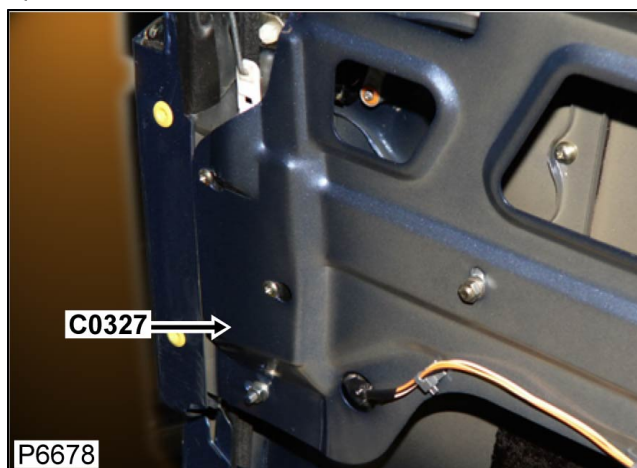
Location: **Behind passenger door trim panel**

CAV	TERMINAL	CSA	COL	CCT	DESTN
1	YPL000080	0.75D	K	893	C0338
2	YPL000080	0.75D	O	893	C0338

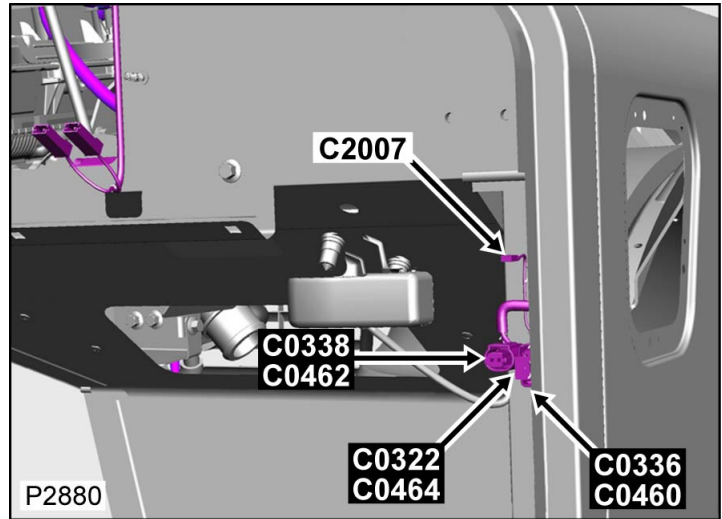
Cavities: **4WY**

Harness: **DOORS FRONT HARNESS**

CAV	TERMINAL	CSA	COL	CCT	DESTN
1	YPJ100640	0.75D	O	892	C0342
2	YPJ100640	0.75D	K	892	C0342
3	YPJ100620	0.5D	B	892	C0342
4	YPJ100620	0.5D	YK	892	C0342

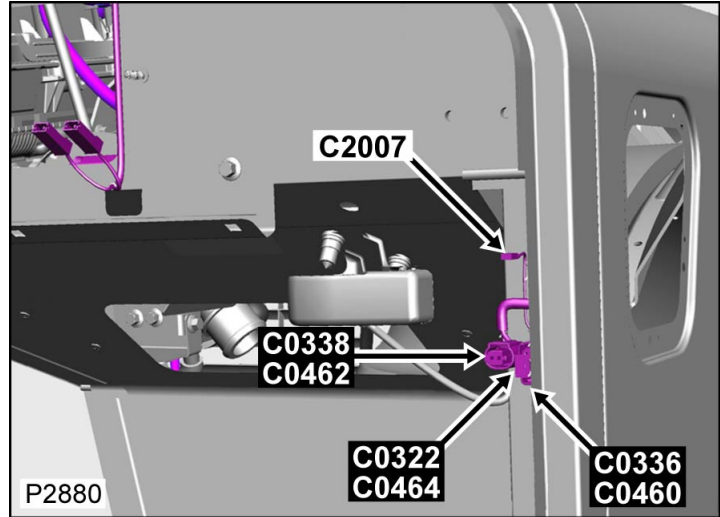
**Cavities: 4WY**

**Harness: DOORS FRONT HARNESS**

CAV	TERMINAL	CSA	COL	CCT	DESTN
1	YPJ100640	0.75D	O	892	C0342
2	YPJ100640	0.75D	K	892	C0342
3	YPJ100620	0.5D	B	892	C0342
4	YPJ100620	0.5D	YK	892	C0342

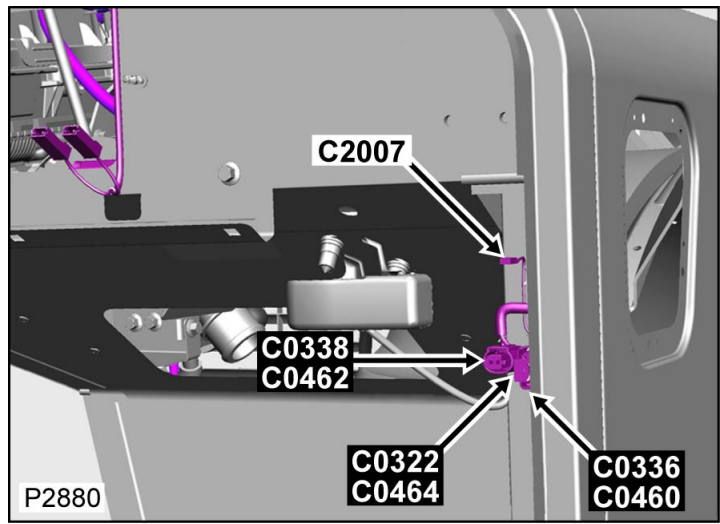
**Cavities: 2WY**

**Harness: DOORS FRONT HARNESS**

CAV	TERMINAL	CSA	COL	CCT	DESTN
1	YPJ100640	0.75D	O	893	C0327
2	YPJ100640	0.75D	K	893	C0327

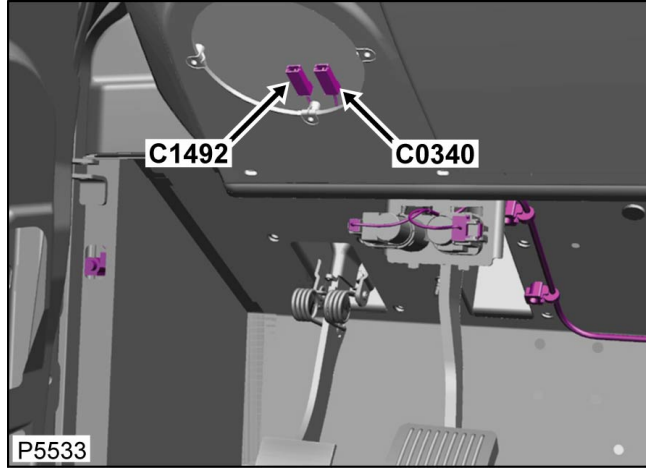
Location: **Instrument panel-left-lower**

CAV	TERMINAL	CSA	COL	CCT	DESTN
I	AGUI318	0.5D	BW	769	C0092
I	AGUI318	0.5D	BW	769	C0530

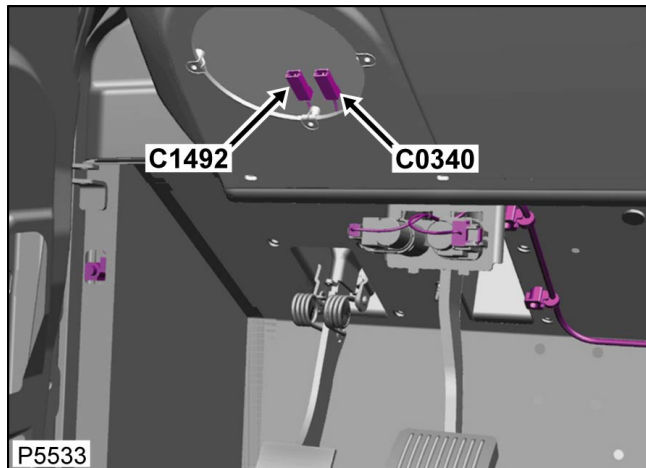
Location: **Instrument panel-left-lower**

CAV	TERMINAL	CSA	COL	CCT	DESTN
I	AGUI318	0.5D	BW	769	C0092
I	AGUI318	0.5D	BW	769	C0530

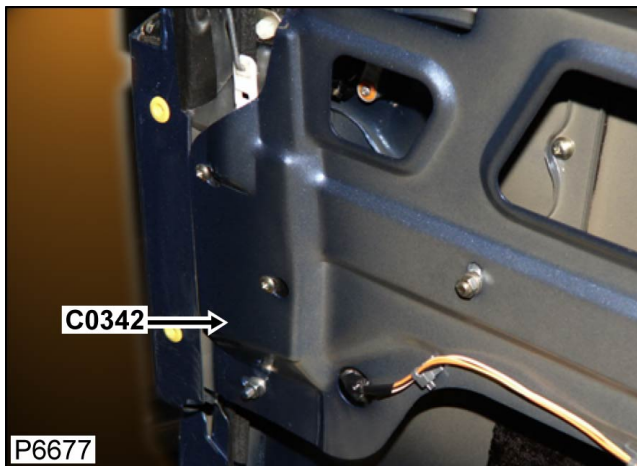
Location: **Behind driver door trim panel**

CAV	TERMINAL	CSA	COL	CCT	DESTN
1	YPL000080	0.75D	K	892	C0336
2	YPL000080	0.75D	O	892	C0336
3	YPL000080	0.5D	YK	892	C0336
4	YPL000080	0.5D	B	892	C0336

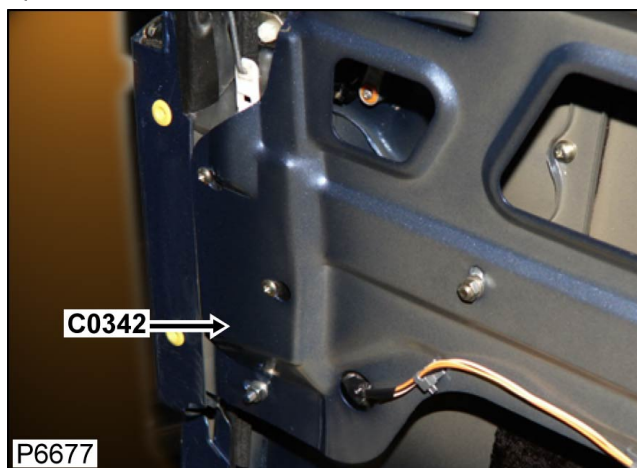
Location: **Behind driver door trim panel**

CAV	TERMINAL	CSA	COL	CCT	DESTN
1	YPL000080	0.75D	K	892	C0336
2	YPL000080	0.75D	O	892	C0336
