DEFENDER - VIN: 412051 >

Electrical Reference Library (1a)

JLR 16 25 21\_IE

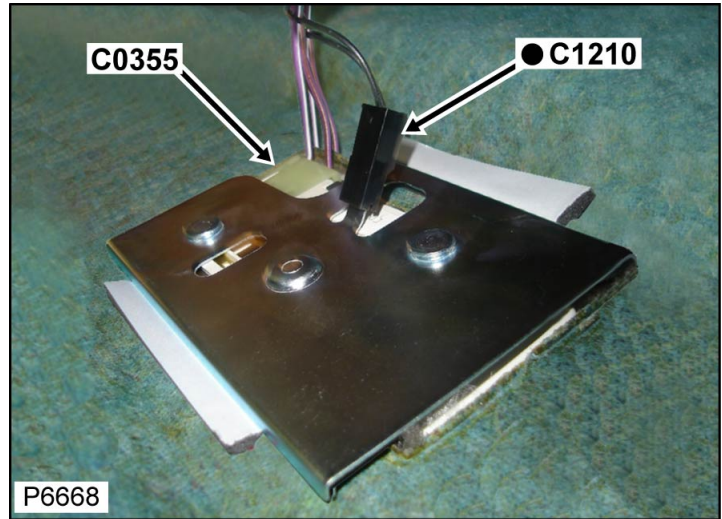
Location: **Front of headlining in the center**

CAV	TERMINAL	CSA	COL	CCT	DESTN
1	YPL10003	1.0D	PW	902	CTAP
1	YPL10003	1.0D	PW	903	CTAP
1	YPL10003	1.0D	PW	904	C0259
3	YPL10003	1.0D	PN	902	CTAP
3	YPL10003	1.0D	PN	903	CTAP
3	YPL10003	1.0D	PN	904	C0259

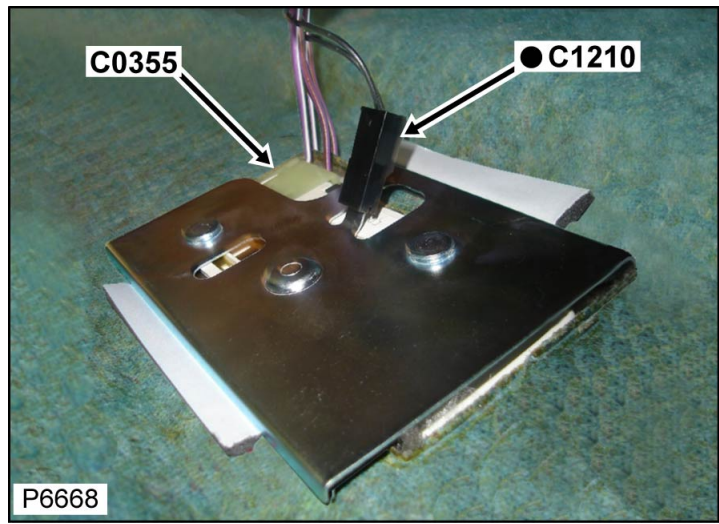
**Cavities: 3WY**

**Harness: ROOF FRONT HARNESS**

CAV	TERMINAL	CSA	COL	CCT	DESTN
1	YPL10003	1.0D	PW	902	CTAP
1	YPL10003	1.0D	PW	903	CTAP
1	YPL10003	1.0D	PW	904	C0259
3	YPL10003	1.0D	PN	902	CTAP
3	YPL10003	1.0D	PN	903	CTAP
3	YPL10003	1.0D	PN	904	C0259

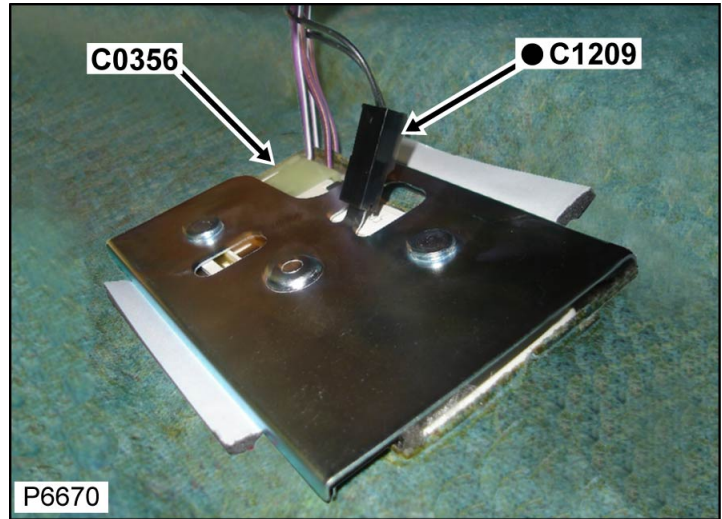
Cavities: **3WY**

Harness: **ROOF FRONT HARNESS**

CAV	TERMINAL	CSA	COL	CCT	DESTN
1	YPL10003	1.0D	PW	903	C0259
3	YPL10003	1.0D	PN	903	C0259

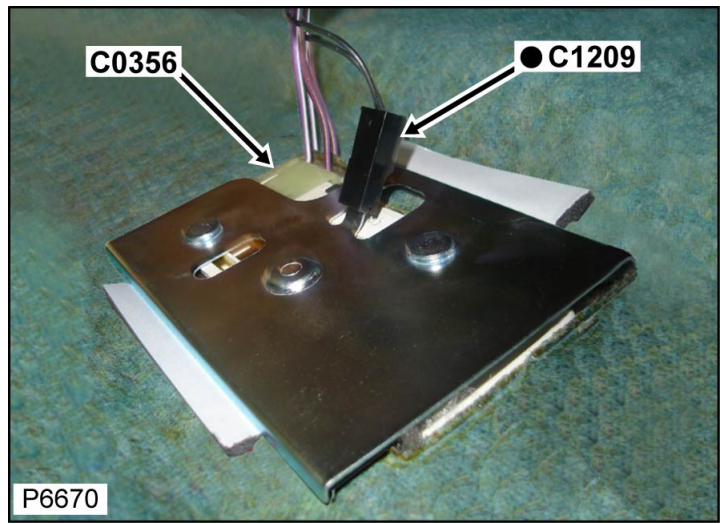
**Cavities: 3WY**

**Harness: ROOF FRONT HARNESS**

CAV	TERMINAL	CSA	COL	CCT	DESTN
1	YPL10003	1.0D	PW	903	C0259
3	YPL10003	1.0D	PN	903	C0259

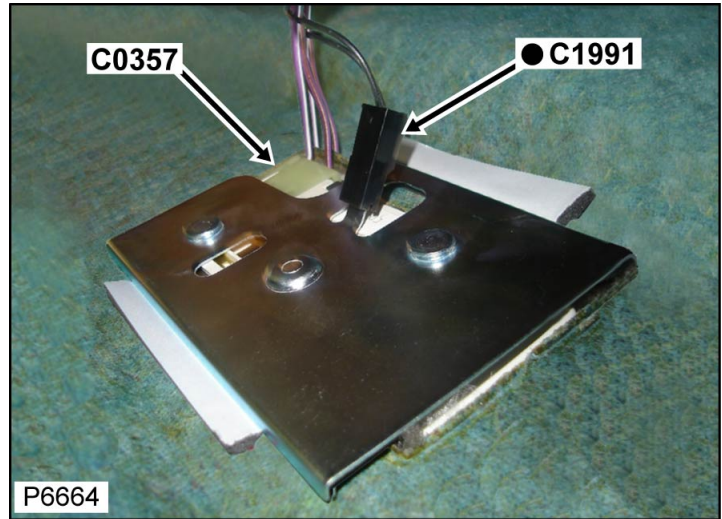
Location: **Rear of headlining**

CAV	TERMINAL	CSA	COL	CCT	DESTN
1	YPL10003	1.0D	PW	902	C0259
3	YPL10003	1.0D	PN	902	C0259

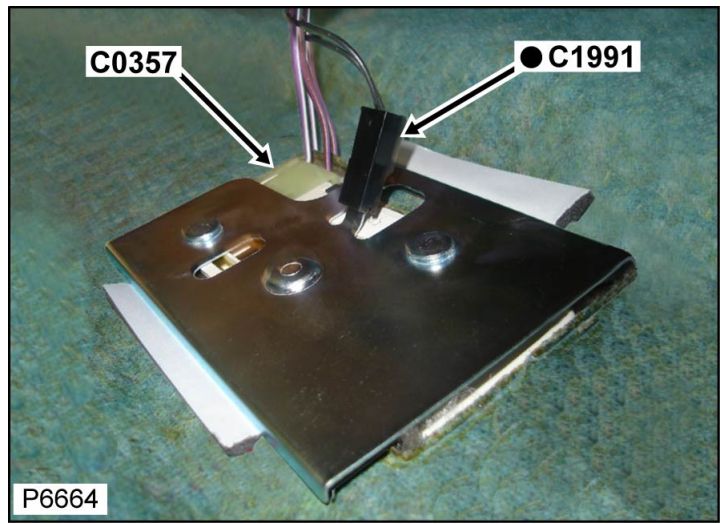
**Cavities: 3WY**

**Harness: ROOF FRONT HARNESS**

CAV	TERMINAL	CSA	COL	CCT	DESTN
1	YPL10003	1.0D	PW	902	C0259
3	YPL10003	1.0D	PN	902	C0259

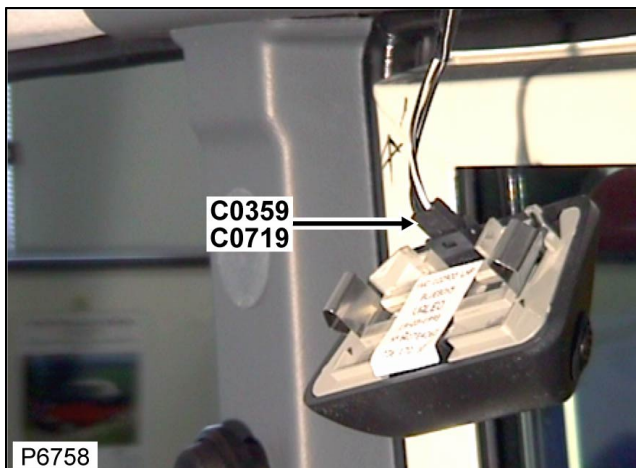
Location: **Behind headlining top of RH 'B' post**

CAV	TERMINAL	CSA	COL	CCT	DESTN
1	AFU3317	0.5D	BN	90I	C0259
2	AFU3317	0.5D	B	90I	C0259
3	AFU3317	0.5D	WB	90I	C0259

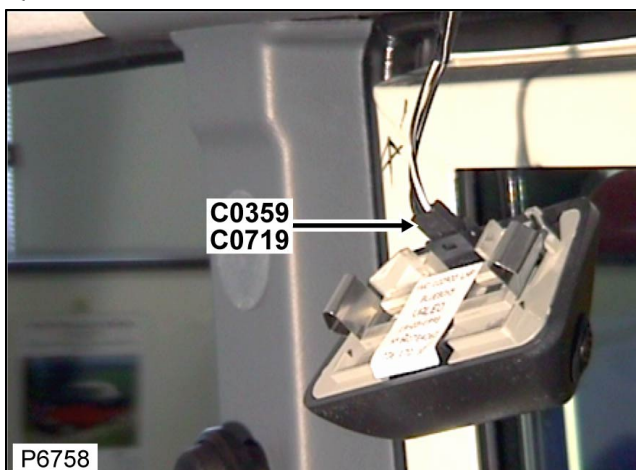
Location: **Behind headlining top of RH 'B' post**

CAV	TERMINAL	CSA	COL	CCT	DESTN
1	AFU3317	0.5D	BN	90I	C0259
2	AFU3317	0.5D	B	90I	C0259

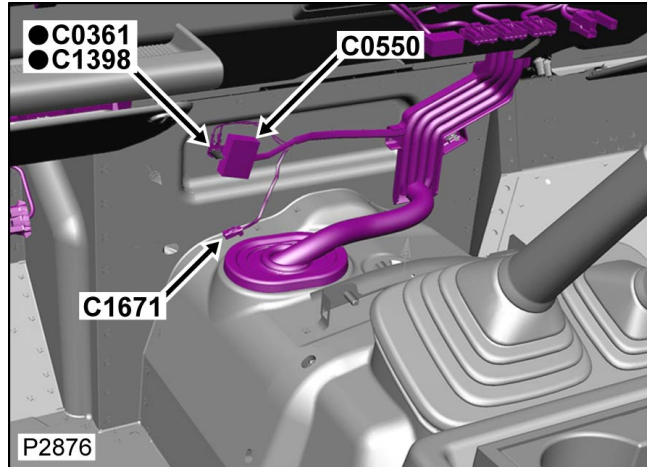
Location: **Behind center of Instrument panel**

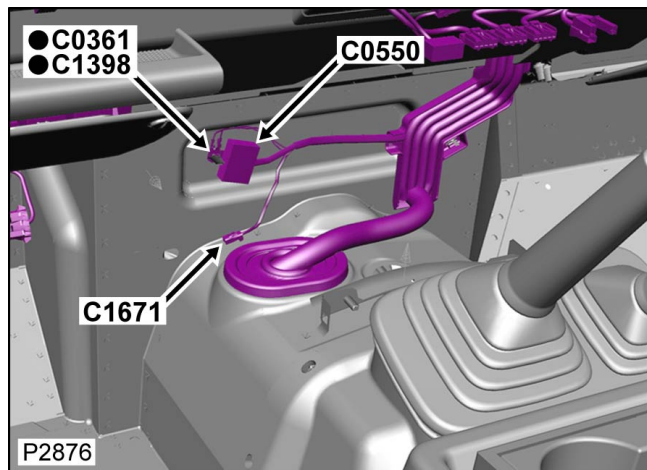
Location: **Behind center of Instrument panel**

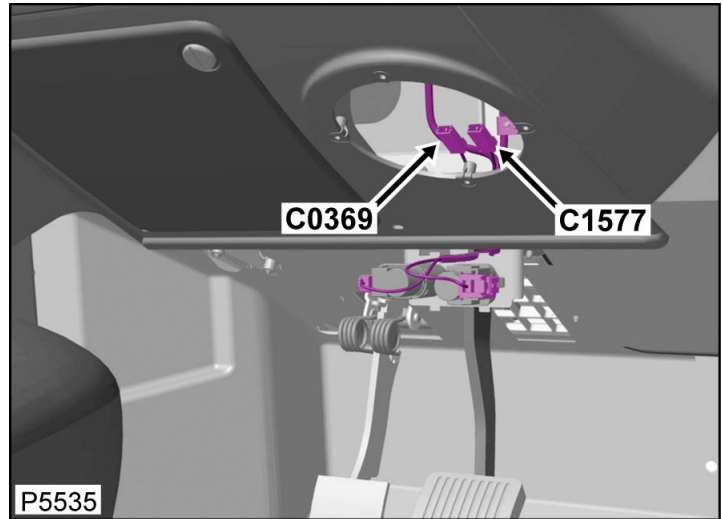
Location: **Instrument panel-right-lower**

Part No.: **AAUI010**

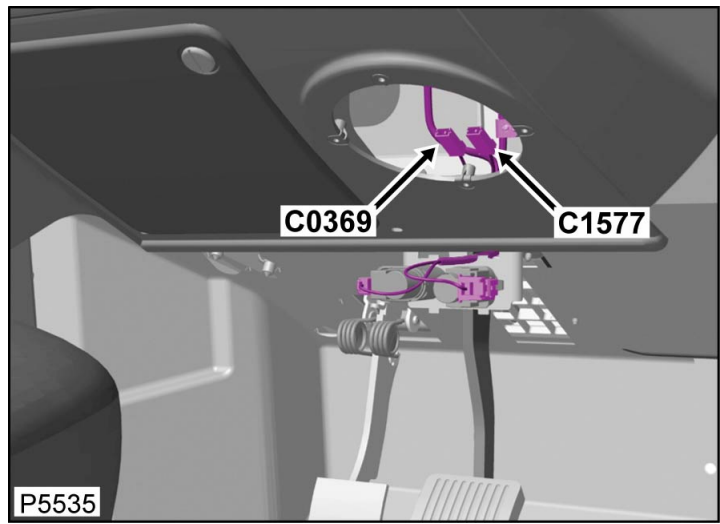
**Cavities: IWY**

**Harness: MAIN LH + RH HARNESS**

CAV	TERMINAL	CSA	COL	CCT	DESTN
I	ADU9566	0.5D	BR	769	C0531
I	ADU9566	0.5D	BR	769	C0092

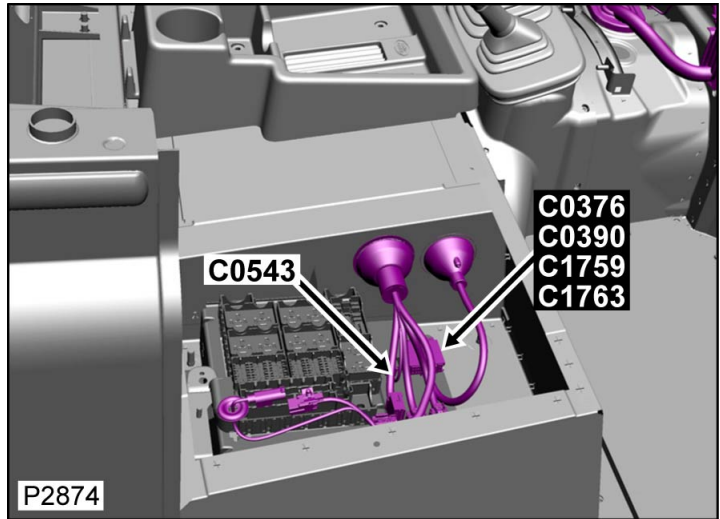
Location: **Beneath RH Front seat**

Part No.: **YPC803280**

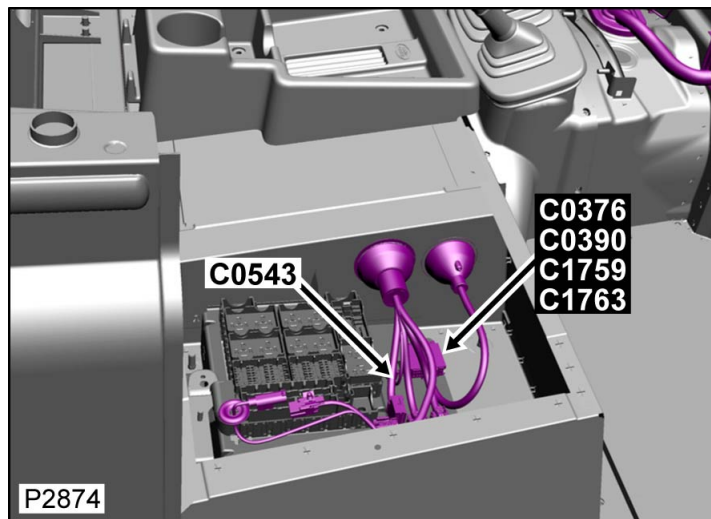
**Location: Beneath RH Front seat**

**Part No.: YPC803280**

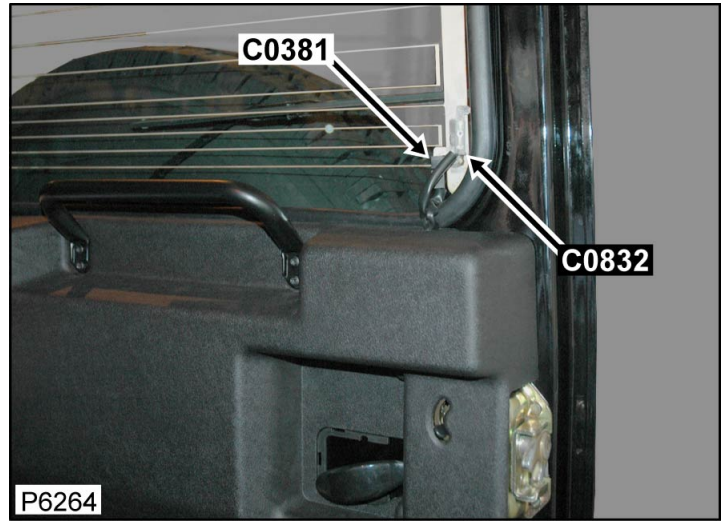
Location: **Rear screen - lower**

Part No.: **AAUI010**

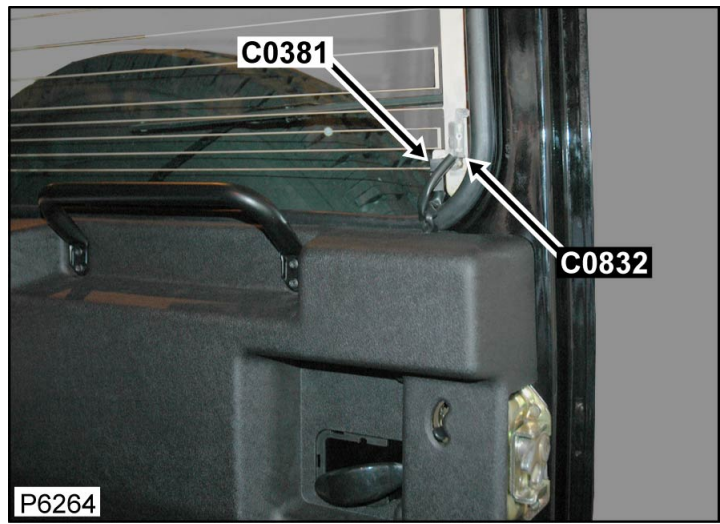
Cavities: **IWY**

Harness: **TAILDOOR HARNESS**

CAV	TERMINAL	CSA	COL	CCT	DESTN
I	ADU9566	1.5D	WB	III	C1102

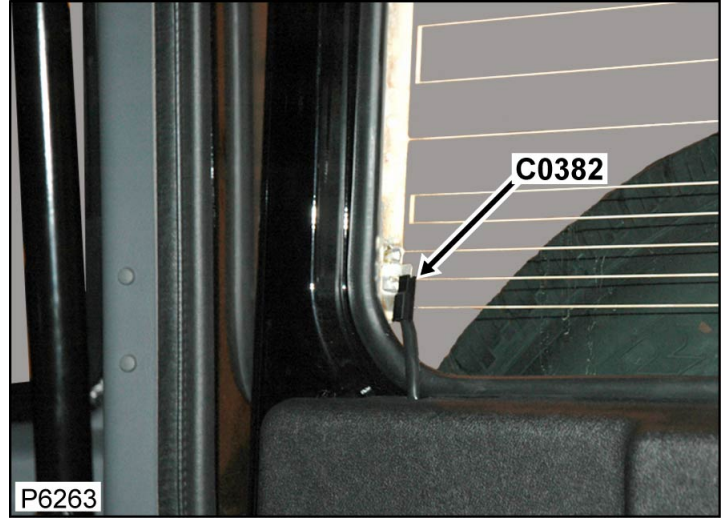
Location: **Rear screen - lower**

Part No.: **AAU1010**

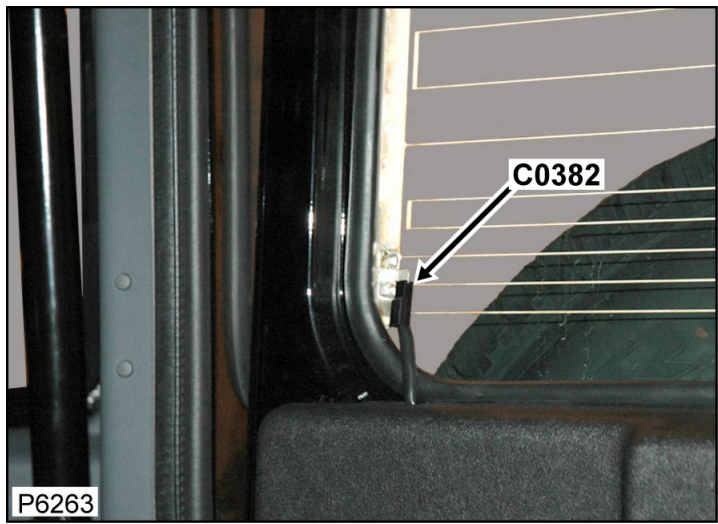
**Cavities: IWY**

**Harness: TAILDOOR HARNESS**

CAV	TERMINAL	CSA	COL	CCT	DESTN
I	ADU9566	1.0D	B	193	S/JOINT SJI
I	ADU9566	1.0D	B	1053	C1102

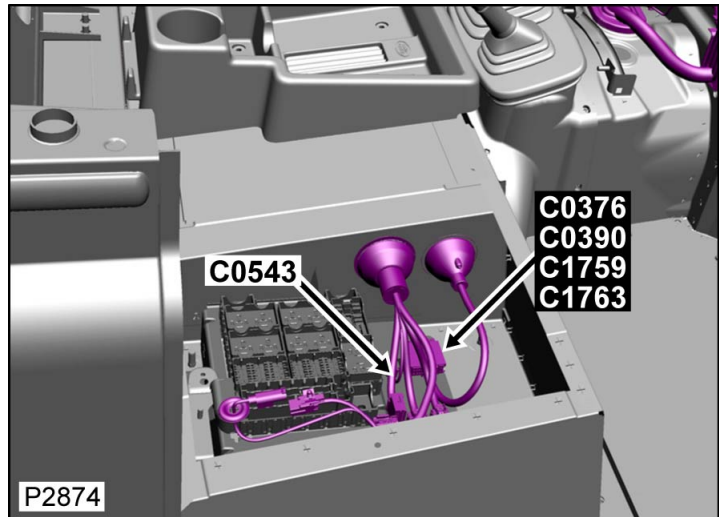
**Location: Beneath RH Front seat**

**Part No.: YPC803300**

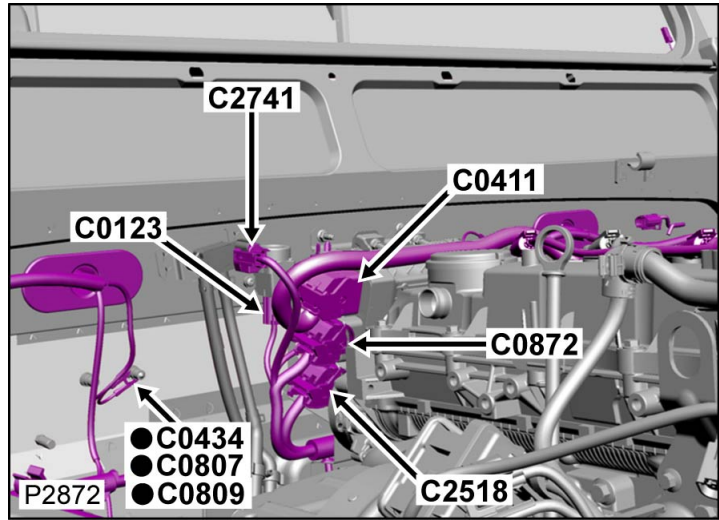
**Cavities: 48WY**

**Harness: ENGINE DIESEL HARNESS**

CAV	TERMINAL	CSA	COL	CCT	DESTN
1	YPL104080	0.75	NU	254	C2467
2	YPL104080	0.5	UW	254	C0175
3	YPL104080	0.5	SU	254	C0272
4	YPL104080	0.5	NU	254	C0176
5	YPL104080	0.75	S	254	C0187
6	YPL104080	0.5	GW	254	C2251
7	YPL104080	0.75	UN	254	C2467
8	YPL104080	0.5	YP	254	C0175
9	YPL104080	0.5	GP	254	C0272
10	YPL104080	0.5	GW	VNT	C2519
11	YPL801980	1.5	UO	254	S/JOINT SJ3
12	YPL801980	1.5	SY	14	C0523
13	YPL104080	0.5	WO	VNT	C2519
14	YPL104080	0.5	GP	254	C1558

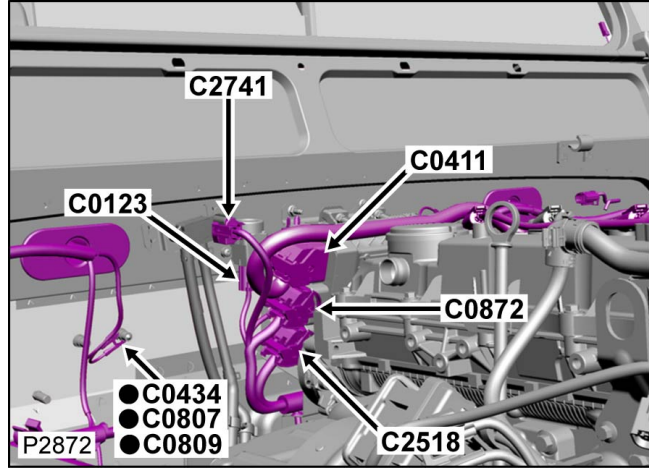
Location: **Rear RH side of engine compartment**

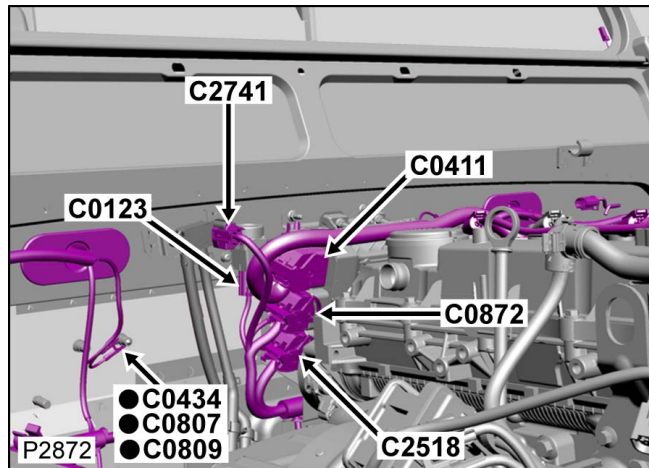
Location: **Rear RH side of engine compartment**

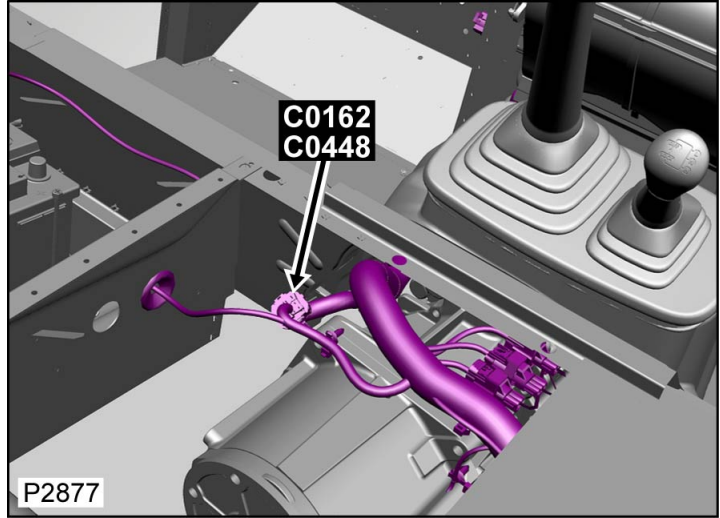
Cavities: **12WY**

Harness: **MAIN LH + RH HARNESS**

CAV	TERMINAL	CSA	COL	CCT	DESTN
1	YPL500530	0.5D	YP	254	C2518
2	YPL500530	0.5D	B	254	C2518
3	YPL500480	1.5D	B	14	S/JOINT SJ11
4	YPL500480	2.5D	NR	499	C3764
5	YPL500530	0.5D	PS	254	C2518
6	YPL500530	0.5D	U	254	C2518
7	YPL500530	0.5D	RG	254	S/JOINT SJ17
8	YPL500530	0.5D	SP	254	C2518
9	YPL500480	1.5D	BG	14	C3766
10	YPL500470	0.75D	RG	254	S/JOINT SJ17

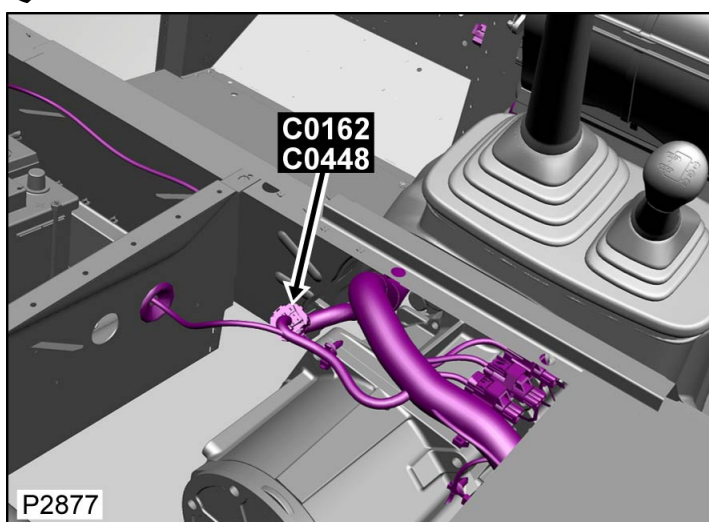
**Cavities: 12WY**

**Harness: MAIN LH + RH HARNESS**

CAV	TERMINAL	CSA	COL	CCT	DESTN
1	YPL500530	0.5D	YP	254	C2518
2	YPL500530	0.5D	B	254	C2518
3	YPL500480	1.5D	B	14	S/JOINT SJ11
4	YPL500480	2.5D	NR	499	C3764
5	YPL500530	0.5D	PS	254	C2518
6	YPL500530	0.5D	U	254	C2518
7	YPL500530	0.5D	RG	254	S/JOINT SJ17
8	YPL500530	0.5D	SP	254	C2518

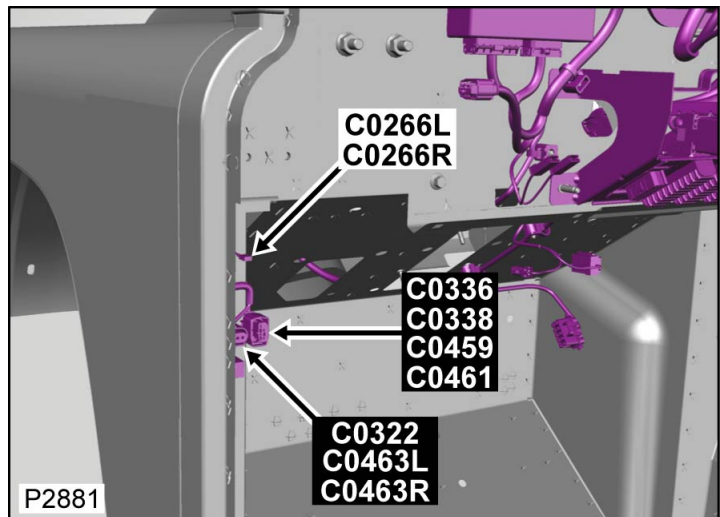
**Cavities: 4WY**

**Harness: MAIN LH + RH HARNESS**

CAV	TERMINAL	CSA	COL	CCT	DESTN
I	YPL101510	0.75D	O	767L	S/JOINT SJ77

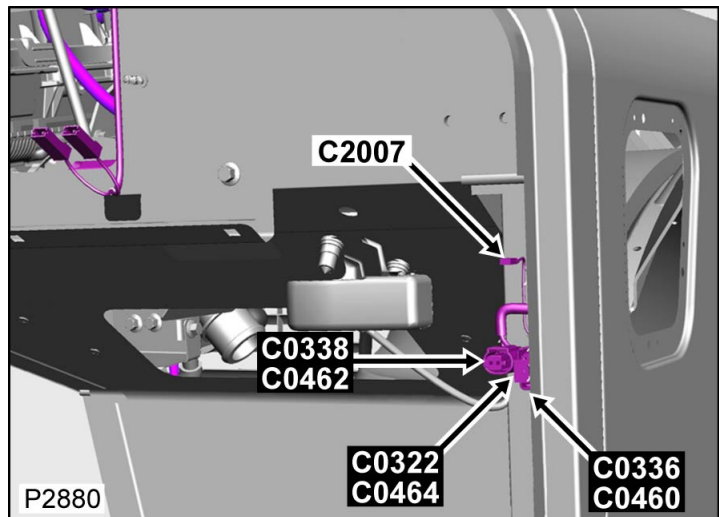
**Cavities: 4WY**

**Harness: MAIN LH + RH HARNESS**

CAV	TERMINAL	CSA	COL	CCT	DESTN
I	YPL101510	0.75D	O	767R	S/JOINT SJ77

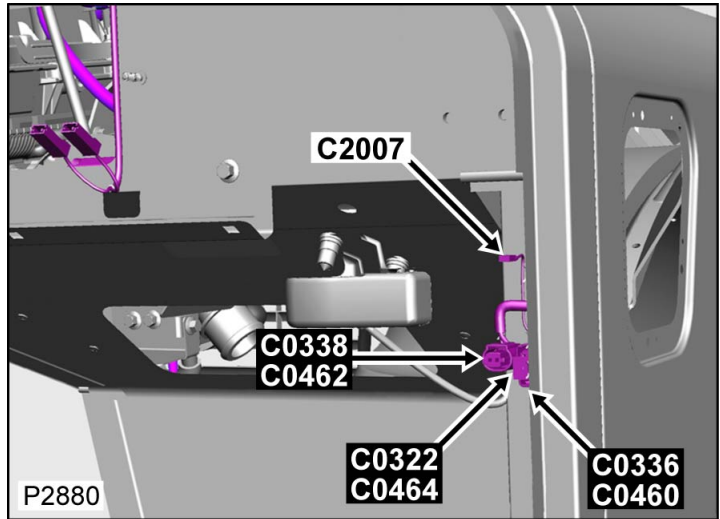
Cavities: **2WY**

Harness: **MAIN LH + RH HARNESS**

CAV	TERMINAL	CSA	COL	CCT	DESTN
1	YPL101510	0.75D	O	767L	S/JOINT SJ77
2	YPL101510	0.75D	K	767L	S/JOINT SJ78

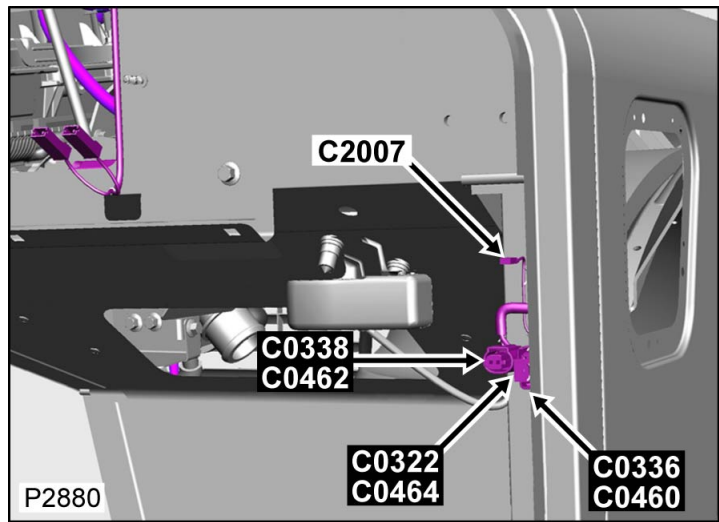
**Cavities: 2WY**

**Harness: MAIN LH + RH HARNESS**

CAV	TERMINAL	CSA	COL	CCT	DESTN
1	YPL101510	0.75D	O	767L	S/JOINT SJ77
2	YPL101510	0.75D	K	767L	S/JOINT SJ78

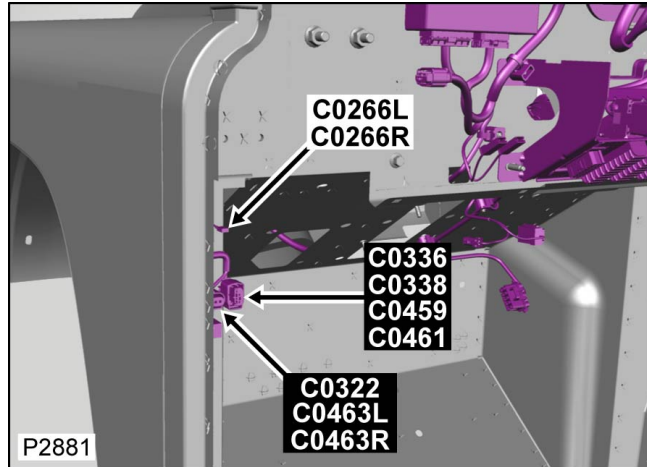
Location: **LH 'A' post**

CAV	TERMINAL	CSA	COL	CCT	DESTN
1	YPLI0027	1.5D	R	247L	C0321
2	YPLI0027	1.5D	U	247L	C0321

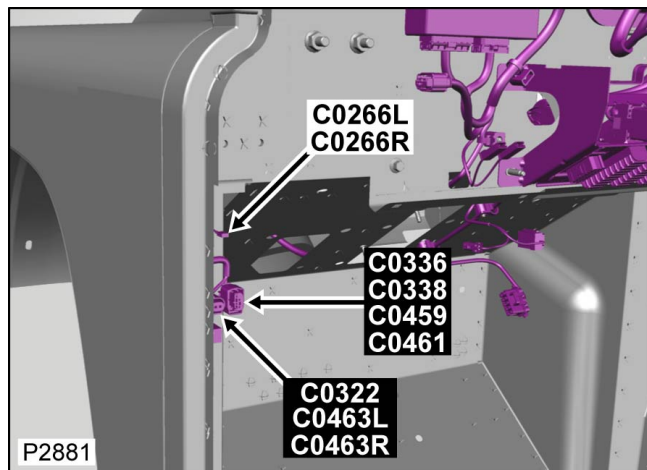
Location: **LH 'A' post**

CAV	TERMINAL	CSA	COL	CCT	DESTN
1	YPLI0027	1.5D	R	247L	C0321
2	YPLI0027	1.5D	U	247L	C0321

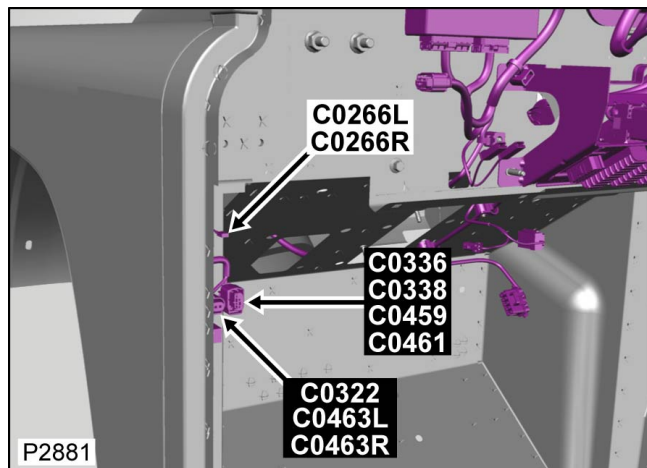
Location: **LH 'A' post**

CAV	TERMINAL	CSA	COL	CCT	DESTN
1	YPLI0027	1.5D	R	247R	C0321
2	YPLI0027	1.5D	U	247R	C0321

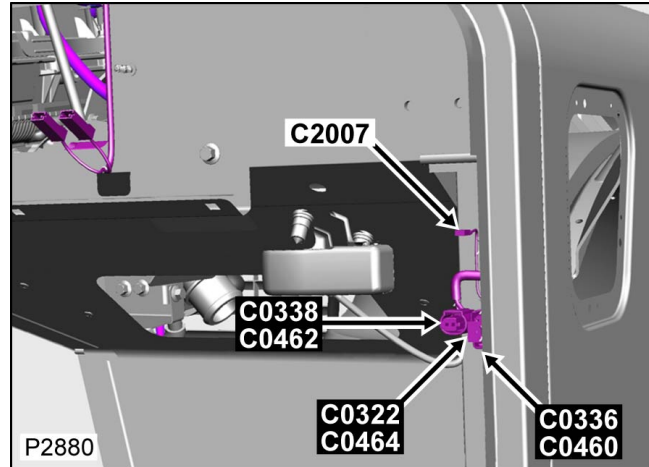
Location: **RH 'A' post**

CAV	TERMINAL	CSA	COL	CCT	DESTN
1	YPLI0027	1.5D	OR	247R	C0242
1	YPLI0027	1.5D	OR	247L	C0242
2	YPLI0027	1.5D	OU	247R	C0242
2	YPLI0027	1.5D	OU	247L	C0242

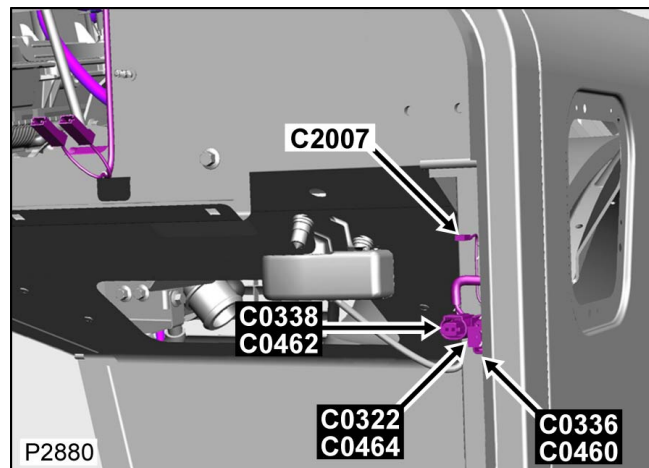
Location: **RH 'A' post**

CAV	TERMINAL	CSA	COL	CCT	DESTN
1	YPLI0027	1.5D	OR	247R	C0242
1	YPLI0027	1.5D	OR	247L	C0242

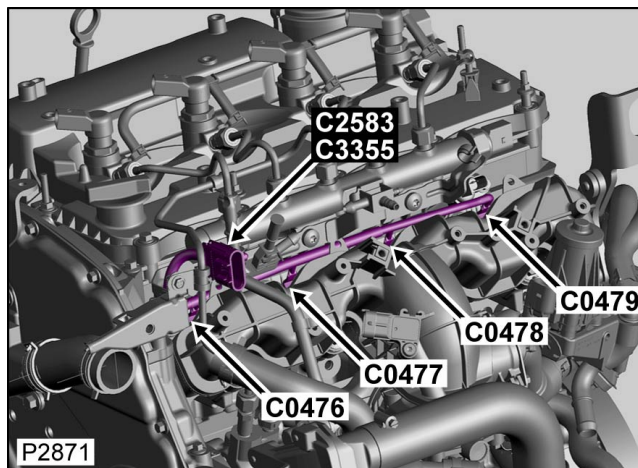
Location: **LH side of engine**

Connector: **C0476**

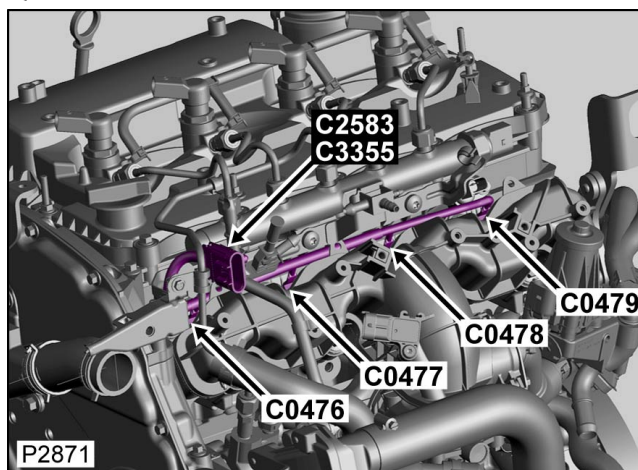
Location: **LH side of engine**

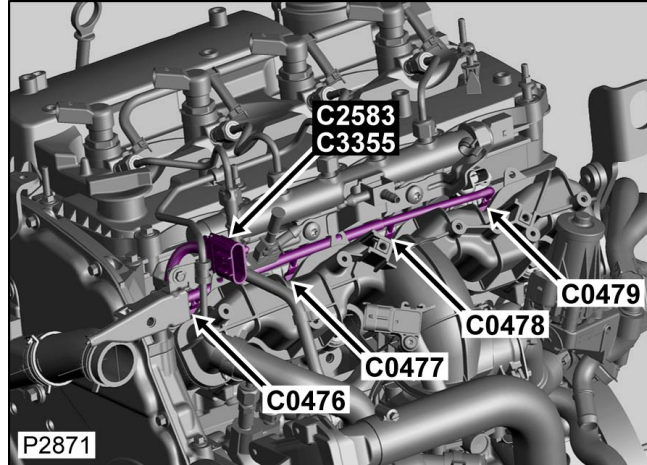
Location: **LH side of engine**

CAV	TERMINAL	CSA	COL	CCT	DESTN
I		2.5D	PW	254	C3355

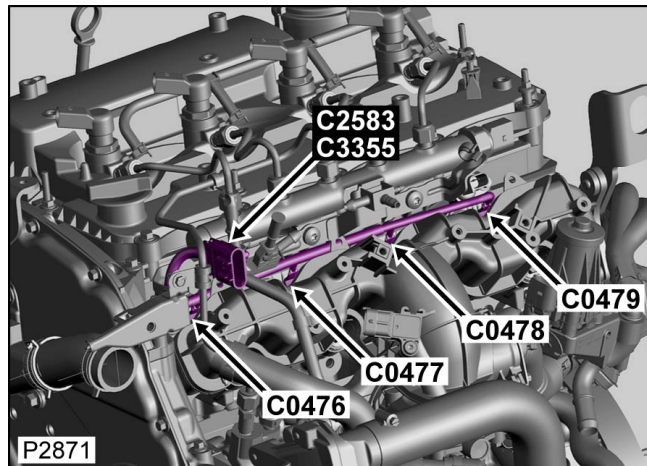
Location: **LH side of engine**

CAV	TERMINAL	CSA	COL	CCT	DESTN
I		2.5D	PW	254	C3355

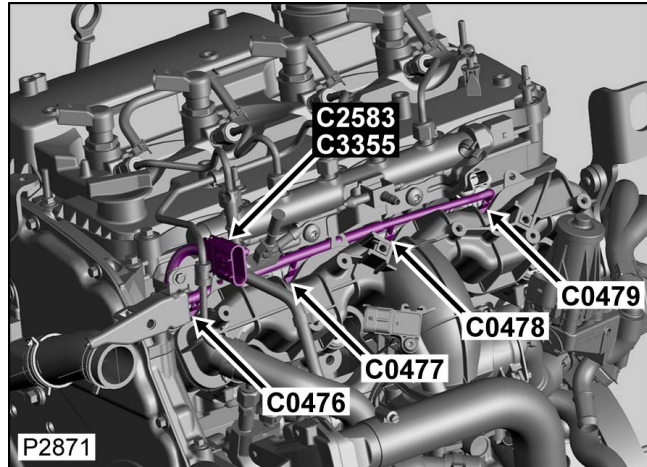
Location: **LH side of engine**

CAV	TERMINAL	CSA	COL	CCT	DESTN
I		2.5D	YU	254	C3355

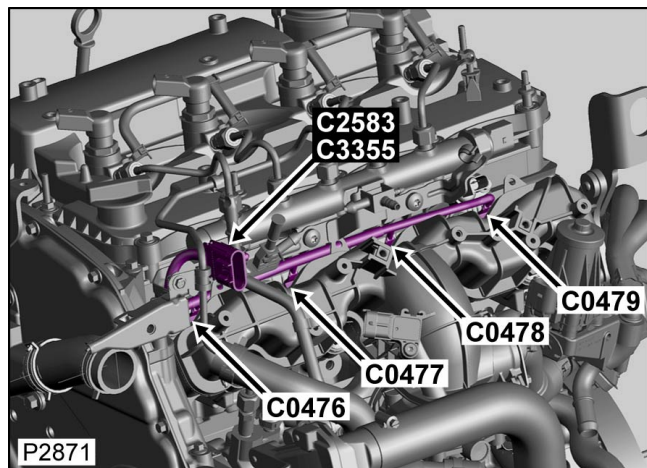
Location: **LH side of engine**

CAV	TERMINAL	CSA	COL	CCT	DESTN
I		2.5D	YU	254	C3355

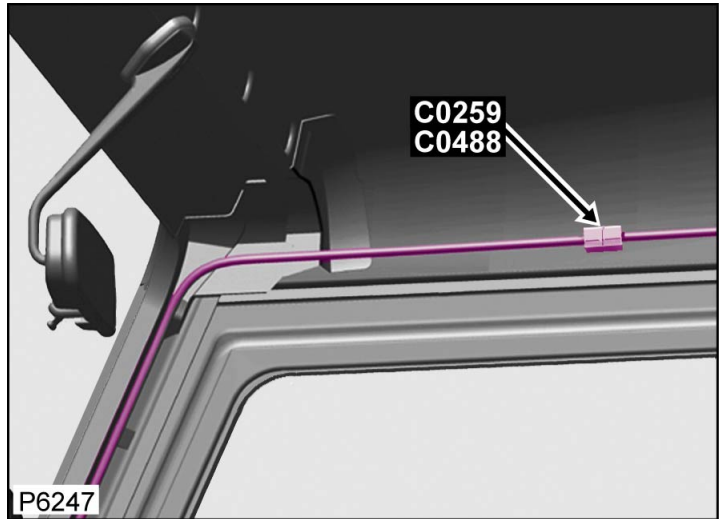
Location: **Headlining - Front RH side**

Part No.: **YPCI0534**

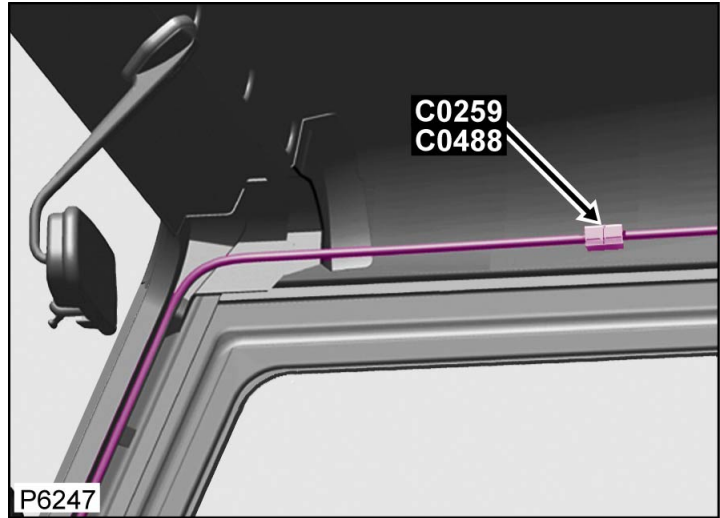
Location: **Headlining - Front RH side**

**Part No.:** YPCI0534  
**Colour:** LIGHT GREY  
**Cavities:** 10WY

**Harness:** MAIN LH + RH HARNESS

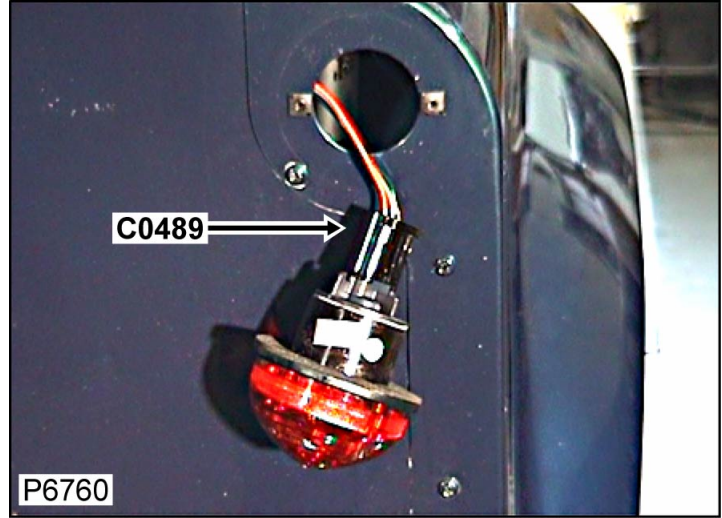
Cavities: **3WY**

Harness: **CHASSIS HARNESS**

CAV	TERMINAL	CSA	COL	CCT	DESTN
1	AFU3802	1.5D	B	772	S/JOINT SJ26
1	AFU3802	1.5D	B	985	S/JOINT SJ4
2	AFU3802	1.5D	GP	772	S/JOINT SJ21
2	AFU3802	1.5D	GP	985	S/JOINT SJ5
3	AFU3802	1.5D	RO	772	S/JOINT SJ24
3	AFU3802	1.5D	RO	985	S/JOINT SJ8

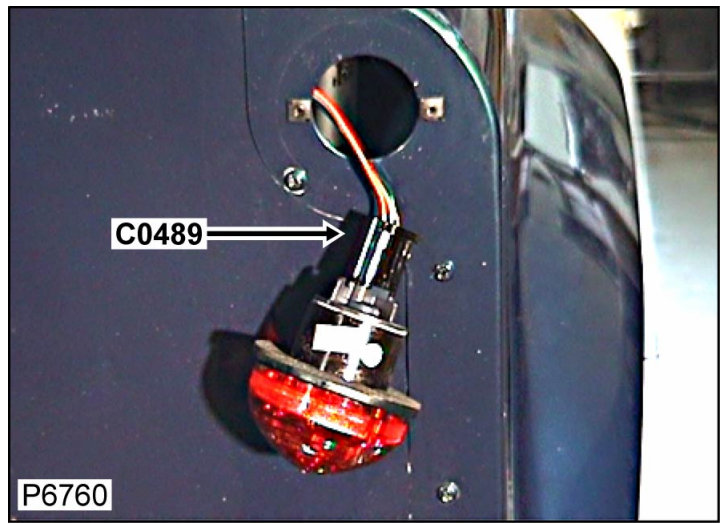
**Cavities: 3WY**

**Harness: CHASSIS HARNESS**

CAV	TERMINAL	CSA	COL	CCT	DESTN
1	AFU3802	1.5D	B	772	S/JOINT SJ26
1	AFU3802	1.5D	B	985	S/JOINT SJ4
2	AFU3802	1.5D	GP	772	S/JOINT SJ21
2	AFU3802	1.5D	GP	985	S/JOINT SJ5
3	AFU3802	1.5D	RO	772	S/JOINT SJ24
3	AFU3802	1.5D	RO	985	S/JOINT SJ8

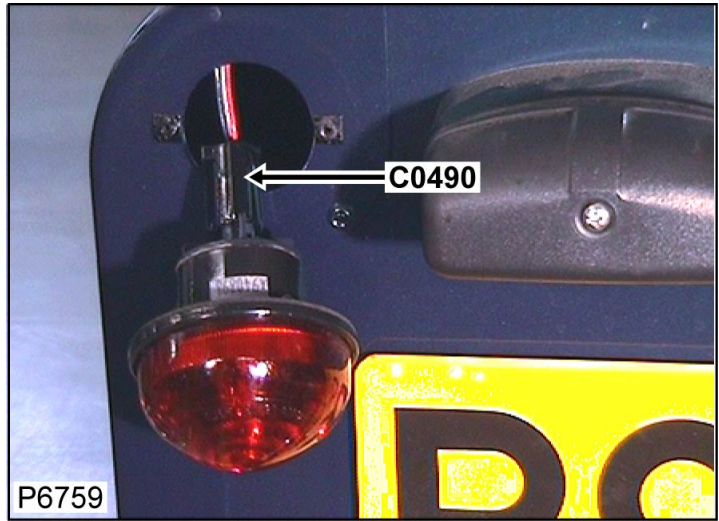
Cavities: **3WY**

Harness: **CHASSIS HARNESS**

CAV	TERMINAL	CSA	COL	CCT	DESTN
1	AFU3802	1.5D	B	772	S/JOINT SJ1
1	AFU3802	1.5D	B	985	S/JOINT SJ1
2	AFU3802	1.5D	GP	772	S/JOINT SJ21
2	AFU3802	1.5D	GP	985	S/JOINT SJ5
3	AFU3802	0.75D	RB	772	S/JOINT SJ23
3	AFU3802	0.75D	RB	985	C1759

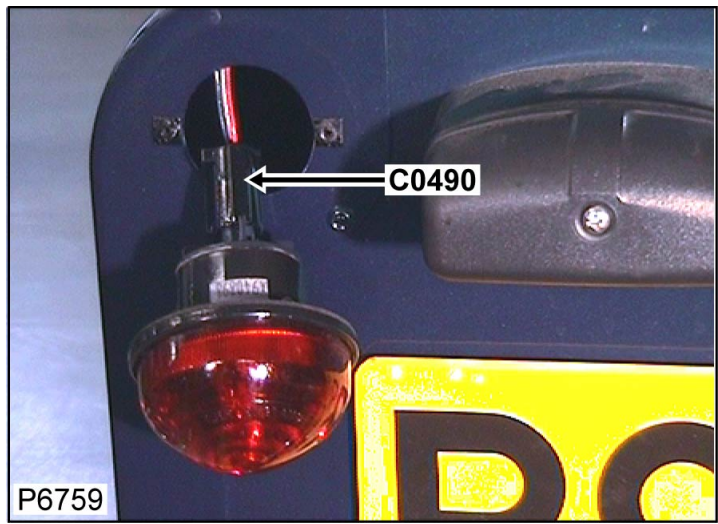
Cavities: **3WY**

Harness: **CHASSIS HARNESS**

CAV	TERMINAL	CSA	COL	CCT	DESTN
1	AFU3802	1.5D	B	772	S/JOINT SJ1
1	AFU3802	1.5D	B	985	S/JOINT SJ1
2	AFU3802	1.5D	GP	772	S/JOINT SJ21
2	AFU3802	1.5D	GP	985	S/JOINT SJ5
3	AFU3802	0.75D	RB	772	S/JOINT SJ23
3	AFU3802	0.75D	RB	985	C1759

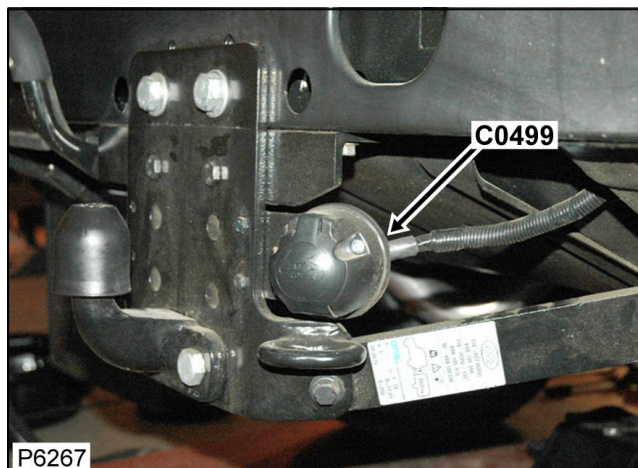
Location: **Behind towing bracket**

CAV	TERMINAL	CSA	COL	CCT	DESTN
1	ASSEMBLY	1.5D	GR	499	C0718
2	ASSEMBLY	1.5D	RY	499	C0439
3	ASSEMBLY	2.0D	B	499	C0718
4	ASSEMBLY	1.5D	GW	499	C0718
5	ASSEMBLY	1.5D	RO	499	C0718
6	ASSEMBLY	1.5D	GP	499	C0718
7	ASSEMBLY	2.0D	RB	499	C0718

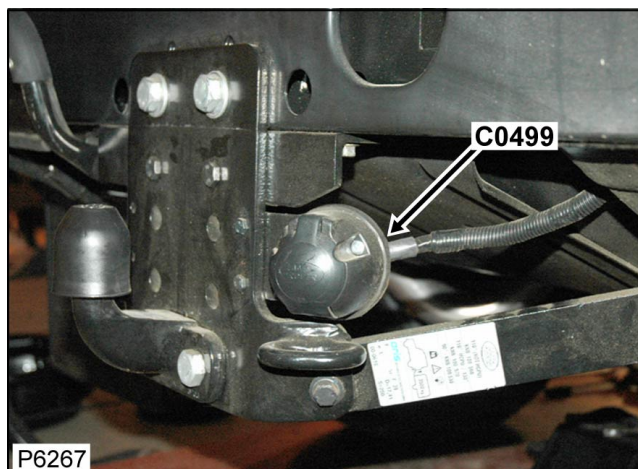
Location: **Behind towing bracket**

CAV	TERMINAL	CSA	COL	CCT	DESTN
1	ASSEMBLY	1.5D	GR	499	C0718

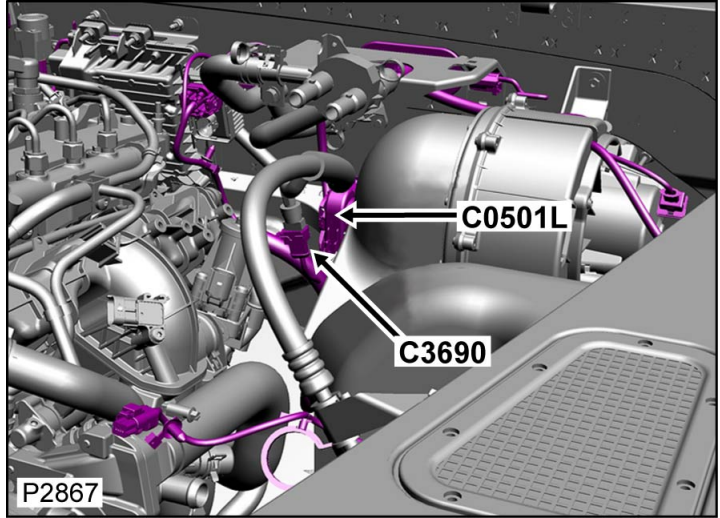
Location: **Rear LH side of engine compartment**

Part No.: **YPC804060**

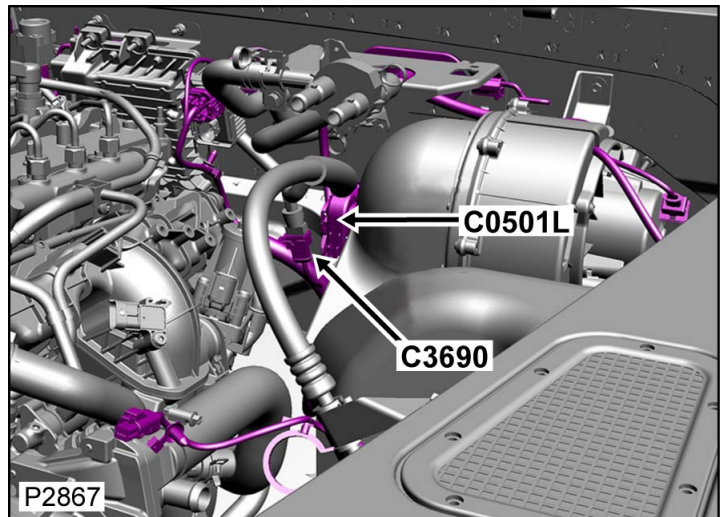
**Location: Rear LH side of engine compartment**

**Part No.: YPC804060**

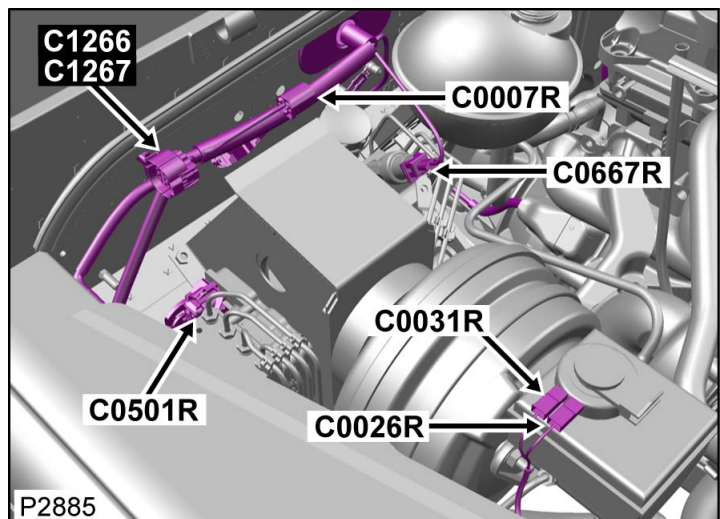
**Location: Rear RH side of engine compartment**

CAV	TERMINAL	CSA	COL	CCT	DESTN
I	YPL903260	4.0D	BR	10	C3762
6	YPL903300	0.5D	Y	10	C0517

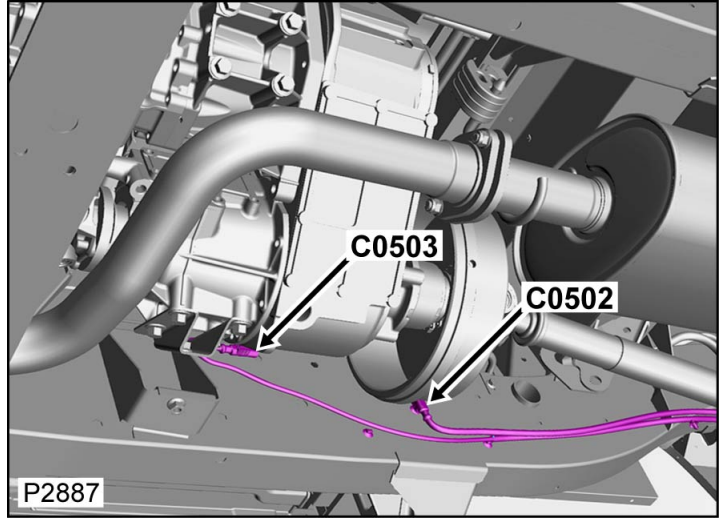
Harness: **MAIN LH + RH HARNESS**

CAV	TERMINAL	CSA	COL	CCT	DESTN
1	YPL101500	0.5D	WY	9	C0501L
1	YPL101500	0.5D	WY	10	C0501R
2	YPL101500	0.5D	W	9	C0501L
2	YPL101500	0.5D	W	10	C0501R

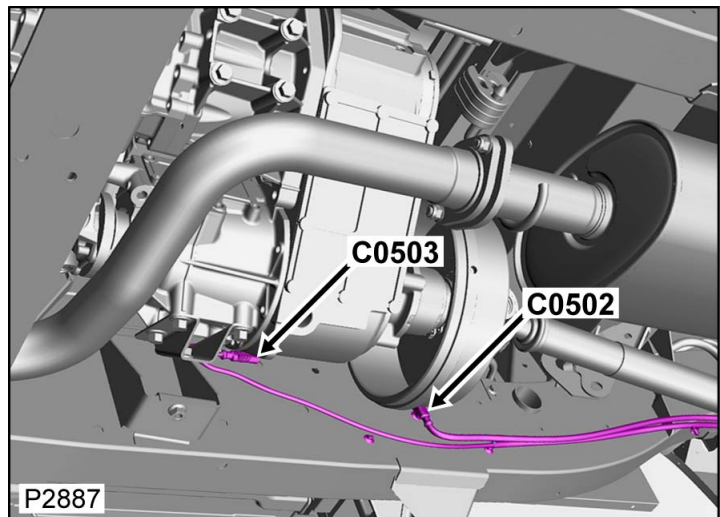
**Harness: MAIN LH + RH HARNESS**

CAV	TERMINAL	CSA	COL	CCT	DESTN
I	YPL101500	0.5D	WY	9	C0501L
I	YPL101500	0.5D	WY	10	C0501R

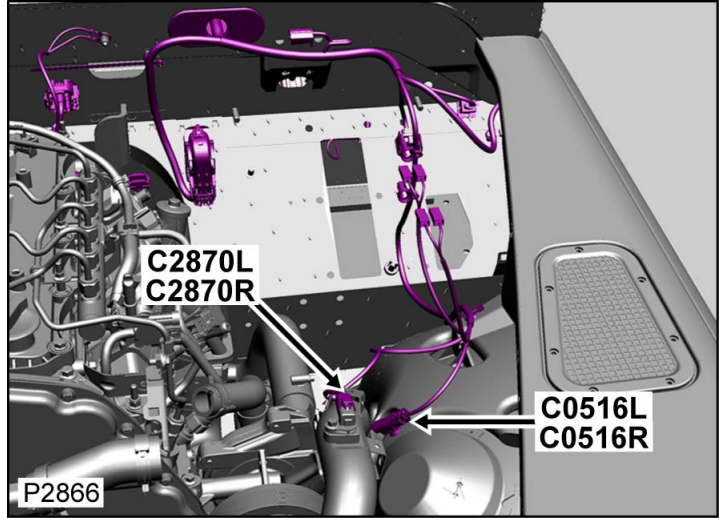
Harness: **MAIN LH + RH HARNESS**

CAV	TERMINAL	CSA	COL	CCT	DESTN
1	YPL101500	0.5D	R	9	C0501L
2	YPL101500	0.5D	UR	9	C0501L

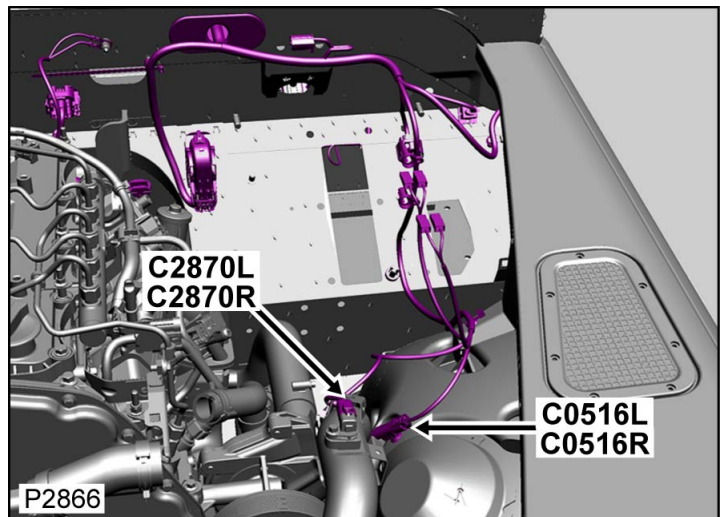
**Harness: MAIN LH + RH HARNESS**

CAV	TERMINAL	CSA	COL	CCT	DESTN
1	YPL101500	0.5D	R	9	C0501L
2	YPL101500	0.5D	UR	9	C0501L

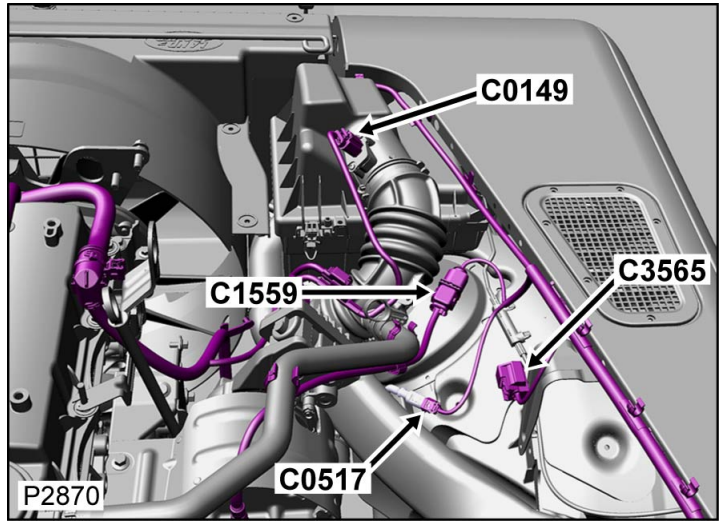
Harness: **MAIN LH + RH HARNESS**

CAV	TERMINAL	CSA	COL	CCT	DESTN
1	YPL101500	0.5D	Y	10	C0501R
1	YPL101500	0.5D	Y	9	C0501L
2	YPL101500	0.5D	UY	10	C0501R
2	YPL101500	0.5D	UY	9	C0501L

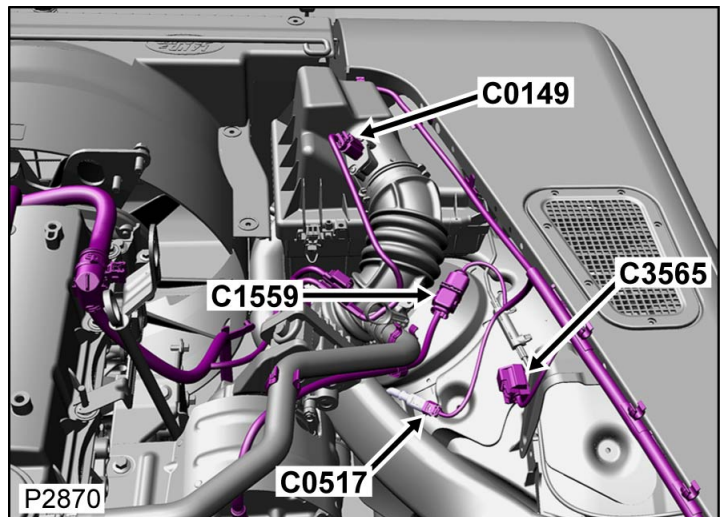
**Harness: MAIN LH + RH HARNESS**

CAV	TERMINAL	CSA	COL	CCT	DESTN
I	YPL101500	0.5D	Y	10	C0501R
I	YPL101500	0.5D	Y	9	C0501L

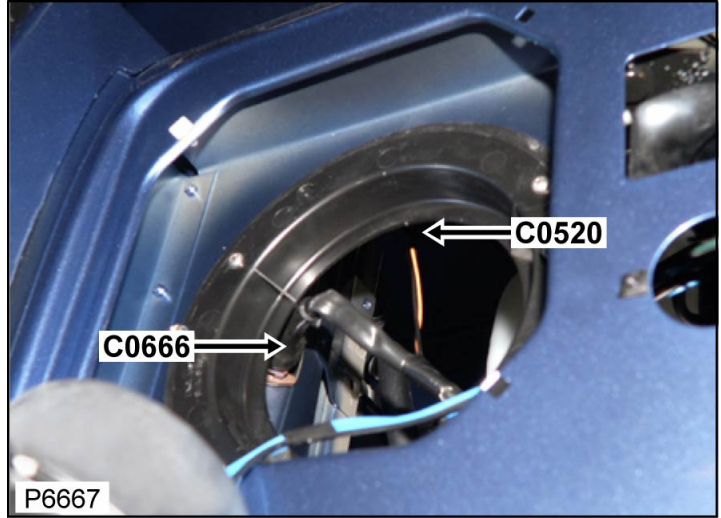
Harness: **WING LH HARNESS**

CAV	TERMINAL	CSA	COL	CCT	DESTN
1	AFU3802	1.0D	B	295	CTAP
2	AFU3802	1.0D	OB	295	C1265

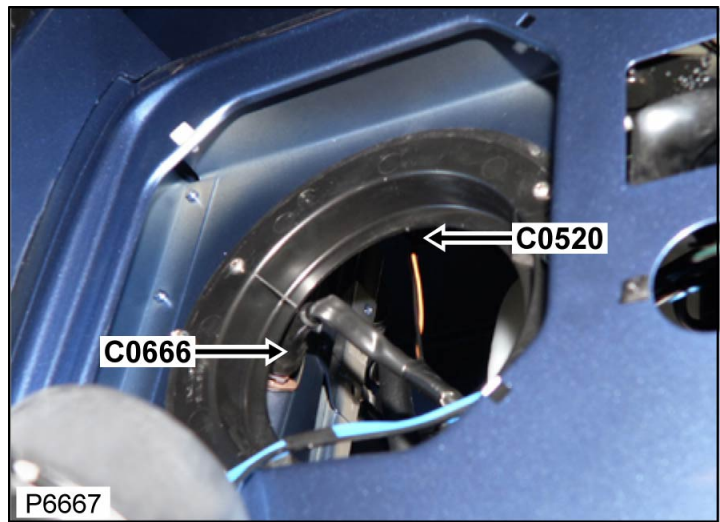
Harness: **WING LH HARNESS**

CAV	TERMINAL	CSA	COL	CCT	DESTN
1	AFU3802	1.0D	B	295	CTAP
2	AFU3802	1.0D	OB	295	C1265

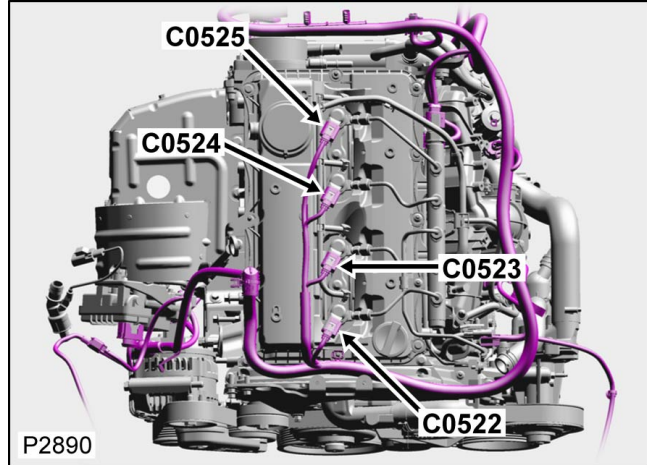
Location: **Top of engine**

CAV	TERMINAL	CSA	COL	CCT	DESTN
1		1.5	YU	254	C0411
2		1.5	GU	254	C0411
