DEFENDER - VIN: 412051 >

Electrical Reference Library (1a)

JLR 16 25 21\_IE

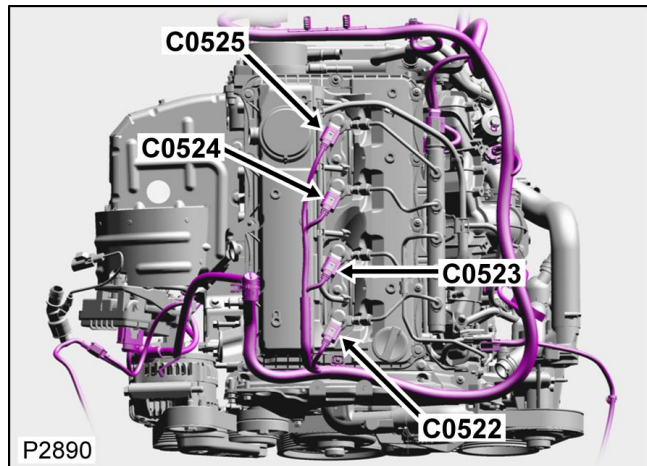
Location: **Top of engine**

CAV	TERMINAL	CSA	COL	CCT	DESTN
1		1.5	YU	254	C0411
2		1.5	GU	254	C0411

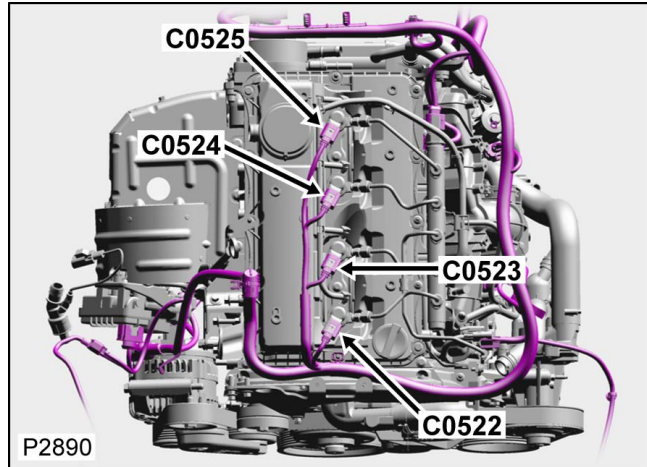
Location: **Top of engine**

CAV	TERMINAL	CSA	COL	CCT	DESTN
1		1.5	UO	254	S/JOINT SJ3
2		1.5	SY	I4	C0411

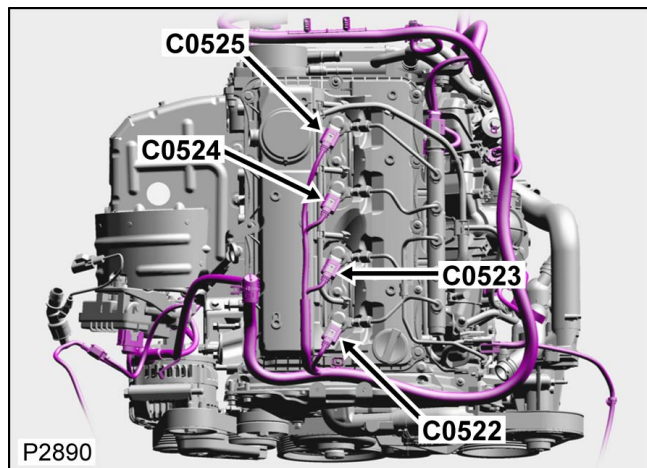
Location: **Top of engine**

CAV	TERMINAL	CSA	COL	CCT	DESTN
1		1.5	UO	254	S/JOINT SJ3
2		1.5	SY	I4	C0411

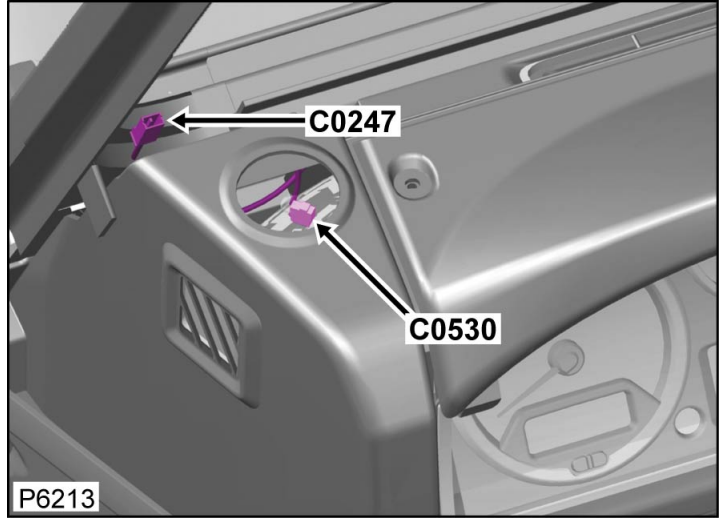
Location: **Instrument panel-left-upper**

CAV	TERMINAL	CSA	COL	CCT	DESTN
1	YPL500360	0.5D	BW	769	C0340
3	YPL500360	0.5D	BN	769	C1492

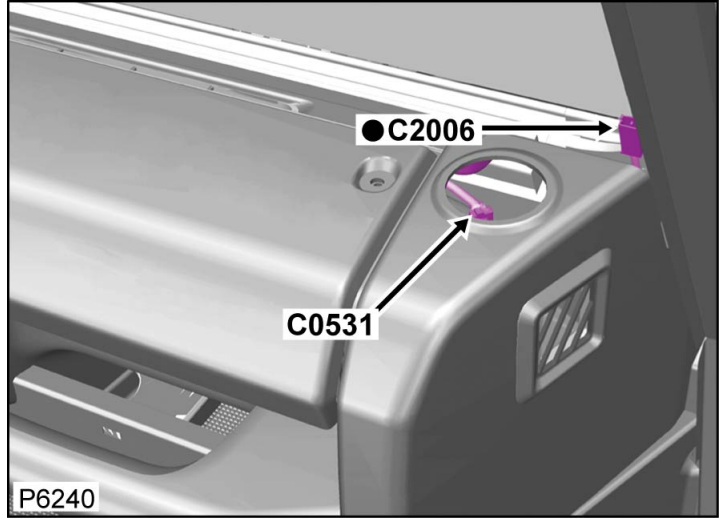
Location: **Instrument panel-right-upper**

CAV	TERMINAL	CSA	COL	CCT	DESTN
1	YPL500360	0.5D	BK	769	C1577
3	YPL500360	0.5D	BR	769	C0369

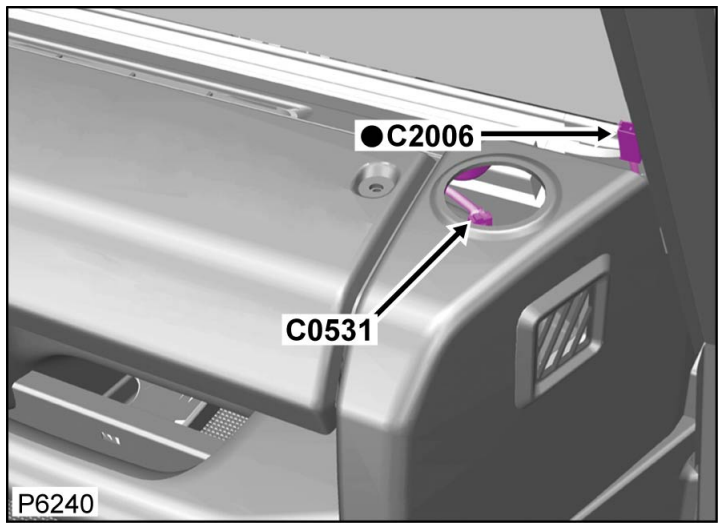
Harness: **MAIN LH + RH HARNESS**

CAV	TERMINAL	CSA	COL	CCT	DESTN
1	YPL500360	0.5D	BK	769	C1577
3	YPL500360	0.5D	BR	769	C0369

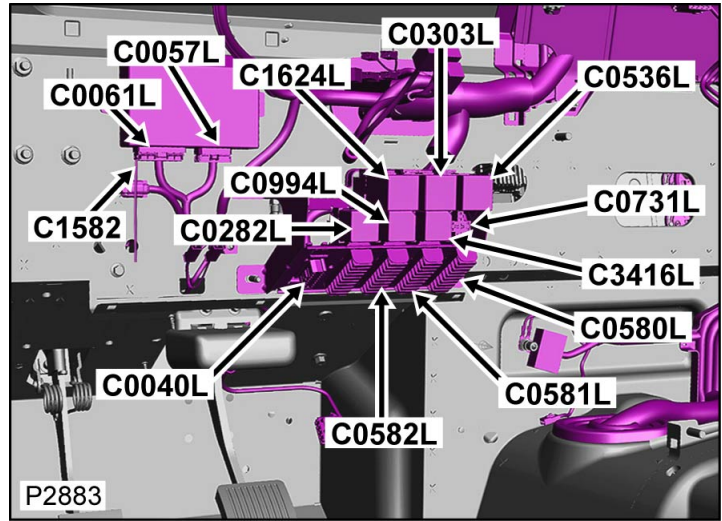
Qualifier: **LHD condition illustrated**

CAV	TERMINAL	CSA	COL	CCT	DESTN
2	AFU3228	0.5D	LGP	I39L	C1040L
4	AFU3228	0.5D	B	I39L	C0289
6	AFU3173	1.5D	LG	I39L	C0096
8	AFU3173	1.5D	LGN	I39L	S/JOINT SJ79

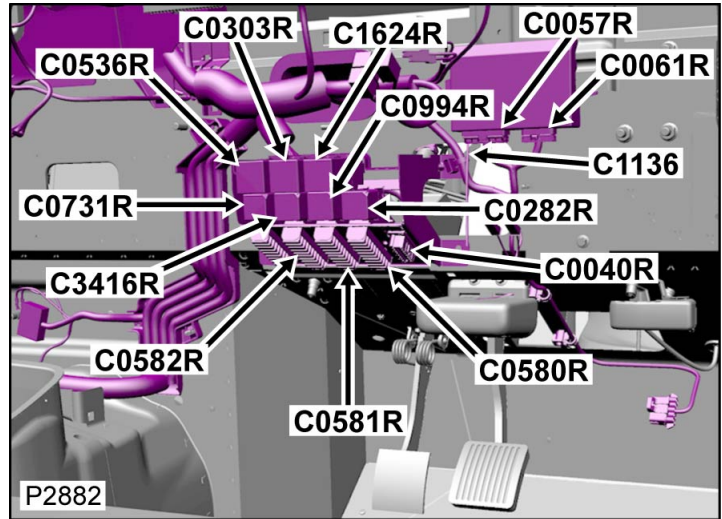
Qualifier: **RHD condition illustrated**

CAV	TERMINAL	CSA	COL	CCT	DESTN
2	AFU3228	0.5D	LGP	200R	C1040R
4	AFU3228	0.5D	B	200R	C0289
6	AFU3173	1.5D	LG	200R	C0096
8	AFU3173	1.5D	LGN	200R	S/JOINT SJ44

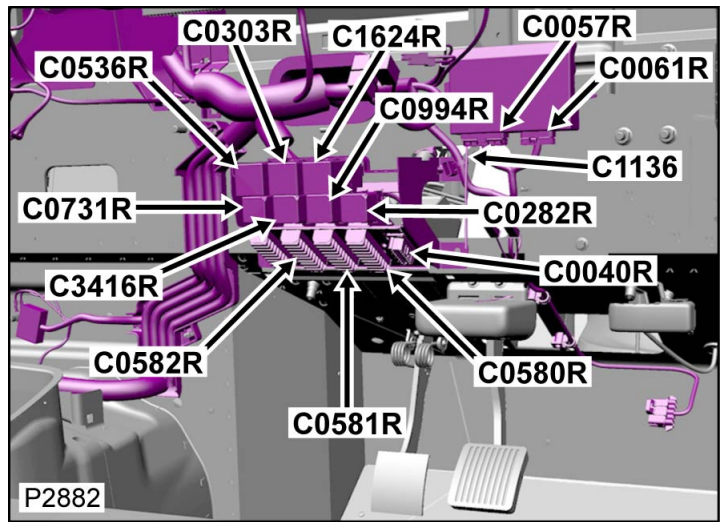
Harness: **MAIN LH + RH HARNESS**

CAV	TERMINAL	CSA	COL	CCT	DESTN
2	AFU3228	0.5D	LGP	200R	C1040R
4	AFU3228	0.5D	B	200R	C0289
6	AFU3173	1.5D	LG	200R	C0096
8	AFU3173	1.5D	LGN	200R	S/JOINT SJ44

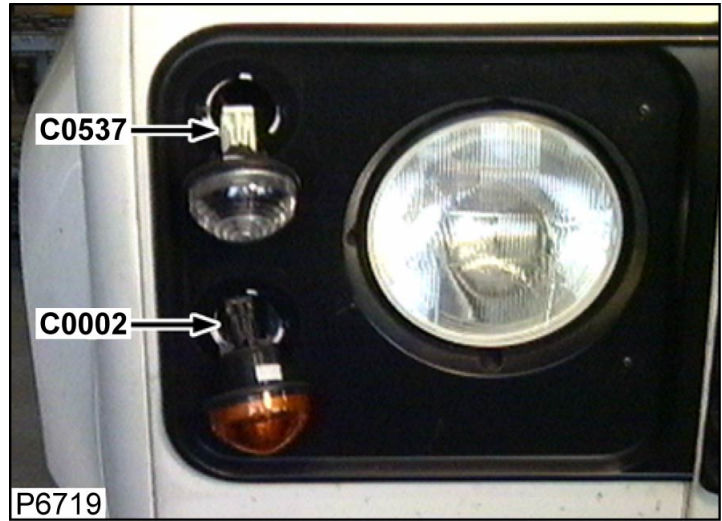
Harness: **WING RH HARNESS**

CAV	TERMINAL	CSA	COL	CCT	DESTN
1	YPL10062	0.5D	B	107	CTAP
1	YPL10062	0.5D	B	896	CTAP
1	YPL10062	0.5D	B	897	CTAP
1	AFU3802	1.0D	B	898	CTAP
2	YPL10062	0.5D	RO	899	C1267
2	YPL10062	0.5D	RB	897	C1267

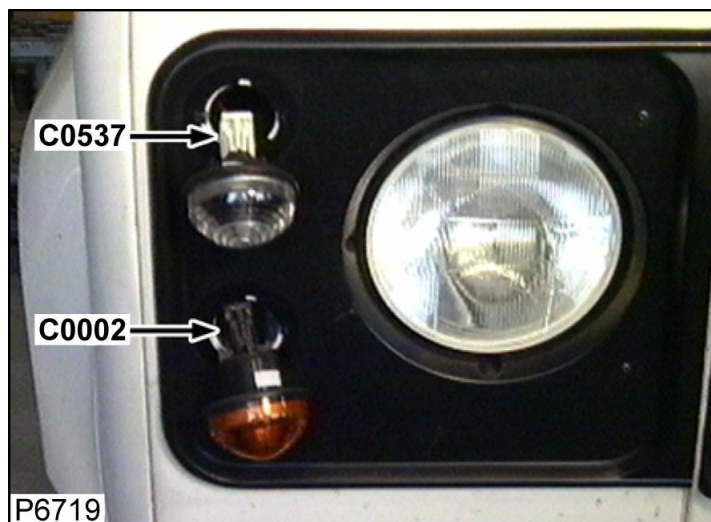
P6719

**Harness: WING RH HARNESS**

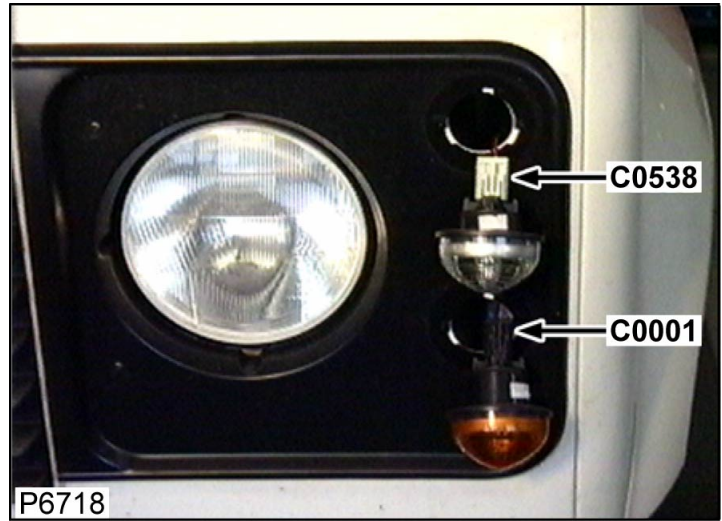
Harness: **WING LH HARNESS**

CAV	TERMINAL	CSA	COL	CCT	DESTN
1	YPL10062	0.5D	B	499	CTAP
2	YPL10062	0.5D	RB	499	C1265

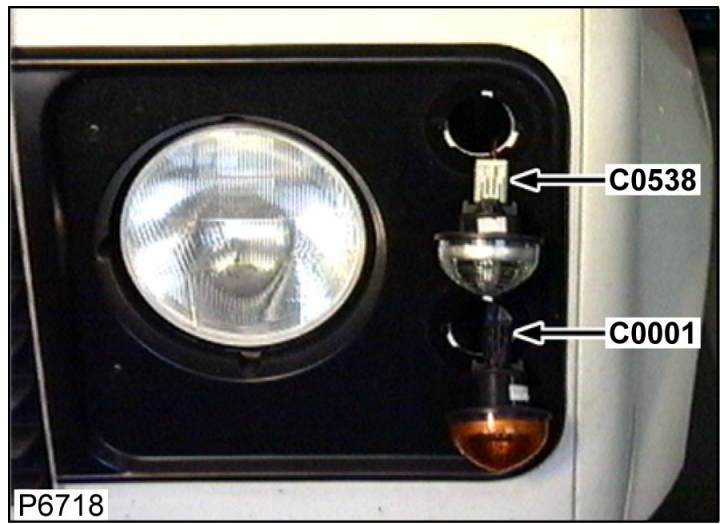
Harness: **WING LH HARNESS**

CAV	TERMINAL	CSA	COL	CCT	DESTN
1	YPL10062	0.5D	B	499	CTAP
2	YPL10062	0.5D	RB	499	C1265

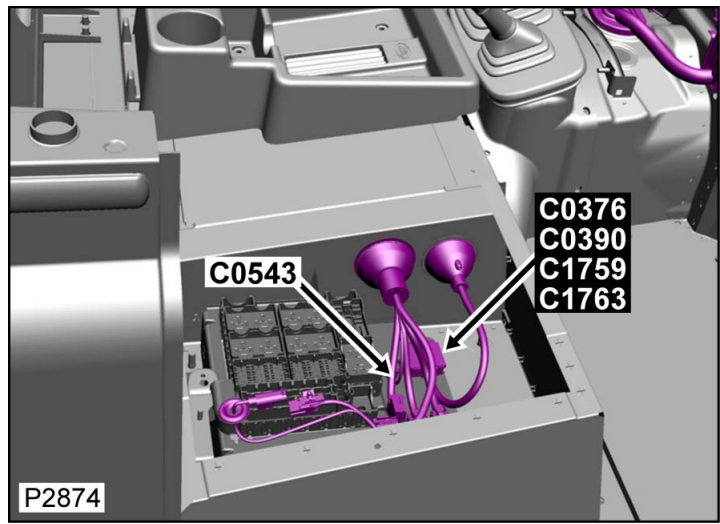
**Harness: MAIN LH + RH HARNESS**

CAV	TERMINAL	CSA	COL	CCT	DESTN
1	YPL10003	0.5D	B	499	S/JOINT SJ11
2	YPL10003	1.0D	UP	200R	C0581R
2	YPL10003	1.0D	UP	139L	C0581L
3	YPL10003	1.0D	RY	499	S/JOINT SJ48
4	YPL10003	0.5D	BS	200R	C1741
4	YPL10003	0.5D	BS	139L	C0064

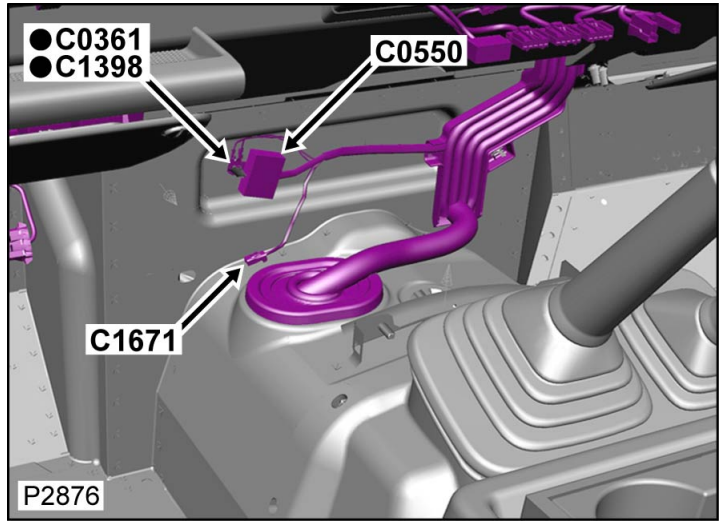
Harness: **MAIN LH + RH HARNESS**

CAV	TERMINAL	CSA	COL	CCT	DESTN
1	YPL10079	1.5D	B	499	C0289
2	YPL10080	2.5D	B	766	S/JOINT SJ20
3	YPL10080	2.0D	B	499	C0289
4	YPL10079	1.5D	B	499	C0289
6	YPL10080	2.0D	B	139L	C1264L
6	YPL10080	2.0D	B	200R	C1264R
7	YPL10079	1.5D	B	499	C1266
8	YPL10080	2.0D	B	499	S/JOINT SJ13
9	YPL10080	2.0D	B	14	S/JOINT SJ14
10	YPL10080	2.0D	B	14	C0280A

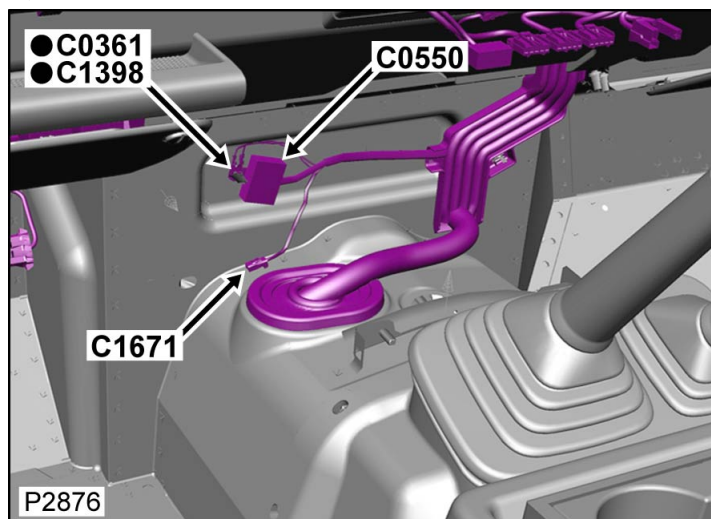
**Location: Behind center of Instrument panel**

**Part No.: YPCI0611**

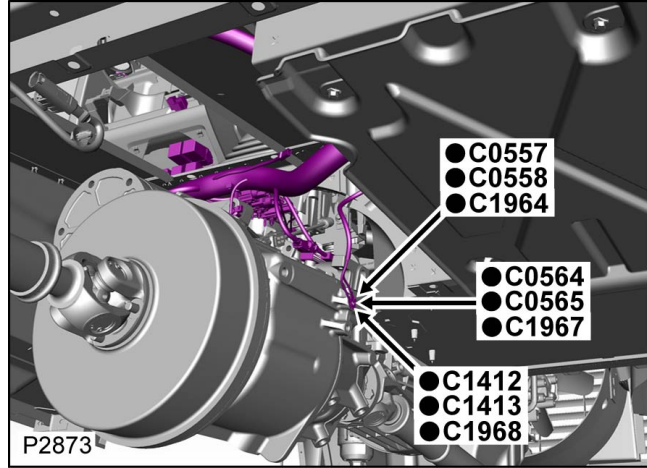
Location: **RH side of transfer box**

CAV	TERMINAL	CSA	COL	CCT	DESTN
I	-	4.0D	B	770	S/JOINT SJ2

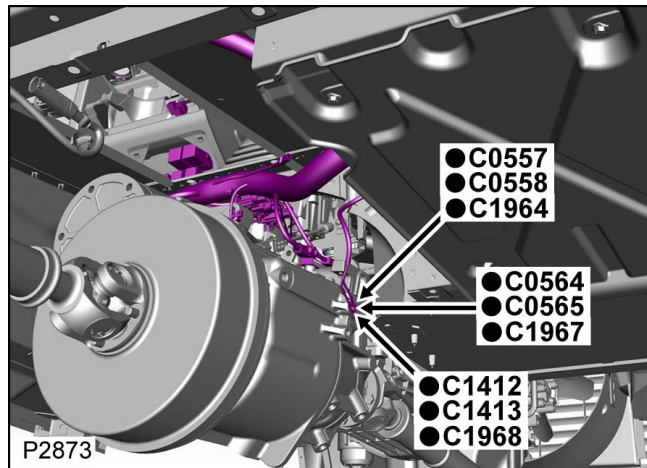
Location: **RH side of transfer box**

CAV	TERMINAL	CSA	COL	CCT	DESTN
I	-	4.0D	B	770	S/JOINT SJ2

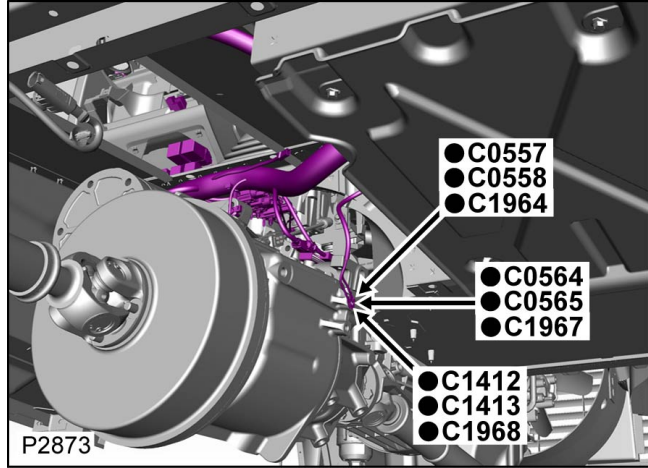
Location: **RH side of transfer box**

Part No.: **YPG900120**

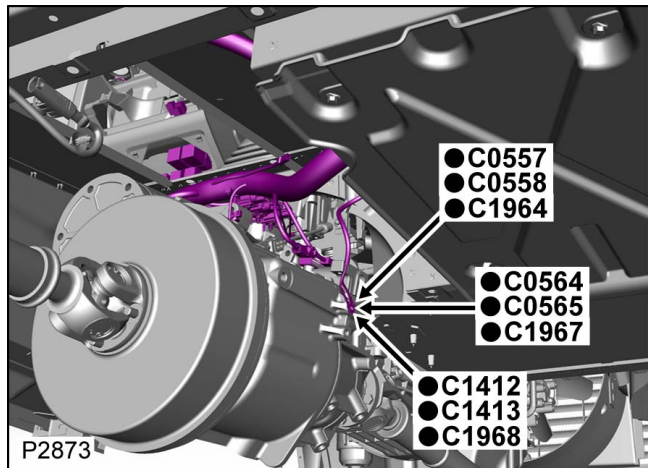
Location: **RH side of transfer box**

Part No.: **YPG900120**

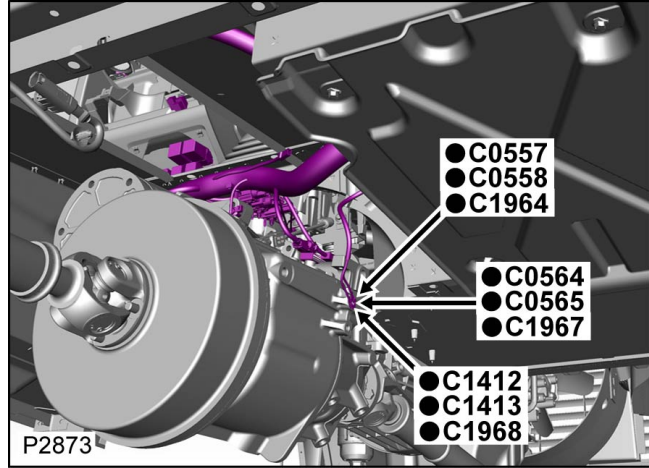
Location: **RH side of transfer box**

Part No.: **YPG900110**

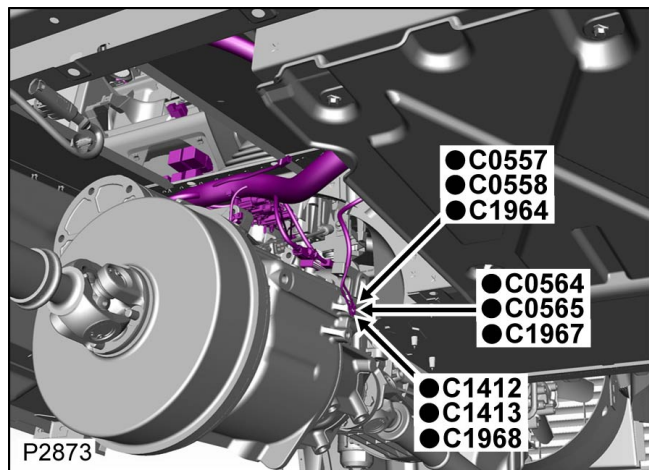
Location: **RH side of transfer box**

Part No.: **YPG900110**

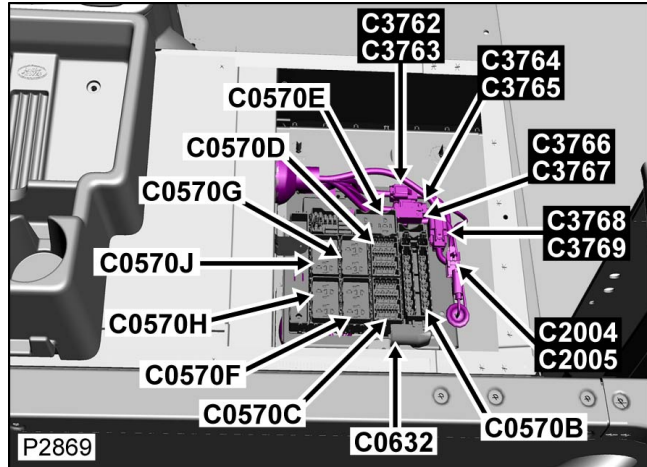
Location: **Beneath RH Front seat**

Part No.: **YQE800140**

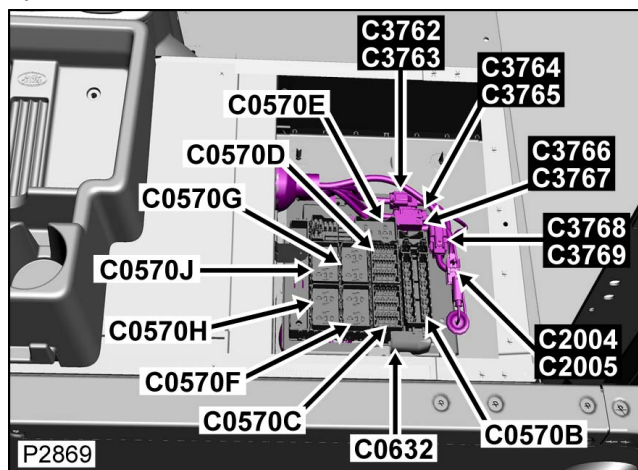
Harness: **ENGINE COMPARTMENT FUSE BOX HARNESS**

CAV	TERMINAL	CSA	COL	CCT	DESTN
1	YPL802770	6.0D	R	499	C0570B
5	YPL802760	2.5D	NO	499	S/JJOINT SJ8
6	YPL802760	2.5D	NS	254	C0570G
7	YPL802750	1.5D	NO	499	C0570F
8	YPL802750	1.5D	NS	254	S/JJOINT SJ69
9	YPL802770	6.0D	R	499	C0570B
13	YPL802760	2.5D	NW	1	C3763
14	YPL802760	2.5D	NP	766	C3765
15	YPL802760	2.5D	NS	14	S/JJOINT SJ23
16	YPL802760	2.5D	P	499	C3767
17	YPL802770	4.0D	W	499	C3769
21	YPL802750	1.0D	NS	254	C0570F
22	YPL802740	0.5D	WG	499	C3767
23	YPL802750	1.0D	LGP	499	C3767
24	YPL802740	0.5D	RG	254	C3767

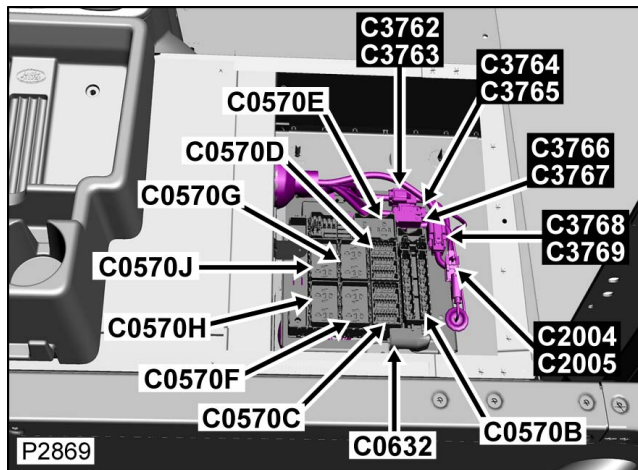
Harness: **ENGINE COMPARTMENT FUSE BOX HARNESS**

CAV	TERMINAL	CSA	COL	CCT	DESTN
1	YPL802770	6.0D	R	499	C0570B
5	YPL802760	2.5D	NO	499	S/JOINT SJ8
6	YPL802760	2.5D	NS	254	C0570G
7	YPL802750	1.5D	NO	499	C0570F
8	YPL802750	1.5D	NS	254	S/JOINT SJ69
9	YPL802770	6.0D	R	499	C0570B
13	YPL802760	2.5D	NW	1	C3763
14	YPL802760	2.5D	NP	766	C3765
15	YPL802760	2.5D	NS	14	S/JOINT SJ23
16	YPL802760	2.5D	P	499	C3767
17	YPL802770	4.0D	W	499	C3769
21	YPL802750	1.0D	NS	254	C0570F
22	YPL802740	0.5D	WG	499	C3767
23	YPL802750	1.0D	LGP	499	C3767
24	YPL802740	0.5D	RG	254	C3767

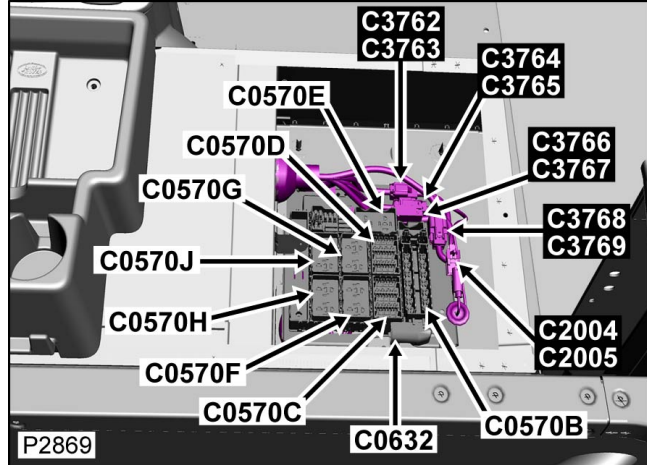
Harness: **ENGINE COMPARTMENT FUSE BOX HARNESS**

CAV	TERMINAL	CSA	COL	CCT	DESTN
1	YPL802800	1.5D	NO	499	C0570H
5	YPL802750	1.0D	G	254	C3767
6	YPL802750	1.0D	RG	499	C3767
7	YPL802740	0.5D	NO	14	S/JOINT SJI

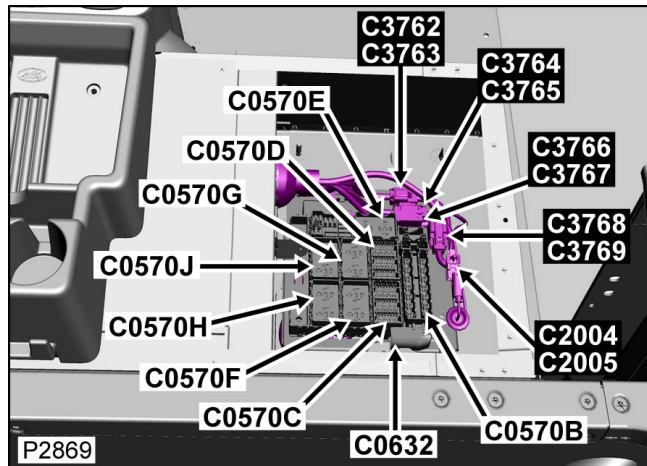
Harness: **ENGINE COMPARTMENT FUSE BOX HARNESS**

CAV	TERMINAL	CSA	COL	CCT	DESTN
1	YPL802800	1.5D	NO	499	C0570H
5	YPL802750	1.0D	G	254	C3767

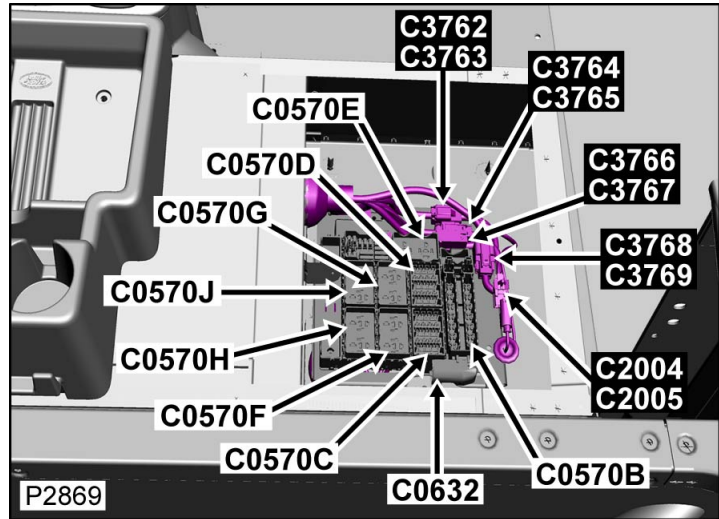
Harness: **ENGINE COMPARTMENT FUSE BOX HARNESS**

CAV	TERMINAL	CSA	COL	CCT	DESTN
1	YPL900350	1.0D	BS	14	S/JOINT S22
2	YPL900350	0.5D	BS	14	C3767
3	YPL900350	1.0D	U	14	C3767
5	YPL900350	1.0D	B	14	S/JOINT S22
6	YPL900350	0.75D	BS	14	C3767
7	YPL900360	0.5D	NO	14	S/JOINT SJI
8	YPL900360	2.5D	NS	14	S/JOINT SJ23
10	YPL900360	1.5D	BG	14	C3767

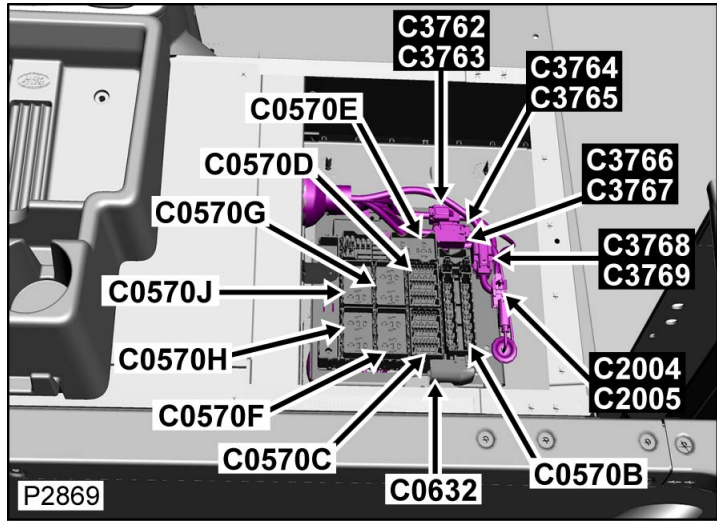
Harness: **ENGINE COMPARTMENT FUSE BOX HARNESS**

CAV	TERMINAL	CSA	COL	CCT	DESTN
1	YPL900350	0.5D	WB	499	C3767
2	YPL900350	1.0D	B	499	S/JOINT S22
3	YPL900360	1.5D	WB	499	C3767
5	YPL900360	1.5D	NO	499	C0570C
6	YPL900350	0.5D	B	254	S/JOINT S22
7	YPL900350	0.5D	RB	254	C3767
8	YPL900350	1.0D	NS	254	C0570C
10	YPL900350	1.0D	WG	499	C3767

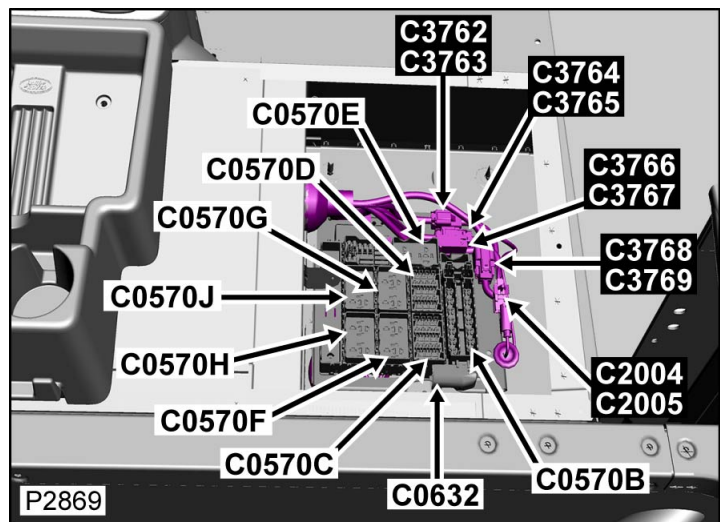
**Location: Beneath RH Front seat**

CAV	TERMINAL	CSA	COL	CCT	DESTN
1	YPL900350	0.75D	U	254	C3767
2	YPL900360	2.5D	NS	254	S/JOINT SJ69
					S/JOINT

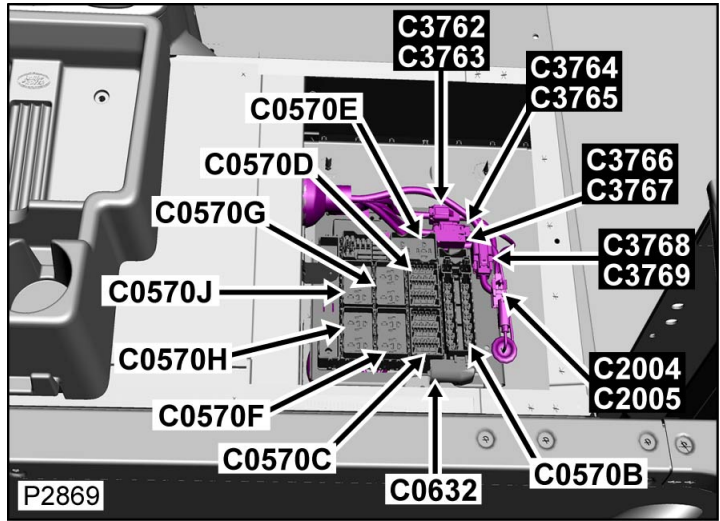
Harness: **ENGINE COMPARTMENT FUSE BOX HARNESS**

CAV	TERMINAL	CSA	COL	CCT	DESTN
1	YPL900350	0.5D	UB	14	C3767
2	YPL900350	0.5D	NO	14	S/JOINT SJ1
3	YPL900360	2.5D	NS	14	S/JOINT SJ23
5	YPL900360	2.5D	BG	14	C3765
6	YPL900350	0.75D	B	499	S/JOINT S22
7	YPL900360	2.5D	U	499	C3765
8	YPL900360	2.5D	NU	499	S/JOINT SJ3
10	YPL900360	2.5D	UR	499	C3765

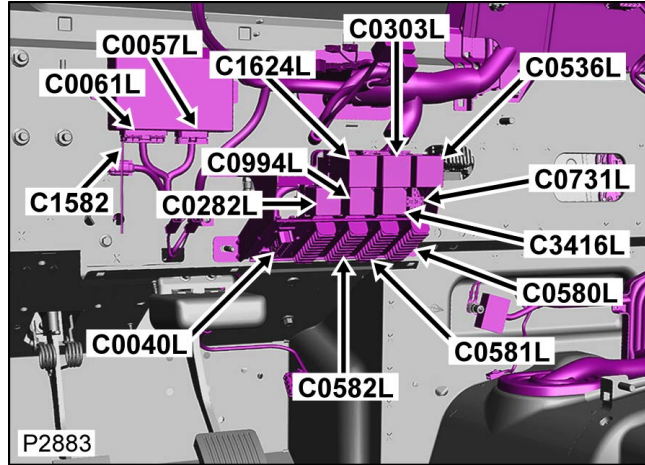
Qualifier: **LHD condition illustrated**

CAV	TERMINAL	CSA	COL	CCT	DESTN
1	YPF100750	4.0D	W	139L	S/JOINT SJ3
2	YPL102460	0.5D	WG	22L	C0285
4	YPL102460	1.0D	WG	139L	C0096
6	YPL102470	1.5D	GO	139L	C0075L
8	YPL102460	0.5D	WG	139L	C0285
9	YPF100790	4.0D	W	139L	S/JOINT SJ3
10	YPL102460	0.75D	W	139L	C3565
12	YPL102460	0.75D	GO	9	S/JOINT SJ34
14	YPL102460	1.0D	WG	14L	C0275
15	YPF100790	4.0D	N	139L	C3768
16	YPL102470	1.5D	PN	22L	S/JOINT SJ36
18	YPL102470	1.5D	PN	768L	C0061L
20	YPL102470	1.5D	NP	139L	C1739

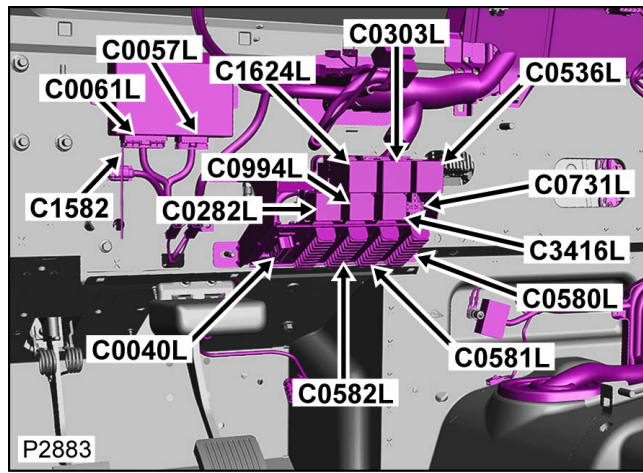
**Harness: MAIN LH + RH HARNESS**

CAV	TERMINAL	CSA	COL	CCT	DESTN
1	YPFI00750	4.0D	W	139L	S/JOINT SJ3
2	YPLI02460	0.5D	WG	22L	C0285
4	YPLI02460	1.0D	WG	139L	C0096
6	YPLI02470	1.5D	GO	139L	C0075L
8	YPLI02460	0.5D	WG	139L	C0285
9	YPFI00790	4.0D	W	139L	S/JOINT SJ3
10	YPLI02460	0.75D	W	139L	C3565
12	YPLI02460	0.75D	GO	9	S/JOINT SJ34
14	YPLI02460	1.0D	WG	14L	C0275
15	YPFI00790	4.0D	N	139L	C3768
16	YPLI02470	1.5D	PN	22L	S/JOINT SJ36
18	YPLI02470	1.5D	PN	768L	C0061L
20	YPLI02470	1.5D	NP	139L	C1739

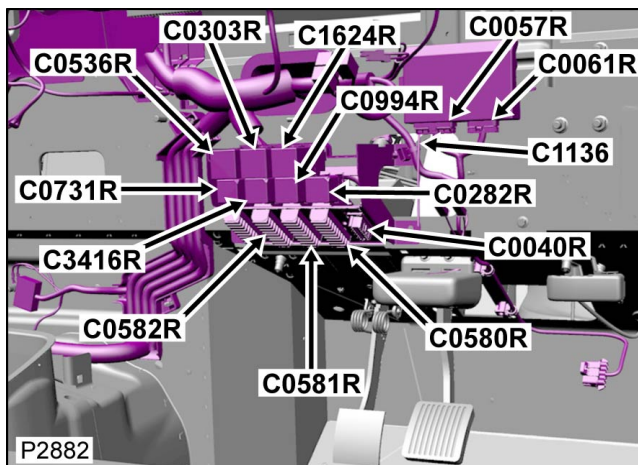
Qualifier: **RHD condition illustrated**

CAV	TERMINAL	CSA	COL	CCT	DESTN
1	YPF100750	4.0D	W	200R	S/JOINT SJ4
2	YPL102460	0.5D	WG	22R	C0285
4	YPL102460	1.0D	WG	200R	C0096
6	YPL102470	1.5D	GO	200R	C0075R
8	YPL102460	0.5D	WG	200R	C0285
11	YPL900280	4.0D	W	200R	S/JOINT SJ4
12	YPL102460	0.75D	GO	10	S/JOINT SJ63
14	YPL102460	1.0D	WG	14R	C0275
15	YPF100790	4.0D	N	200R	C3768
16	YPL102470	1.5D	PN	22R	S/JOINT SJ36
18	YPL102470	1.5D	PN	768R	C0061R
20	YPL102470	1.5D	NP	200R	CI042

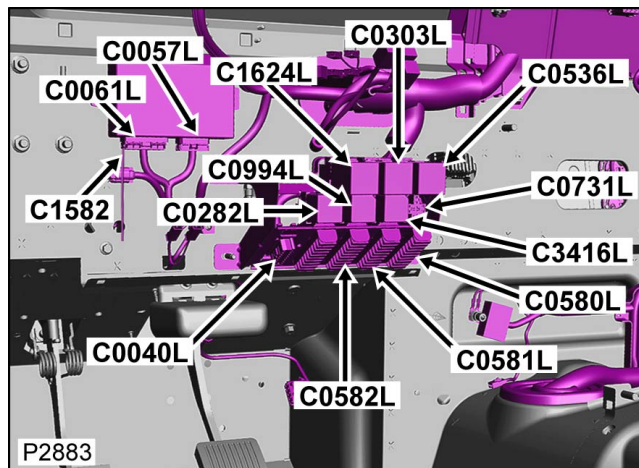
Harness: **MAIN LH + RH HARNESS**

CAV	TERMINAL	CSA	COL	CCT	DESTN
1	YPFI00740	1.5D	R	139L	CI082
2	YPLI02460	1.0D	RB	139L	C0288
4	YPLI02460	1.0D	RO	139L	S/JOINT SJ50
6	YPLI02460	1.0D	RO	139L	C0286
7	YPLI02480	4.0D	NS	95L	C3416L
7	YPLI02480	4.0D	NS	247L	S/JOINT SJ16
8	YPLI02460	1.0D	WG	139L	S/JOINT SJ33
9	YPFI00730	1.5D	UR	139L	CI739
10	YPLI02470	1.5D	UB	139L	CI266
12	YPLI02470	1.5D	UK	139L	CI264L
13	YPFI00730	2.0D	UW	139L	CI739
14	YPLI02470	1.5D	UO	139L	CI266
16	YPLI02470	1.5D	US	139L	S/JOINT SJ41
17	YPLI02470	2.0D	U	139L	S/JOINT SJ38
18	YPLI02460	1.0D	UP	139L	C0543
19	YPLI02470	1.5D	PR	271	C0787

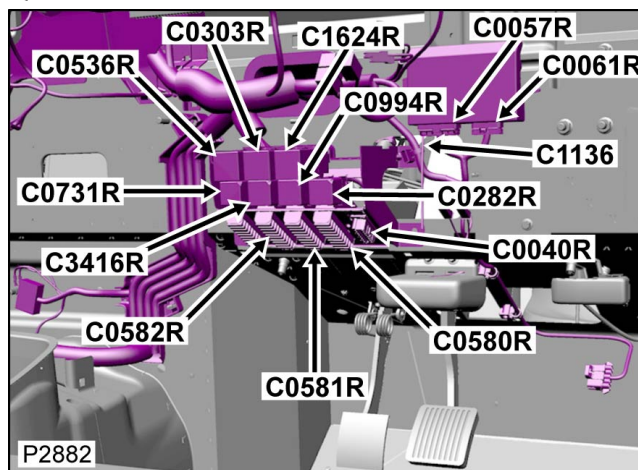
Harness: **MAIN LH + RH HARNESS**

CAV	TERMINAL	CSA	COL	CCT	DESTN
1	YPF100740	1.5D	R	200R	C0041
2	YPL102460	1.0D	RB	200R	C0288
4	YPL102460	1.0D	RO	200R	S/JOINT SJ50
6	YPL102460	1.0D	RO	200R	C0286
7	YPL102480	4.0D	NS	247R	S/JOINT SJ15
7	YPL102480	4.0D	NS	95R	C3416R
8	YPL102460	1.0D	WG	200R	S/JOINT SJ33
9	YPF100730	1.5D	UR	200R	C1042
10	YPL102470	1.5D	UB	200R	C1266
12	YPL102470	1.5D	UK	200R	C1264R
13	YPF100730	2.0D	UW	200R	C1042
14	YPL102470	1.5D	UO	200R	S/JOINT SJ64
16	YPL102470	1.5D	US	200R	C1264R
17	YPL102470	2.5D	U	200R	S/JOINT SJ61
18	YPL102460	1.0D	UP	200R	C0543
19	YPL102470	1.5D	PS	200R	C0287

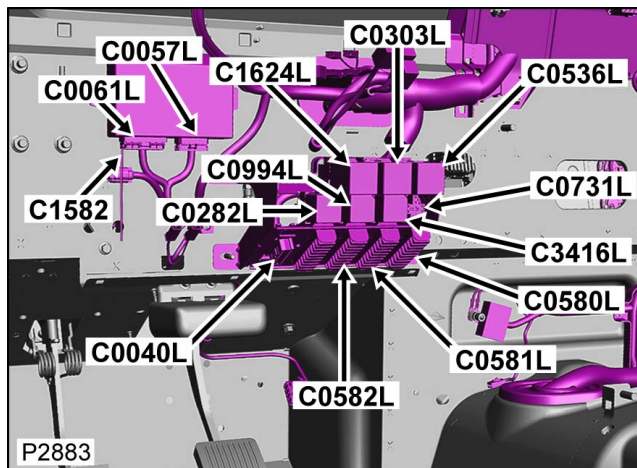
Location: **Behind LH side of Instrument panel**

CAV	TERMINAL	CSA	COL	CCT	DESTN
3	YPF100750	4.0D	NS	247L	S/JOINT SJ16
4	YPL102460	1.0D	LGW	766L	C0249
6	YPL102460	1.0D	LGW	766L	C0250
8	YPL102470	1.5D	SO	247L	C0242
10	YPL102470	1.5D	RG	247L	C0321
11	YPF100790	4.0D	WO	139L	C0099L
12	YPL102460	1.0D	PG	139L	C0089
14	YPL102460	0.5D	WO	769L	C0098
16	YPL102470	2.5D	O	139L	C0056L
17	YPF100730	2.5D	NK	139L	C3766
18	YPL102460	0.5D	PN	769L	S/JOINT SJ58
20	YPL102460	1.0D	PN	139L	S/JOINT SJ77A

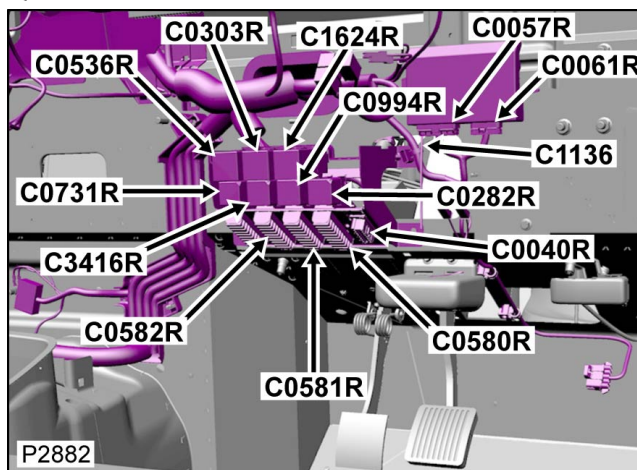
Location: **Behind RH side of Instrument panel**

CAV	TERMINAL	CSA	COL	CCT	DESTN
3	YPF100750	4.0D	NS	247R	S/JOINT SJ15
4	YPL102460	1.0D	LGW	766R	C0249
6	YPL102460	1.0D	LGW	766R	C0250
8	YPL102470	1.5D	SO	247R	C0242
10	YPL102470	1.5D	RG	247R	C0321
11	YPF100790	4.0D	WO	200R	C0099R
12	YPL102460	1.0D	PG	200R	C0089
14	YPL102460	0.5D	WO	769R	C0098
16	YPL102470	2.5D	O	200R	C0056R
17	YPF100730	2.5D	NK	200R	C3766
18	YPL102460	0.5D	PN	769R	S/JOINT SJ58
20	YPL102460	1.0D	PN	200R	S/JOINT SJ126

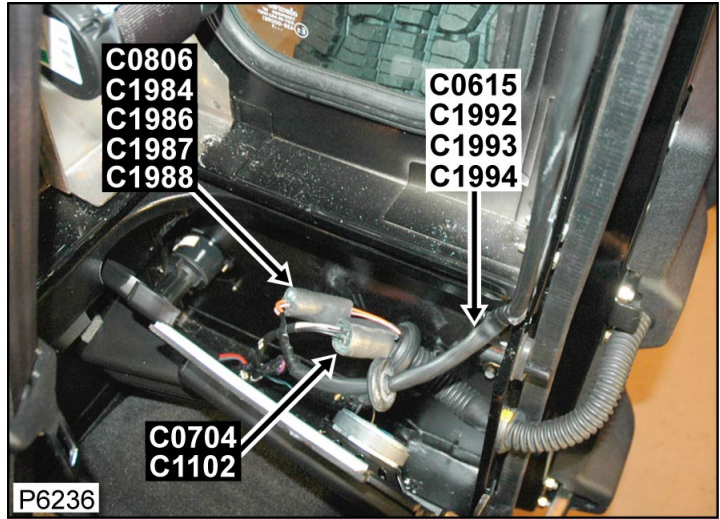
Harness: **ROOF FRONT HARNESS**

CAV	TERMINAL	CSA	COL	CCT	DESTN
I	AFU3262	0.5D	PU	902	C0259

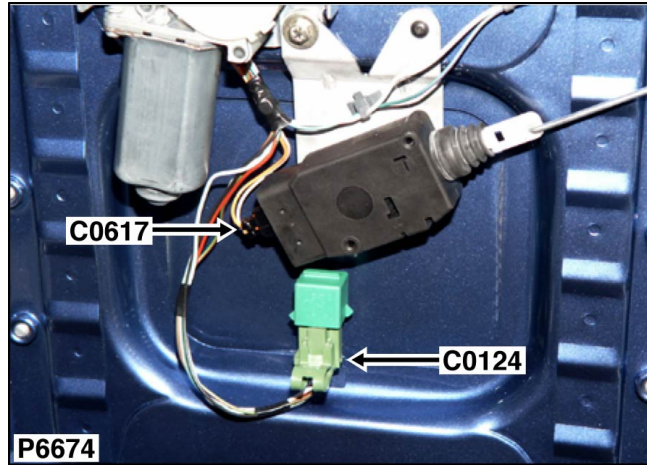
Location: **Center of taildoor, behind trim panel**

CAV	TERMINAL	CSA	COL	CCT	DESTN
1	YPL000080	0.5D	O	767	C1988
2	YPL000080	0.5D	K	767	C1988

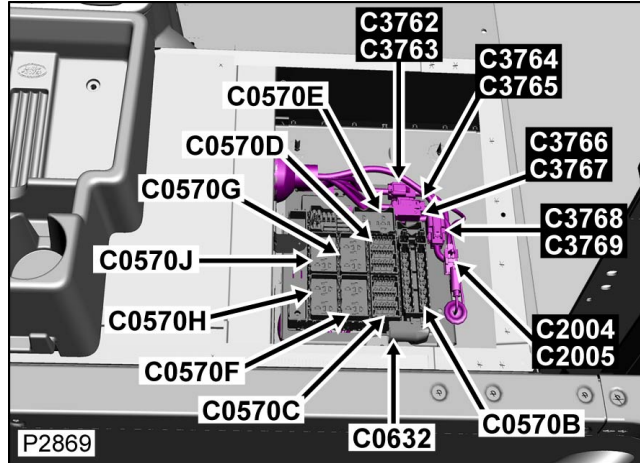
Location: **Beneath RH Front seat**

CAV	TERMINAL	CSA	COL	CCT	DESTN
I	-	10.0D	N	499	C0192

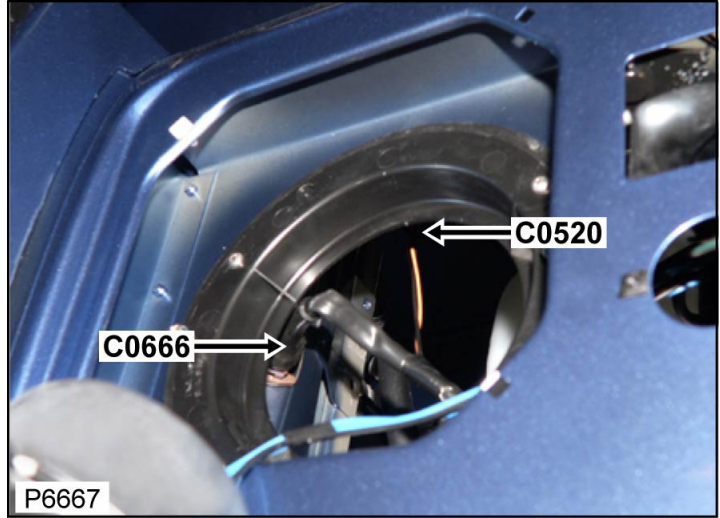
Harness: **WING LH HARNESS**

CAV	TERMINAL	CSA	COL	CCT	DESTN
1	ALU1033	0.5D	B	828	CI265
2	AFU3415	1.0D	B	828	CI265
3	ALU1033	0.5D	B	828	CI265
4	AFU3415	1.0D	B	828	CTAP

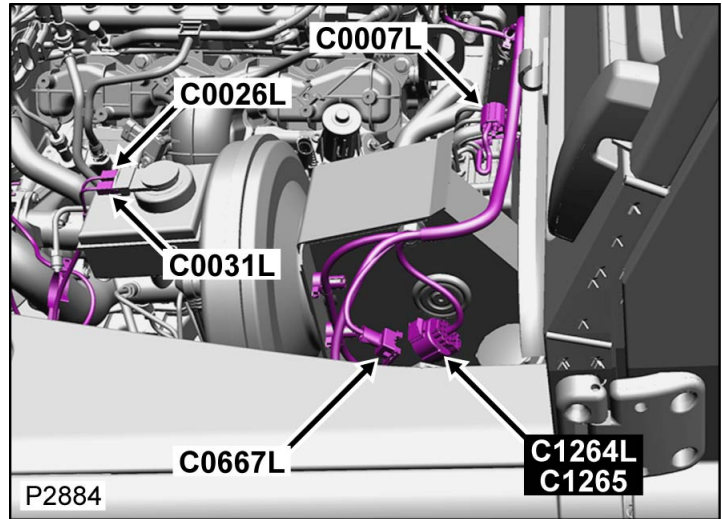
Location: **Rear LH side of engine compartment**

CAV	TERMINAL	CSA	COL	CCT	DESTN
1	YPF10017	0.5D	BW	254L	C0872
2	YPF10017	0.5D	B	139L	S/JOINT SJ18

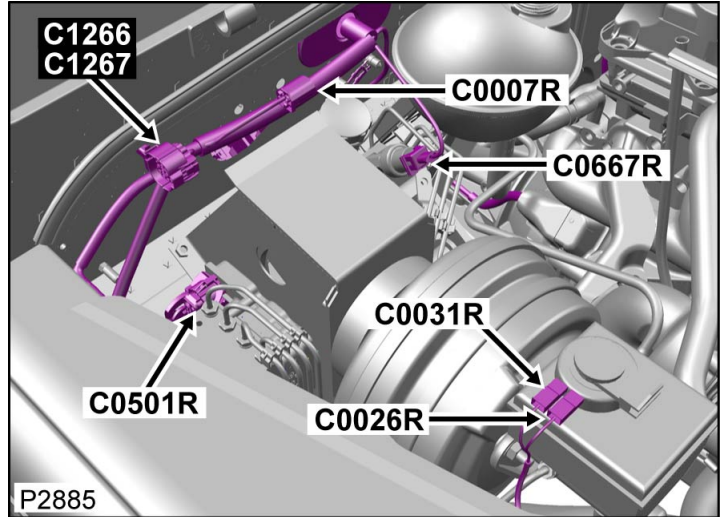
**Harness: MAIN LH + RH HARNESS**

CAV	TERMINAL	CSA	COL	CCT	DESTN
1	YPF10017	0.5D	BW	254R	C0872
2	YPF10017	0.5D	B	200R	S/JOINT SJ19

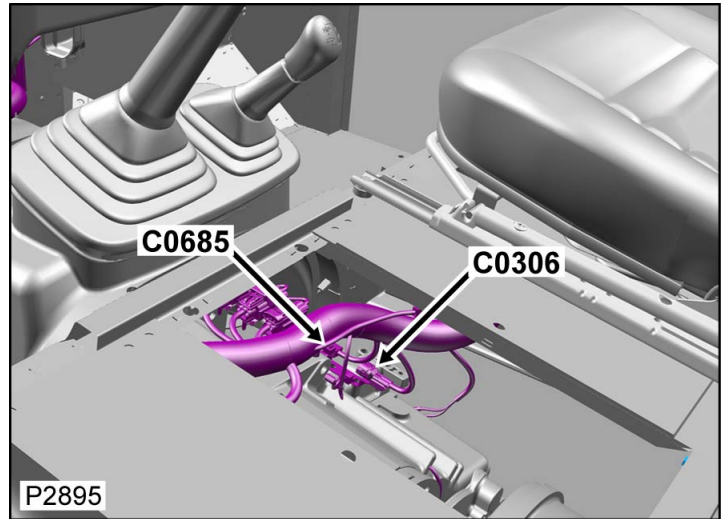
Location: **Top of transfer box**

CAV	TERMINAL	CSA	COL	CCT	DESTN
1	DBP8548	0.5D	WB	139L	C1040L
1	DBP8548	0.5D	WB	200R	C1040R
3	DBP8548	0.5D	B	499	S/JOINT SJ13

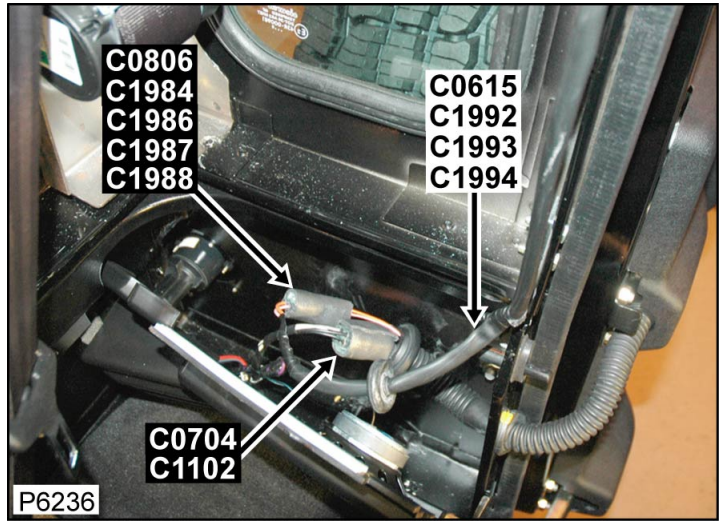
Harness: **CHASSIS HARNESS**

CAV	TERMINAL	CSA	COL	CCT	DESTN
1	YPL10027	1.5D	WB	771	CI759
1	YPL10027	1.5D	WB	770	C0390
2	YPL10027	1.5D	GP	771	S/JOINT SJ20
2	YPL10027	1.5D	GP	770	S/JOINT SJ14
3	DBP8548	0.75D	BG	771	CI759
3	DBP8548	0.75D	BG	770	C0390
4	DBP8548	1.0D	WG	771	CI759
4	DBP8548	1.0D	WG	770	C0390
6	YPL10027	1.5D	B	771	S/JOINT SJ3
6	YPL10027	1.5D	B	770	S/JOINT SJ2

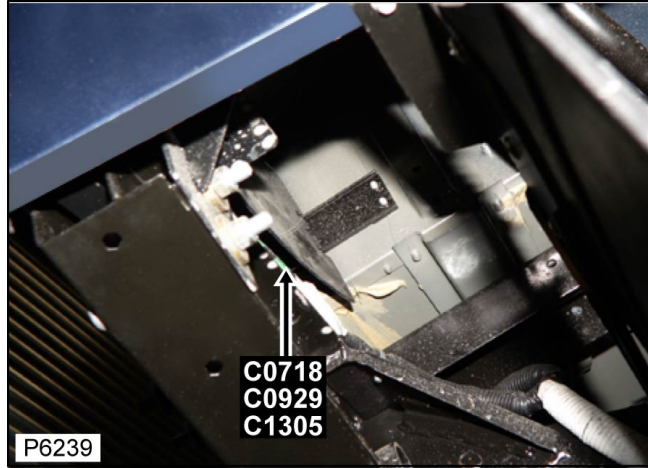
Harness: **TOWING HARNESS**

CAV	TERMINAL	CSA	COL	CCT	DESTN
1	YPJ100890	1.5D	GR	499	C0499
2	YPJ100890	2.0D	RB	499	C0499
3	YPJ100890	1.5D	GW	499	C0499
4	YPJ100890	1.5D	RO	499	C0499
5	YPJ100890	1.5D	GP	499	C0499
6	YPJ100540	2.0D	P	499	C0596
7	YPJ100890	1.5D	GN	499	C0595
8	YPJ100890	1.5D	RY	499	C0439
9	YPJ100540	2.0D	B	499	C0499

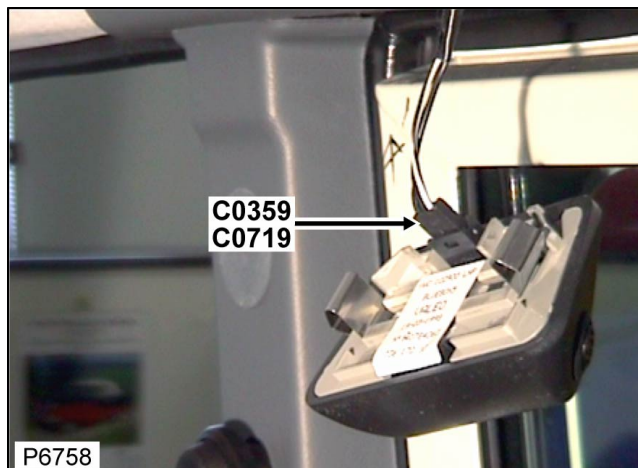
Location: **Behind headlining top of RH 'B' post**

CAV	TERMINAL	CSA	COL	CCT	DESTN
1	AFU3317	0.5D	BN	900	C0259
2	AFU3317	0.5D	B	900	C0259
3	AFU3317	0.5D	WB	900	C0259

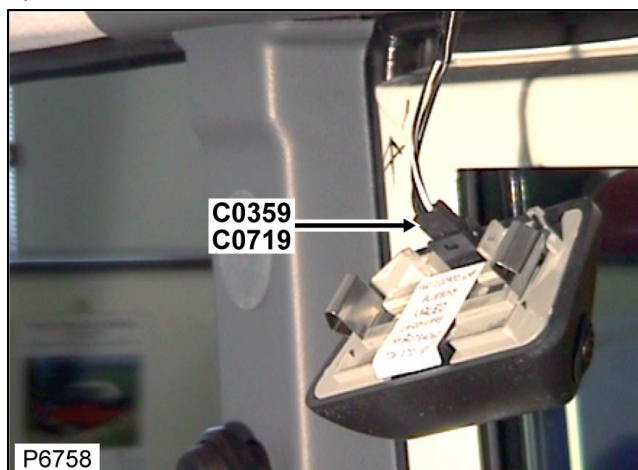
Location: **Behind headlining top of RH 'B' post**

CAV	TERMINAL	CSA	COL	CCT	DESTN
1	AFU3317	0.5D	BN	900	C0259
2	AFU3317	0.5D	B	900	C0259

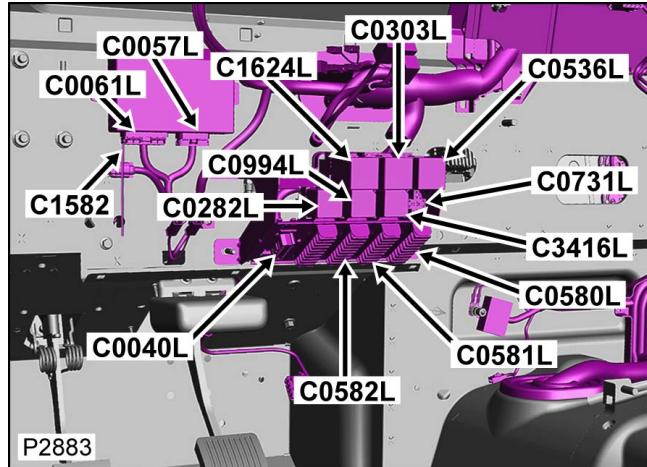
Qualifier: **LHD condition illustrated**

CAV	TERMINAL	CSA	COL	CCT	DESTN
30	AFU3120	1.0D	OB	22L	C1264L
85	AFU3120	1.5D	PN	22L	S/JOINT SJ40
86	AFU3119	0.5D	OW	22L	C0286
87A	AFU3120	1.0D	OR	22L	C0581L
87	AFU3120	1.5D	PN	22L	S/JOINT SJ40

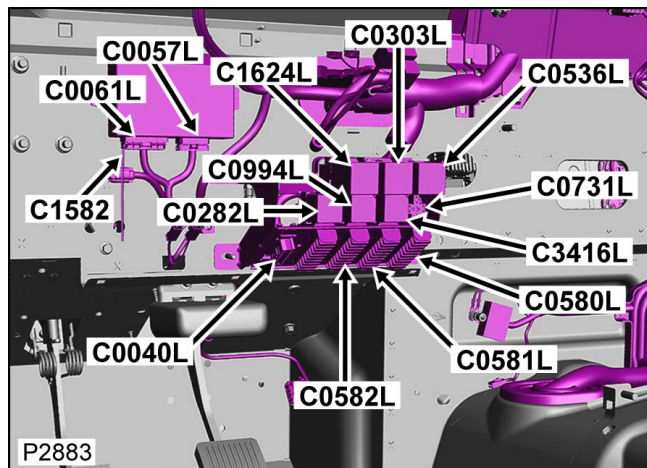
Location: **Behind LH side of Instrument panel**

CAV	TERMINAL	CSA	COL	CCT	DESTN
30	AFU3120	1.0D	OB	22L	C1264L
85	AFU3120	1.5D	PN	22L	S/JOINT SJ40

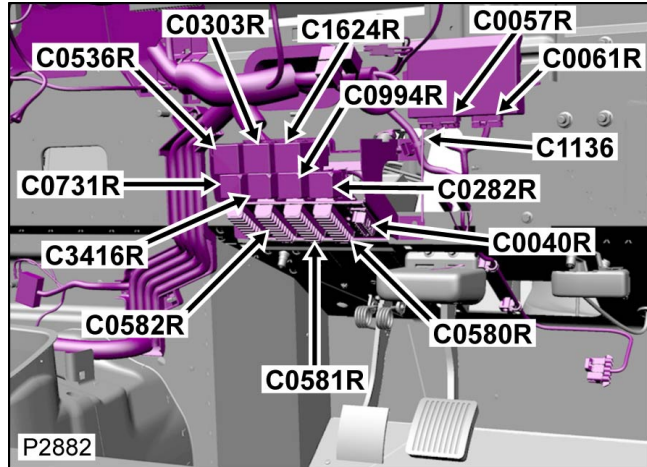
Qualifier: **RHD condition illustrated**

CAV	TERMINAL	CSA	COL	CCT	DESTN
30	AFU3120	1.0D	OB	22R	C1264R
85	AFU3120	1.5D	PN	22R	S/JOINT SJ65
86	AFU3119	0.5D	OW	22R	C0286
87A	AFU3120	1.0D	OR	22R	C0581R
87	AFU3120	1.5D	PN	22R	S/JOINT SJ65

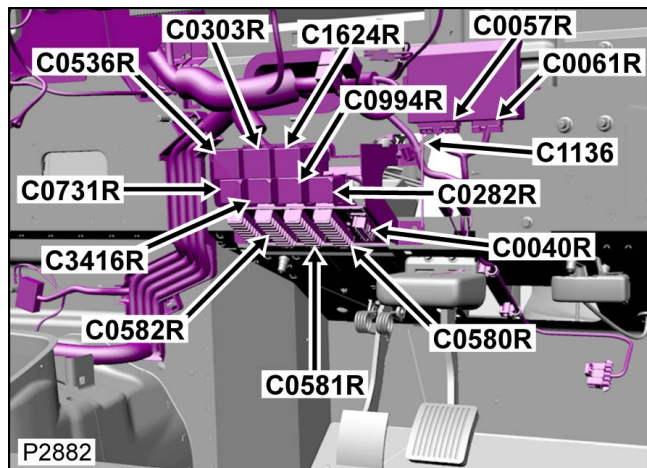
Location: **Behind RH side of Instrument panel**

CAV	TERMINAL	CSA	COL	CCT	DESTN
30	AFU3120	1.0D	OB	22R	C1264R
85	AFU3120	1.5D	PN	22R	S/JOINT SJ65

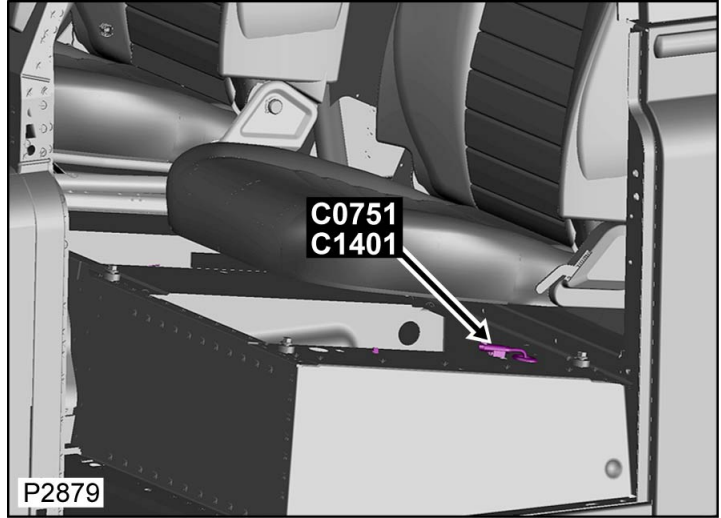
Location: **Beneath LH Front seat**

CAV	TERMINAL	CSA	COL	CCT	DESTN
1	YPL101510	0.75D	US	56	C0237
2	YPL101510	0.75D	B	56	C0237

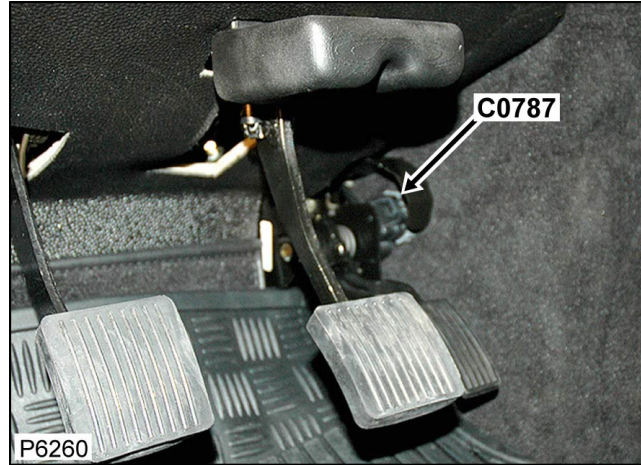
Location: **Beneath footwell carpet - RH side**

CAV	TERMINAL	CSA	COL	CCT	DESTN
B	YPLI0111	0.5D	PN	254R	C0872
D	YPLI0111	0.5D	WG	254R	C0872
F	YPLI0111	0.5D	RG	254R	C0872
K	YPLI0111	0.5D	WS	254R	C0872
G	YPLI0111	0.5D	B	254R	C0872
J	YPLI0064	0.75D	B	254R	C0872

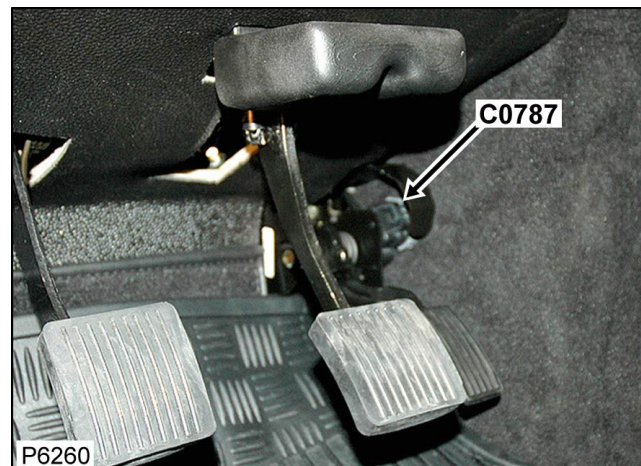
Location: **Beneath footwell carpet - RH side**

CAV	TERMINAL	CSA	COL	CCT	DESTN
B	YPLI0111	0.5D	PN	254R	C0872
D	YPLI0111	0.5D	WG	254R	C0872

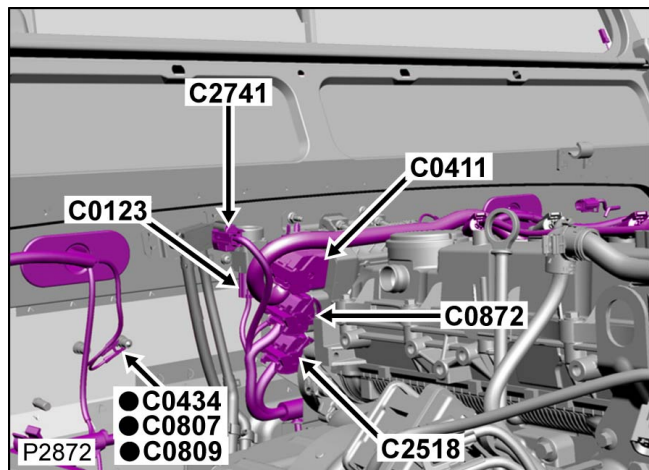
Location: **Rear RH side of engine compartment**

Part No.: **YPG800660**

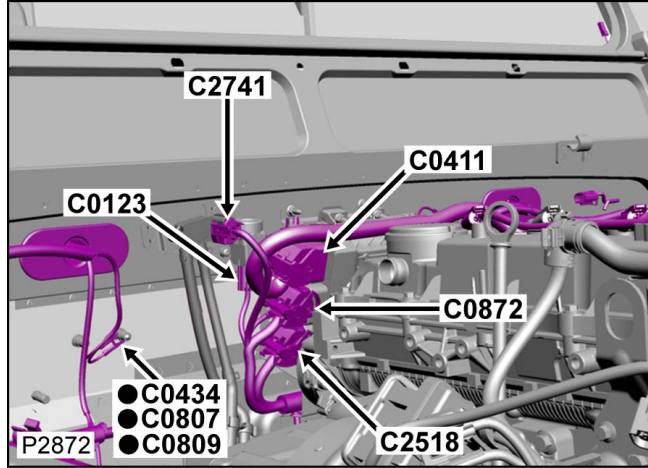
Location: **Rear RH side of engine compartment**

Part No.: **YPG800220**
