DEFENDER - VIN: 412051 >

Electrical Reference Library (1a)

JLR 16 25 21\_IE

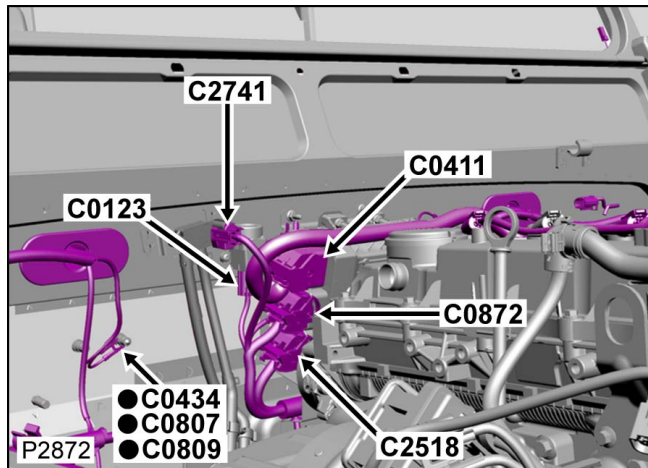
Location: **Rear RH side of engine compartment**

Part No.: **YPG800220**

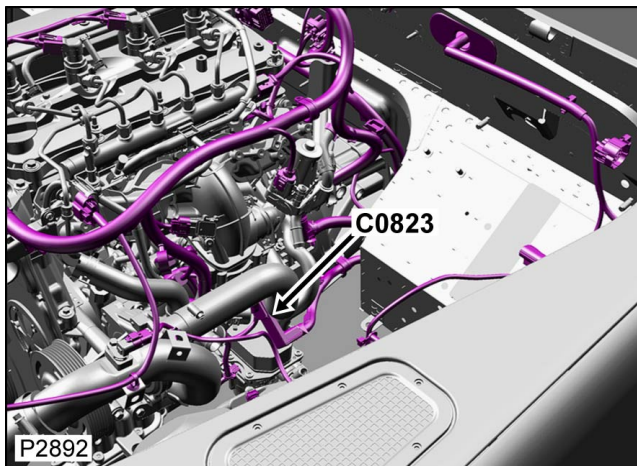
Location: **Lower rear of engine - LH side**

CAV	TERMINAL	CSA	COL	CCT	DESTN
I	-	50.0D	R	499	CI64I

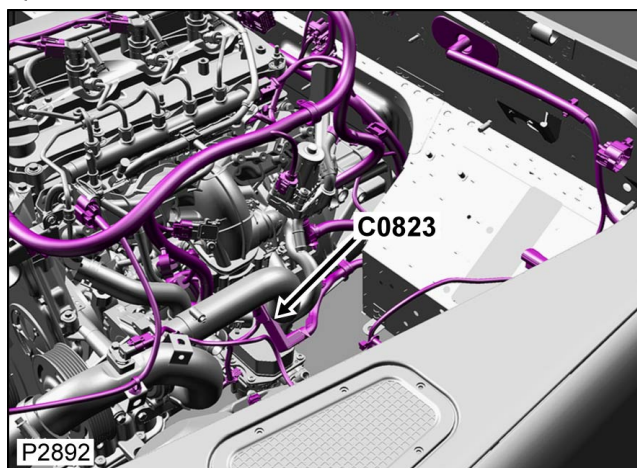
Location: **Lower rear of engine - LH side**

CAV	TERMINAL	CSA	COL	CCT	DESTN
I	-	50.0D	R	499	CI64I

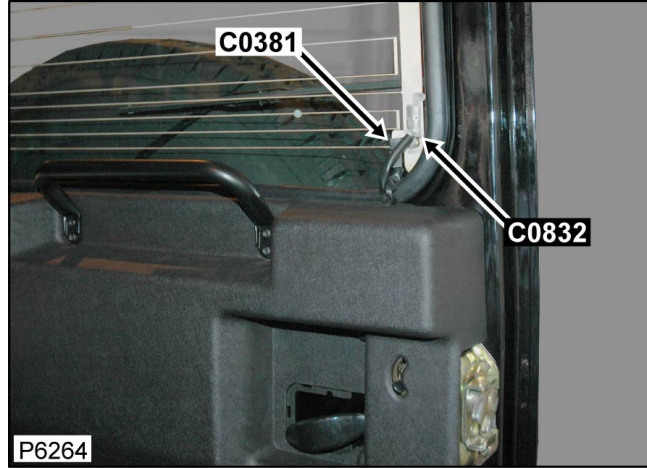
Location: **Rear screen - lower**

CAV	TERMINAL	CSA	COL	CCT	DESTN
I	AGUI318	1.0D	GP	I2I	CI102

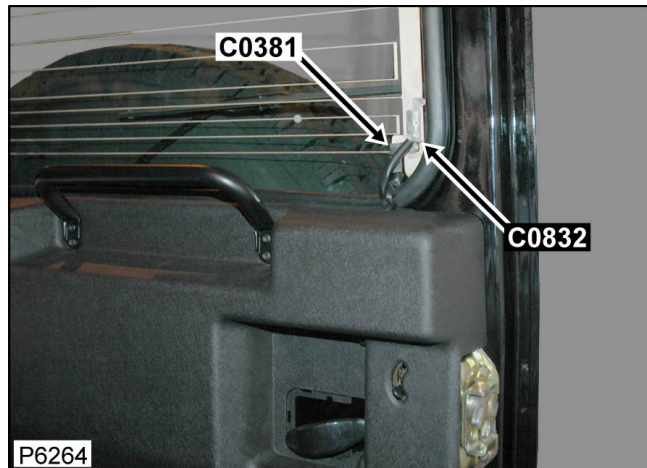
Location: **Rear screen - lower**

CAV	TERMINAL	CSA	COL	CCT	DESTN
I	AGUI318	1.0D	GP	I2I	CI102

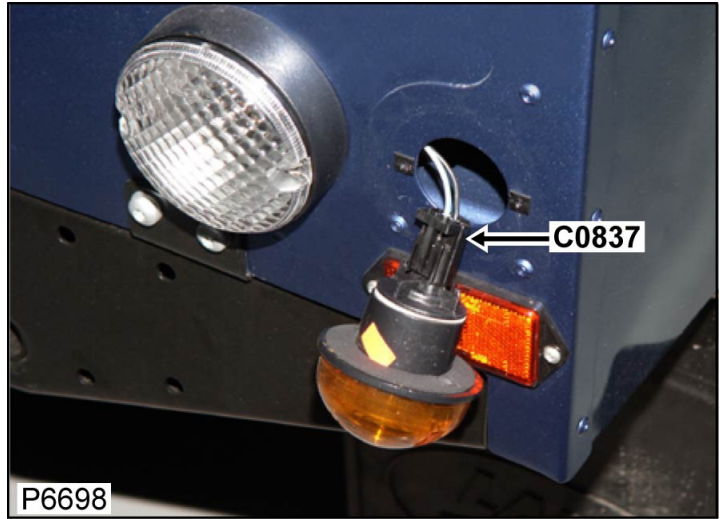
Description: **Turn signal indicator/ hazard flasher lamp-Rear-RH**

Harness: **CHASSIS HARNESS**

CAV	TERMINAL	CSA	COL	CCT	DESTN
1	AFU3802	1.5D	B	770	S/JOINT SJ2
1	AFU3802	1.5D	B	771	S/JOINT SJ3
2	AFU3802	1.5D	GW	771	S/JOINT SJ17
2	AFU3802	1.5D	GW	770	S/JOINT SJ11

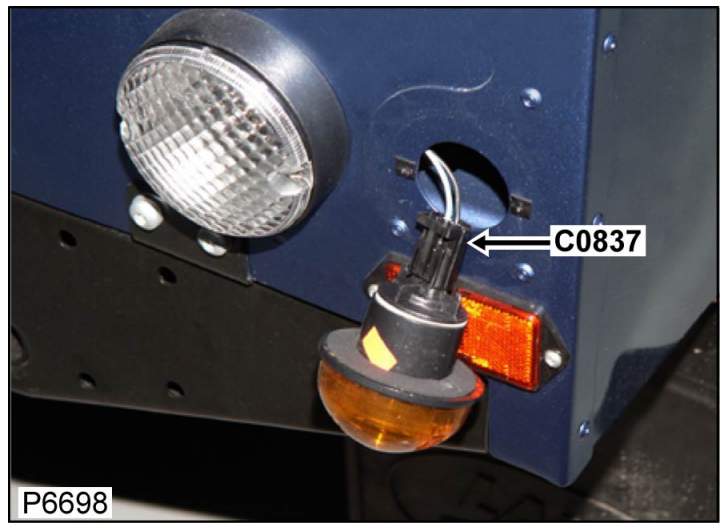
Description: **Turn signal indicator/ hazard flasher lamp-Rear-RH**

Harness: **CHASSIS HARNESS**

CAV	TERMINAL	CSA	COL	CCT	DESTN
1	AFU3802	1.5D	B	770	S/JOINT SJ2
1	AFU3802	1.5D	B	771	S/JOINT SJ3
2	AFU3802	1.5D	GW	771	S/JOINT SJ17
2	AFU3802	1.5D	GW	770	S/JOINT SJ11

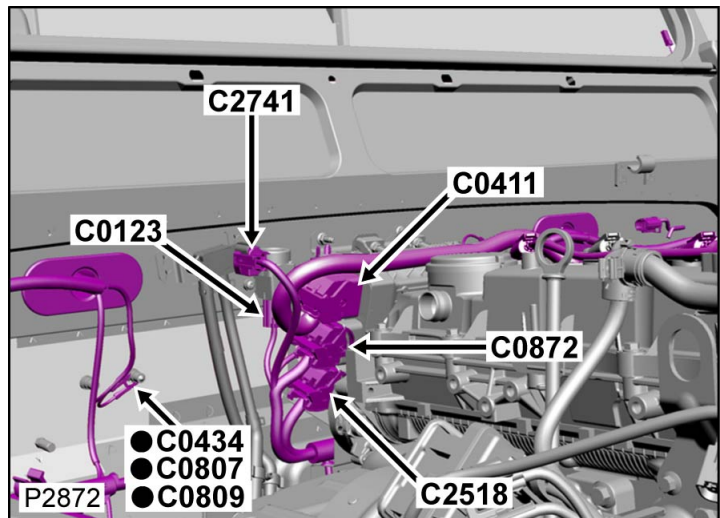
**Harness: MAIN LH + RH HARNESS**

CAV	TERMINAL	CSA	COL	CCT	DESTN
2	YPL802000	0.75D	B	499	C0556
3	YPL802000	0.75D	B	499	C0559
5	YPL802010	1.5D	N	499	S/JJOINT SJ30

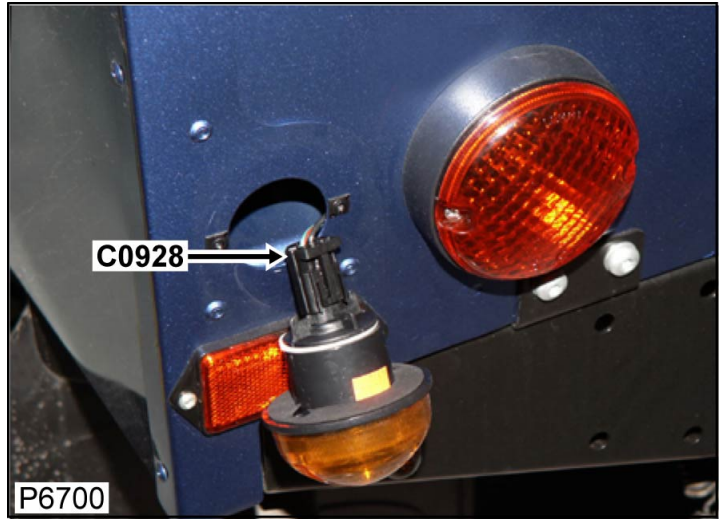
Description: **Turn signal indicator/ hazard flasher lamp-Rear-LH**

Harness: **CHASSIS HARNESS**

CAV	TERMINAL	CSA	COL	CCT	DESTN
1	AFU3802	1.5D	B	771	S/JOINT SJ28
1	AFU3802	1.5D	B	770	S/JOINT SJ27
2	AFU3802	1.5D	GR	771	S/JOINT SJ16
2	AFU3802	1.5D	GR	770	S/JOINT SJ10

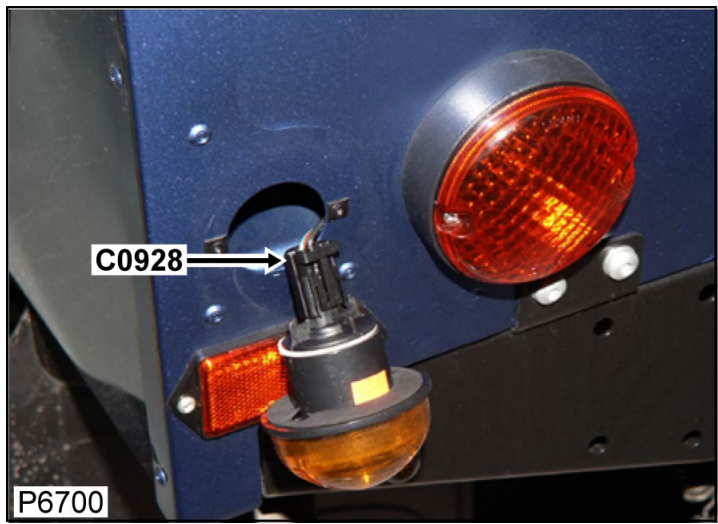
Description: **Turn signal indicator/ hazard flasher lamp-Rear-LH**

Harness: **CHASSIS HARNESS**

CAV	TERMINAL	CSA	COL	CCT	DESTN
1	AFU3802	1.5D	B	771	S/JOINT SJ28
1	AFU3802	1.5D	B	770	S/JOINT SJ27
2	AFU3802	1.5D	GR	771	S/JOINT SJ16
2	AFU3802	1.5D	GR	770	S/JOINT SJ10

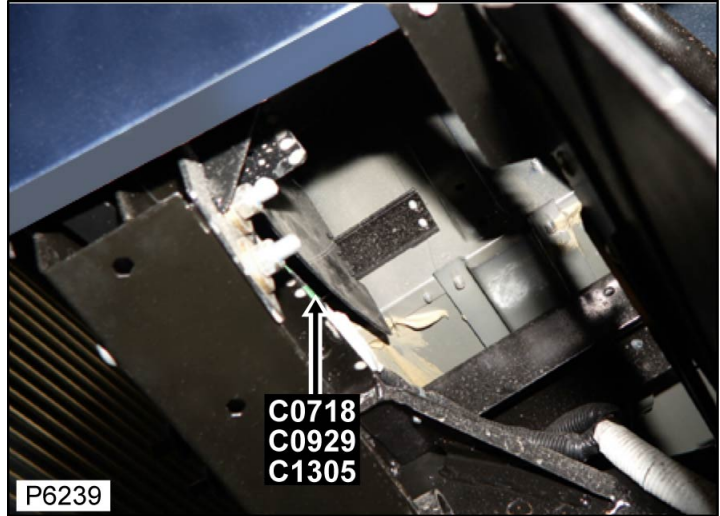
Harness: **CHASSIS HARNESS**

CAV	TERMINAL	CSA	COL	CCT	DESTN
1	YPL101830	1.5D	GR	771	S/JOINT SJ16
1	YPL101830	1.5D	GR	770	S/JOINT SJ10
2	YPL101840	0.75D	RB	771	S/JOINT SJ18
2	YPL101840	0.75D	RB	770	S/JOINT SJ12
3	YPL101830	1.5D	GW	771	S/JOINT SJ17
3	YPL101830	1.5D	GW	770	S/JOINT SJ11
4	YPL101840	0.75D	RO	771	S/JOINT SJ15
4	YPL101840	0.75D	RO	770	S/JOINT SJ9
5	YPL101830	1.5D	GP	771	S/JOINT SJ20
5	YPL101830	1.5D	GP	770	S/JOINT SJ14
6	YPL101700	2.5D	P	771	C1759

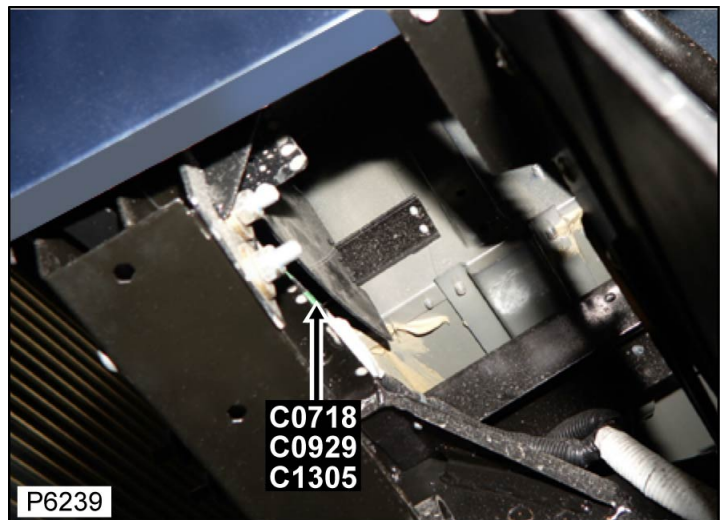
**Harness: CHASSIS HARNESS**

CAV	TERMINAL	CSA	COL	CCT	DESTN
1	YPL101830	1.5D	GR	771	S/JOINT SJ16
1	YPL101830	1.5D	GR	770	S/JOINT SJ10
2	YPL101840	0.75D	RB	771	S/JOINT SJ18
2	YPL101840	0.75D	RB	770	S/JOINT SJ12
3	YPL101830	1.5D	GW	771	S/JOINT SJ17
3	YPL101830	1.5D	GW	770	S/JOINT SJ11

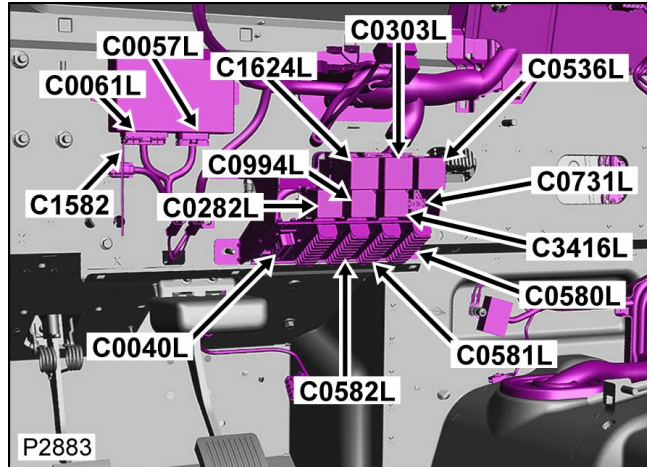
Qualifier: **LHD condition illustrated**

CAV	TERMINAL	CSA	COL	CCT	DESTN
30	YPLI0045	2.5D	NP	766L	C3764
85	AFU3119	0.5D	PY	109L	C1624L
86	AFU3119	0.5D	B	766L	C0289
87	YPLI0045	2.5D	PS	766L	S/JOINT SJ42

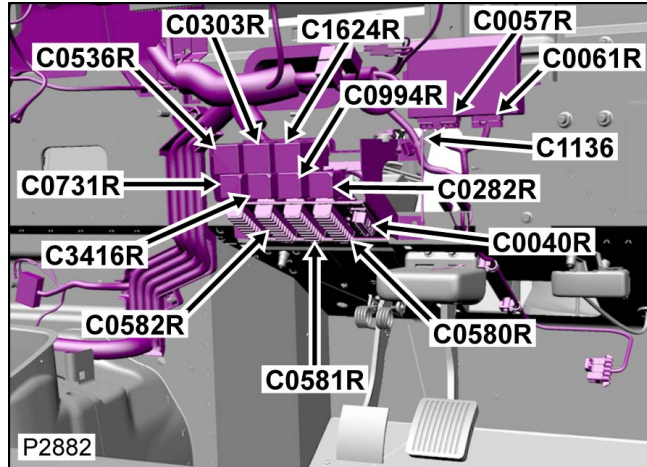
Qualifier: **RHD condition illustrated**

CAV	TERMINAL	CSA	COL	CCT	DESTN
30	YPLI0045	2.5D	NP	766R	C3764
85	AFU3119	0.5D	PY	109R	C1624R
86	AFU3119	0.5D	B	766R	C0289
87	YPLI0045	2.5D	PS	766R	S/JOINT SJ42

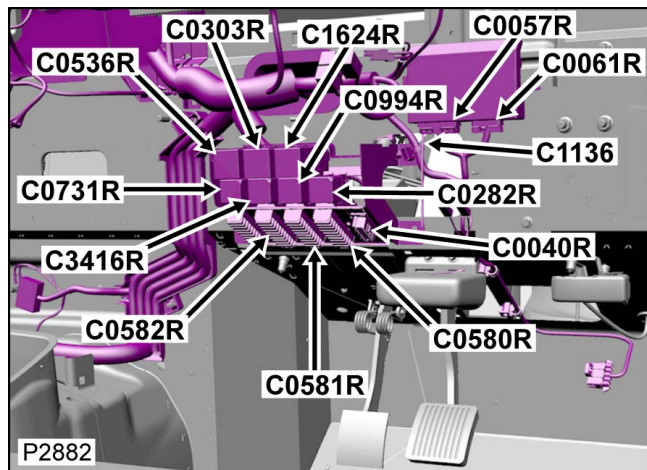
Location: **Behind RH side of Instrument panel**

CAV	TERMINAL	CSA	COL	CCT	DESTN
30	YPLI0045	2.5D	NP	766R	C3764
85	AFU3119	0.5D	PY	109R	C1624R

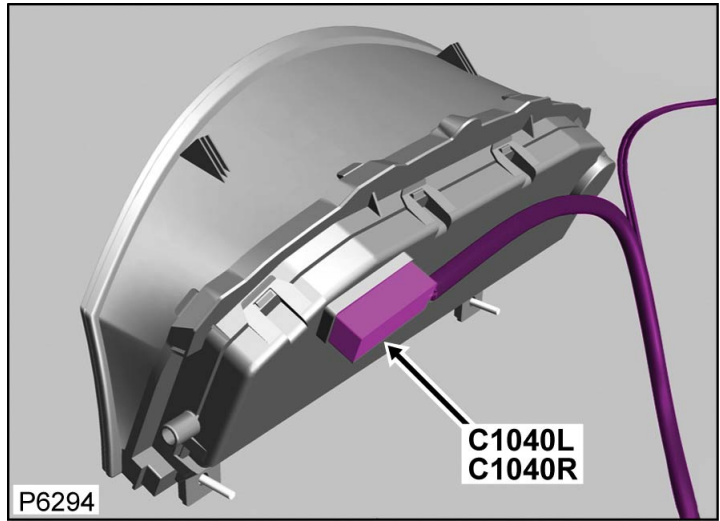
Location: **Behind instrument cluster**

Part No.: **YPC901800**

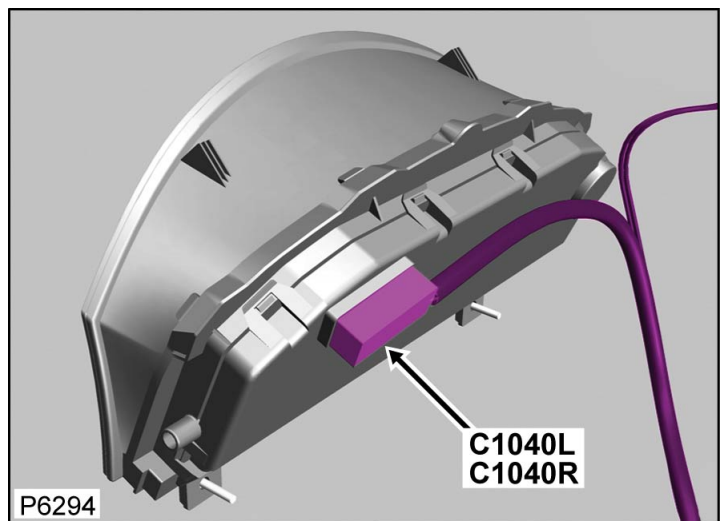
**Location: Behind instrument cluster**

**Part No.: YPC901800**

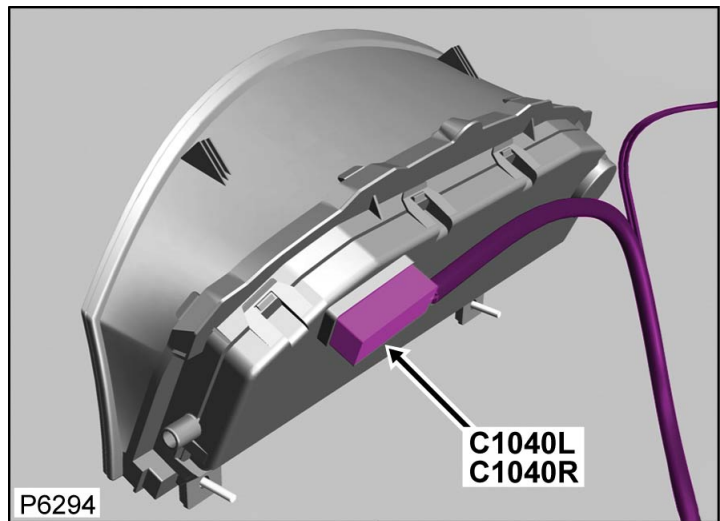
**Location: Behind instrument cluster**

**Part No.: YPC901800**

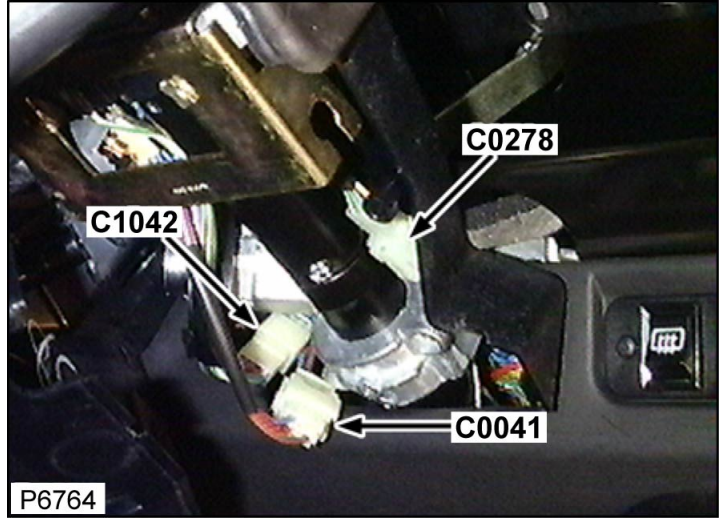
Location: **Underside of steering column**

CAV	TERMINAL	CSA	COL	CCT	DESTN
1	YPL10002	2.0D	U	200R	S/JOINT SJ61
2	AFU3572	0.5D	GW	200R	C0287
3	YPL10002	1.5D	LGN	200R	S/JOINT SJ44
4	AFU3572	0.5D	GR	200R	C0287
5	YPL10002	2.0D	UW	200R	C0581R
6	YPL10002	1.5D	UR	200R	C0581R
7	YPL10002	1.5D	NP	200R	C0580R
8	YPL10002	1.5D	PB	200R	C0287

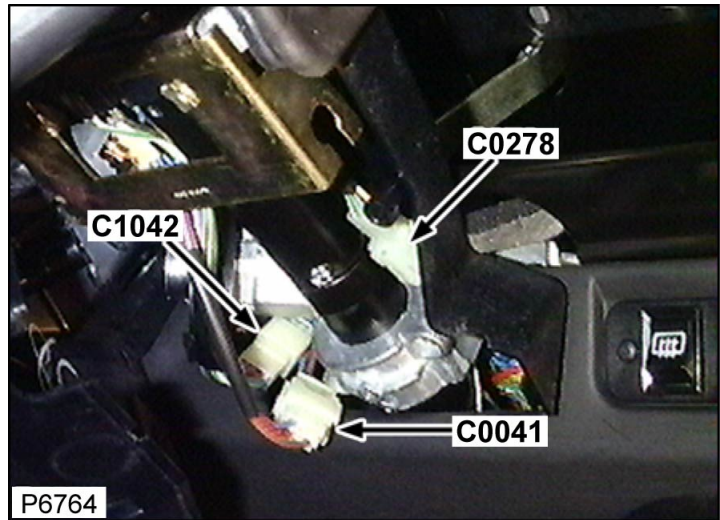
**Location: Underside of steering column**

CAV	TERMINAL	CSA	COL	CCT	DESTN
1	YPL10002	2.0D	U	200R	S/JOINT SJ61
2	AFU3572	0.5D	GW	200R	C0287
3	YPL10002	1.5D	LGN	200R	S/JOINT SJ44
4	AFU3572	0.5D	GR	200R	C0287
5	YPL10002	2.0D	UW	200R	C0581R
6	YPL10002	1.5D	UR	200R	C0581R
7	YPL10002	1.5D	NP	200R	C0580R
8	YPL10002	1.5D	PB	200R	C0287

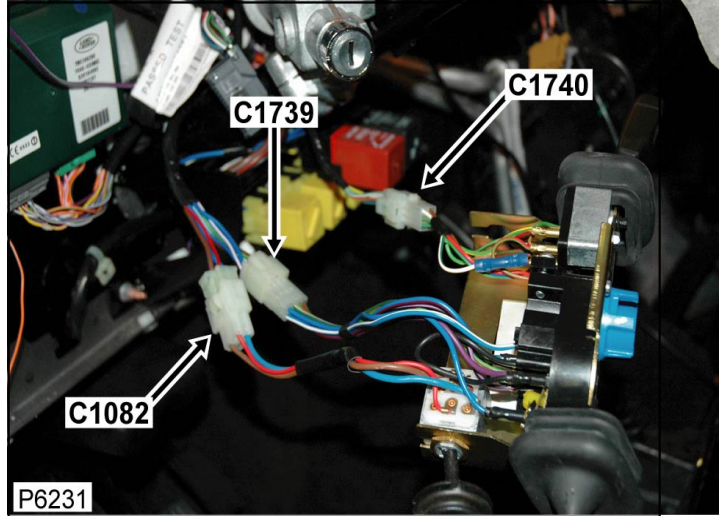
Location: **Underside of steering column**

CAV	TERMINAL	CSA	COL	CCT	DESTN
1	AFU3725	2.5D	NU	I39L	C3764
2	AFU3567	1.5D	R	I39L	C0581L
4	AFU3725	2.5D	U	I39L	C3764

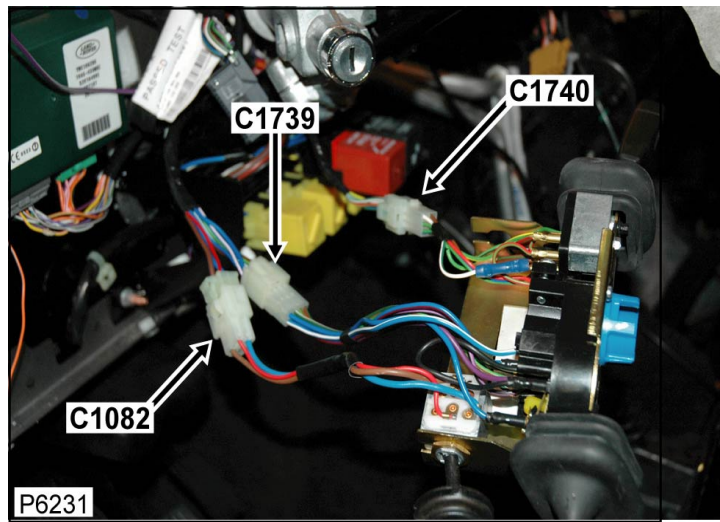
**Harness: MAIN LH + RH HARNESS**

CAV	TERMINAL	CSA	COL	CCT	DESTN
1	AFU3725	2.5D	NU	I39L	C3764
2	AFU3567	1.5D	R	I39L	C0581L
4	AFU3725	2.5D	U	I39L	C3764

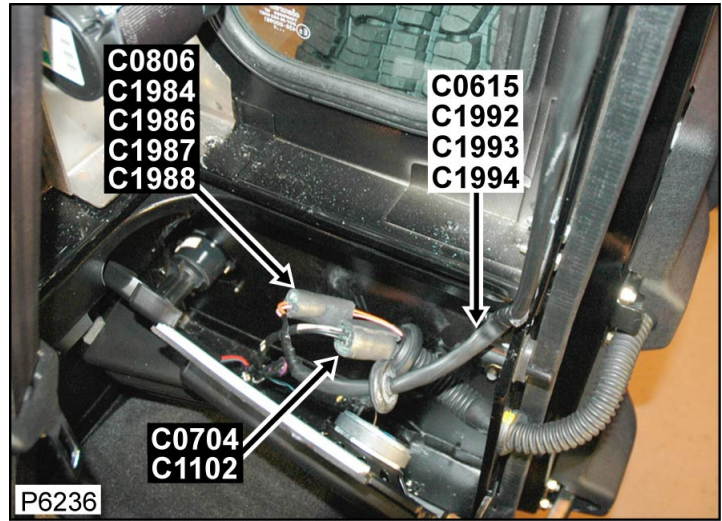
Location: **Base of 'D' post RH side**

CAV	TERMINAL	CSA	COL	CCT	DESTN
1	YPJ10008	1.5D	WB	111	C0381
2	DBP8550	1.0D	GP	121	C0832
3	DBP8550	1.0D	BG	193	C0124
4	DBP8550	1.0D	WG	193	S/JOINT SJ2
6	YPJ10008	1.5D	B	193	S/JOINT SJ1
6	DBP8550	1.0D	B	1053	C0382

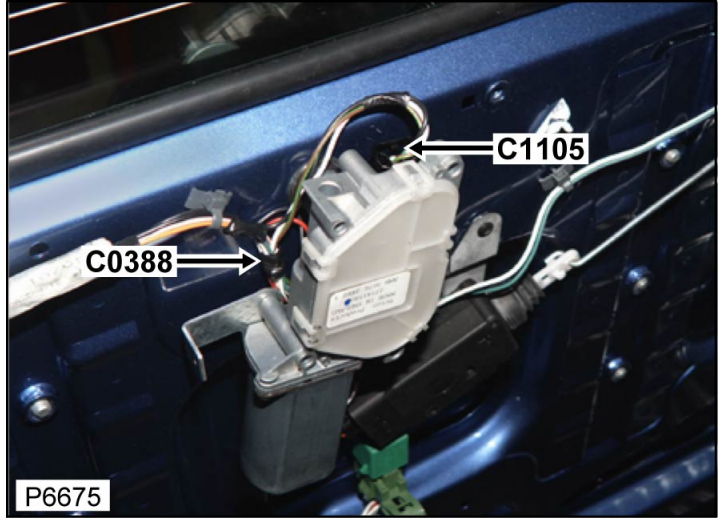
Harness: **TAILDOOR HARNESS**

CAV	TERMINAL	CSA	COL	CCT	DESTN
1	AFU3802	1.0D	NLG	193	C0124
2	AFU3802	1.0D	WG	193	S/JOINT SJ2
3	AFU3802	1.5D	B	193	S/JOINT SJ1

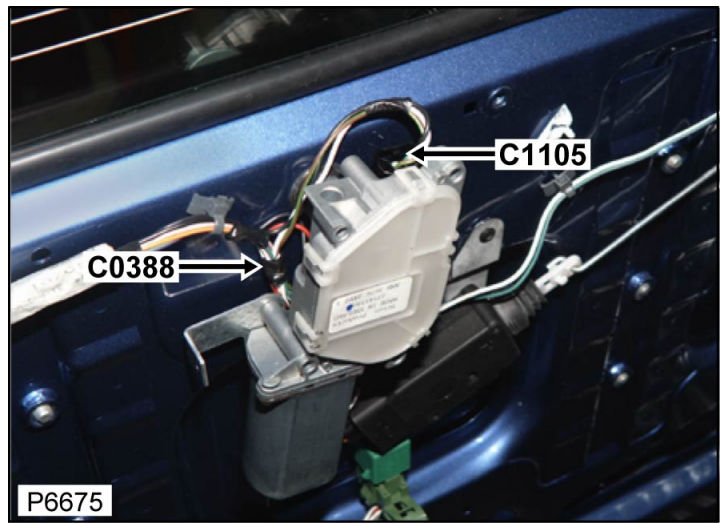
Harness: **TAILDOOR HARNESS**

CAV	TERMINAL	CSA	COL	CCT	DESTN
1	AFU3802	1.0D	NLG	193	C0124
2	AFU3802	1.0D	WG	193	S/JOINT SJ2
3	AFU3802	1.5D	B	193	S/JOINT SJ1

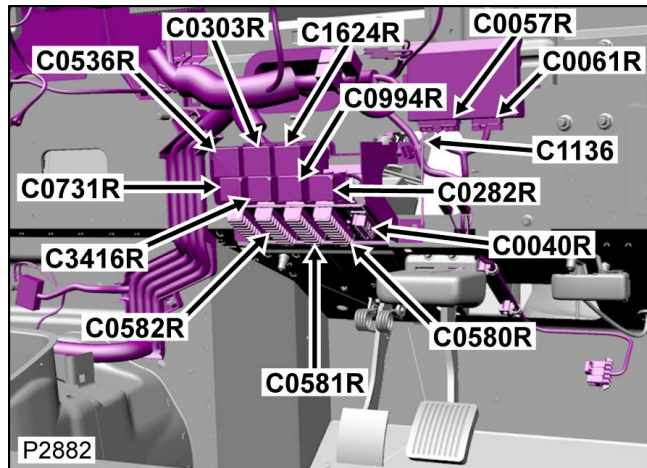
Location: **Behind RH side of Instrument panel**

Part No.: **ASSYEND**

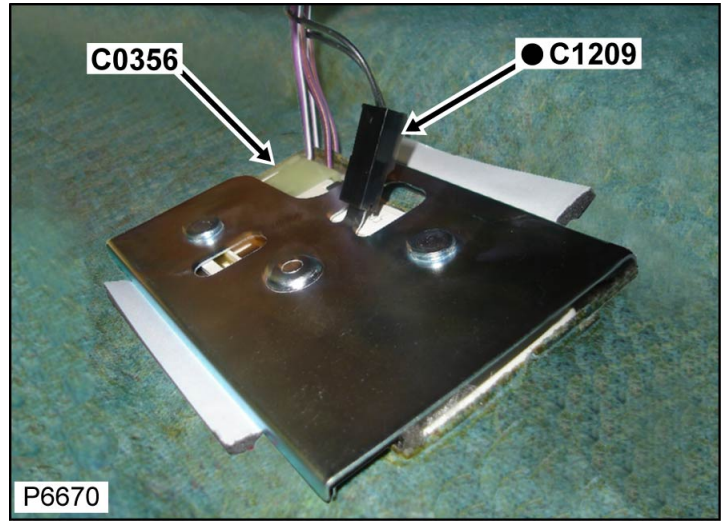
Location: **Rear of headlining**

Part No.: **AAUI010**

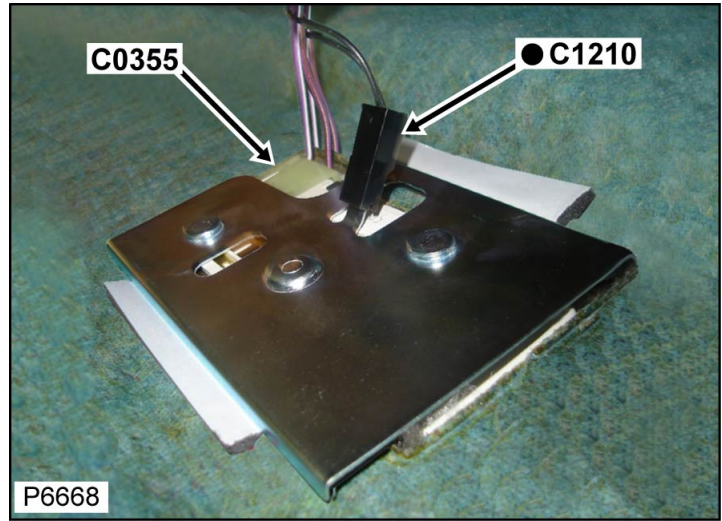
Location: **Front of headlining in the center**

Part No.: **AAU1010**

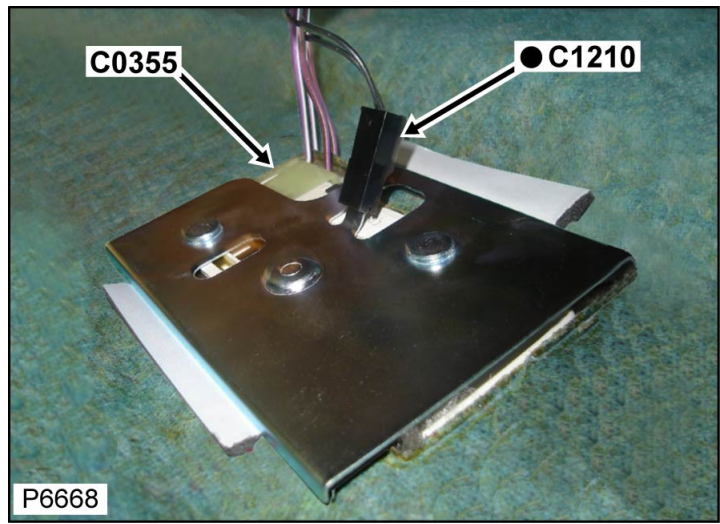
**Harness: ROOF FRONT HARNESS**

CAV	TERMINAL	CSA	COL	CCT	DESTN
I	AFU3262	0.5D	B	902	CTAP
I	AFU3262	0.5D	B	903	CTAP
I	AFU3262	0.5D	B	904	C0259

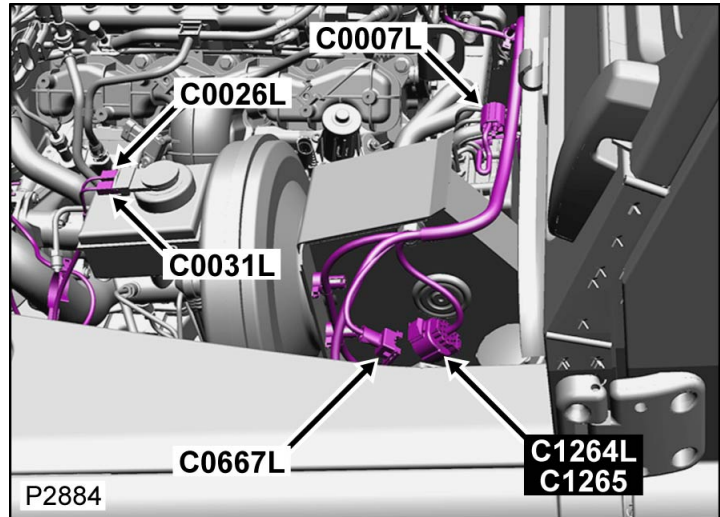
**Harness: MAIN LH + RH HARNESS**

CAV	TERMINAL	CSA	COL	CCT	DESTN
1	DBP8548	0.5D	US	139L	S/JOINT SJ41
2	YPL10027	1.5D	UK	139L	C0581L
3	YPL10027	2.0D	B	139L	C0550
4	DBP8548	0.5D	GR	139L	C0287
5	DBP8548	0.5D	RB	139L	C0288
6	DBP8548	0.75D	PB	139L	C0287
7	DBP8548	1.0D	RO	107L	C0286
8	DBP8548	1.0D	OB	22L	C0731L
9	DBP8548	1.0D	B	22L	S/JOINT SJ36
10	DBP8548	0.5D	B	22L	C0285
11	DBP8548	0.5D	B	22L	C0286
12	YPL10027	1.5D	LGB	139L	C0285
13	DBP8548	0.5D	BLG	139L	C0073
14	DBP8548	1.0D	UY	107L	S/JOINT SJ56

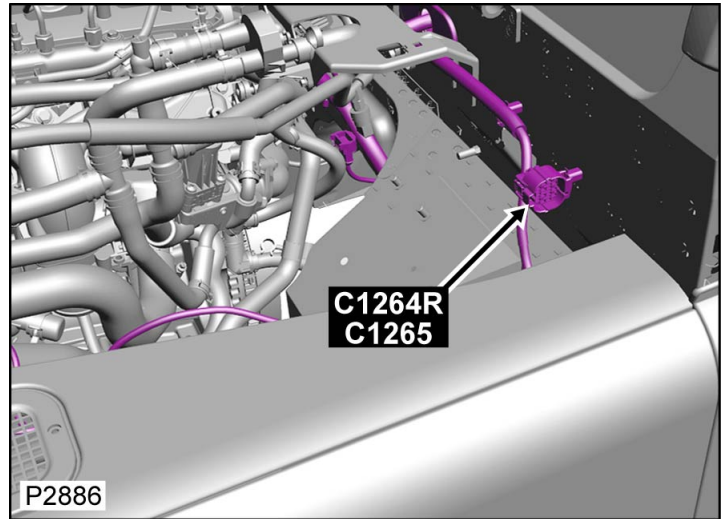
Harness: **MAIN LH + RH HARNESS**

CAV	TERMINAL	CSA	COL	CCT	DESTN
1	YPL10027	1.5D	US	200R	C0581R
2	YPL10027	1.5D	UK	200R	C0581R
3	YPL10027	2.0D	B	200R	C0550
4	DBP8548	0.5D	GR	200R	C0287
5	DBP8548	0.5D	RB	200R	C0288
6	DBP8548	0.75D	PB	200R	C0287
7	DBP8548	1.0D	RO	107R	C0286
8	DBP8548	1.0D	OB	22R	C0731R
9	DBP8548	1.0D	B	22R	S/JOINT SJ36
10	DBP8548	0.5D	B	22R	C0285
11	DBP8548	0.5D	B	22R	C0286
12	YPL10027	1.5D	LGB	200R	C0285
13	DBP8548	0.5D	BLG	200R	C0073
14	DBP8548	1.0D	UY	107R	S/JOINT SJ56

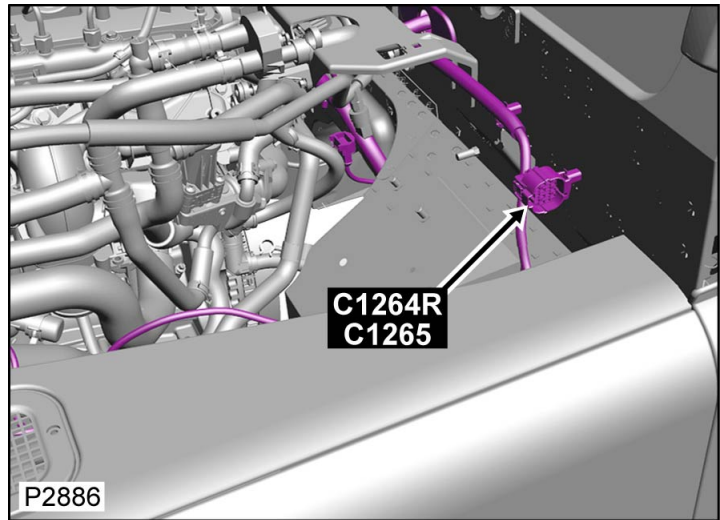
**Harness: MAIN LH + RH HARNESS**

CAV	TERMINAL	CSA	COL	CCT	DESTN
1	YPL10027	1.5D	US	200R	C0581R
2	YPL10027	1.5D	UK	200R	C0581R
3	YPL10027	2.0D	B	200R	C0550
4	DBP8548	0.5D	GR	200R	C0287
5	DBP8548	0.5D	RB	200R	C0288
6	DBP8548	0.75D	PB	200R	C0287
7	DBP8548	1.0D	RO	107R	C0286
8	DBP8548	1.0D	OB	22R	C0731R
9	DBP8548	1.0D	B	22R	S/JOINT SJ36
10	DBP8548	0.5D	B	22R	C0285
11	DBP8548	0.5D	B	22R	C0286
12	YPL10027	1.5D	LGB	200R	C0285
13	DBP8548	0.5D	BLG	200R	C0073
14	DBP8548	1.0D	UY	107R	S/JOINT SJ56

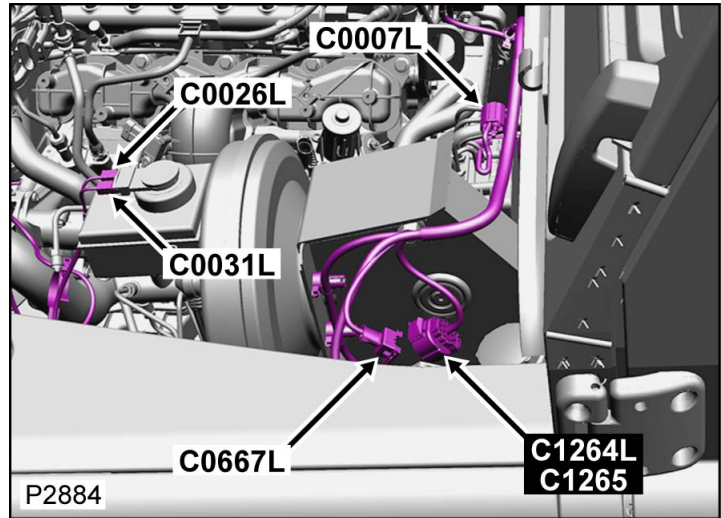
**Harness: WING LH HARNESS**

CAV	TERMINAL	CSA	COL	CCT	DESTN
1	YPJ10008	1.5D	US	499	C0009
2	YPJ10008	1.5D	UK	499	C0009
3	YPJ10008	1.5D	B	499	C0009
4	DBP8550	0.75D	GR	499	C0001
5	DBP8550	0.5D	RB	499	C0538
6	DBP8550	0.75D	PB	896	C0003
6	DBP8550	0.75D	PB	897	C1913
7	DBP8550	1.0D	UO	898	C1007
7	DBP8550	0.5D	RO	107	C0071
7	DBP8550	1.0D	UO	897	C1007
8	DBP8550	1.0D	OB	295	C0520
9	DBP8550	1.0D	B	828	C0666
10	DBP8550	0.5D	B	828	C0666
11	DBP8550	0.5D	B	828	C0666

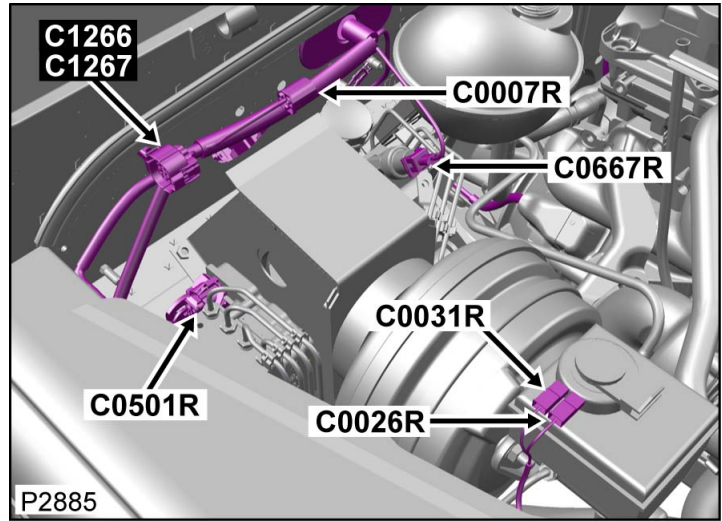
Qualifier: **RHD condition illustrated**

CAV	TERMINAL	CSA	COL	CCT	DESTN
1	YPL10027	1.5D	UO	139L	C0581L
1	YPL10027	1.5D	UO	200R	S/JOINT SJ64
2	YPL10027	1.5D	UB	139L	C0581L
2	YPL10027	1.5D	UB	200R	C0581R
3	YPL10027	1.5D	B	499	C0550
4	DBP8548	0.5D	GW	499	C0287
5	DBP8548	1.0D	RO	499	S/JOINT SJ50
6	DBP8548	0.75D	PB	499	C0287
7	DBP8548	1.0D	RO	107	C0286
8	DBP8548	1.0D	UY	107	S/JOINT SJ56

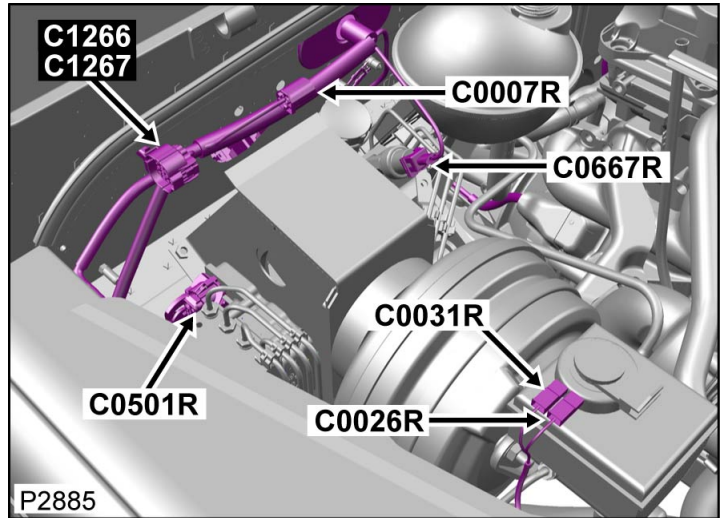
**Harness: WING RH HARNESS**

CAV	TERMINAL	CSA	COL	CCT	DESTN
1	YPJ10008	1.5D	UO	499	C0011
2	YPJ10008	1.5D	UB	499	C0011
3	YPJ10008	1.5D	B	107	C0011
3	YPJ10008	1.5D	B	896	C0011
3	YPJ10008	1.5D	B	897	C0011
3	YPJ10008	1.5D	B	898	C0011
4	DBP8550	0.75D	GW	499	C0002
5	DBP8550	0.5D	RO	899	C0537
5	DBP8550	0.5D	RB	897	C0537
6	DBP8550	0.75D	PB	899	C0004
7	DBP8550	0.5D	RO	107	C0070
7	DBP8550	1.0D	UO	897	C1008
7	DBP8550	1.0D	UO	898	C1008
8	DBP8550	0.5D	UY	107	C0070
9	YPJ10008	1.5D	NW	765	C0014

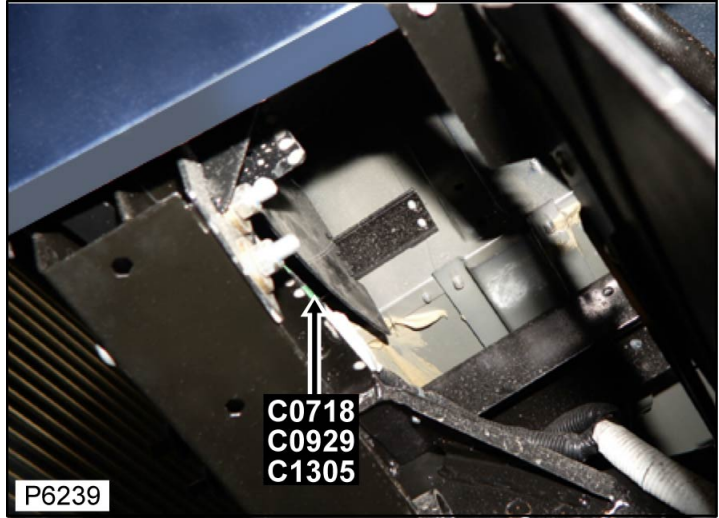
Harness: **CHASSIS HARNESS**

CAV	TERMINAL	CSA	COL	CCT	DESTN
1	YPL101830	1.5D	GR	772	S/JOINT SJ22
1	YPL101830	1.5D	GR	985	S/JOINT SJ7
2	YPL101830	1.5D	RB	772	S/JOINT SJ23
2	YPL101830	1.5D	RB	985	C0140
3	YPL101830	1.5D	GW	772	S/JOINT SJ25
3	YPL101830	1.5D	GW	985	S/JOINT SJ6
4	YPL101830	1.5D	RO	772	S/JOINT SJ24
4	YPL101830	1.5D	RO	985	S/JOINT SJ8
5	YPL101830	1.5D	GP	772	S/JOINT SJ21
5	YPL101830	1.5D	GP	985	S/JOINT SJ5
6	YPL101700	2.5D	P	772	C1763

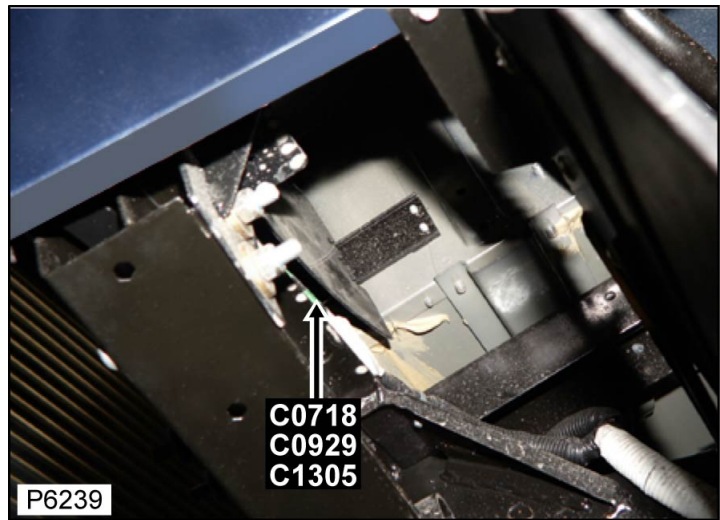
**Harness: CHASSIS HARNESS**

CAV	TERMINAL	CSA	COL	CCT	DESTN
1	YPL101830	1.5D	GR	772	S/JOINT SJ22
1	YPL101830	1.5D	GR	985	S/JOINT SJ7
2	YPL101830	1.5D	RB	772	S/JOINT SJ23
2	YPL101830	1.5D	RB	985	C0140
3	YPL101830	1.5D	GW	772	S/JOINT SJ25
3	YPL101830	1.5D	GW	985	S/JOINT SJ6

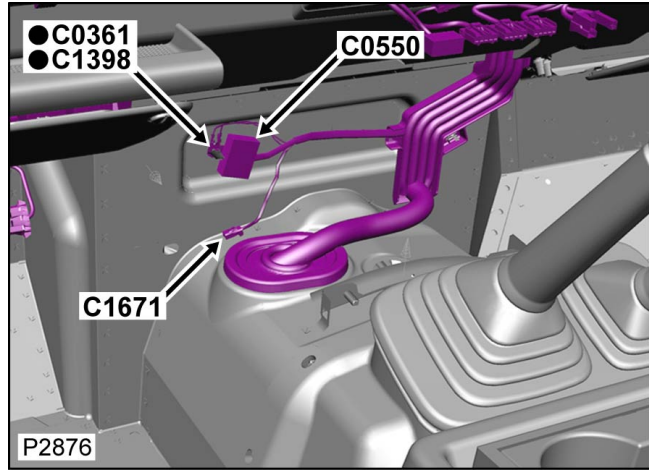
Location: **Behind center of Instrument panel**

CAV	TERMINAL	CSA	COL	CCT	DESTN
I	-	1.0D	B	22	C0488
I	-	1.5D	B	499	C0288

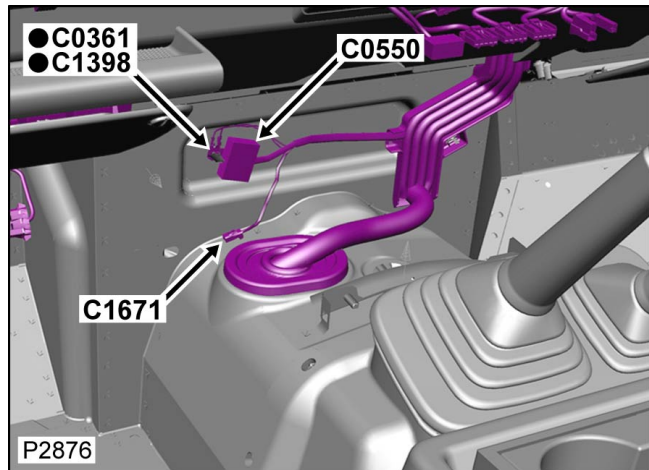
Location: **Behind center of Instrument panel**

CAV	TERMINAL	CSA	COL	CCT	DESTN
I	-	1.0D	B	22	C0488
I	-	1.5D	B	499	C0288

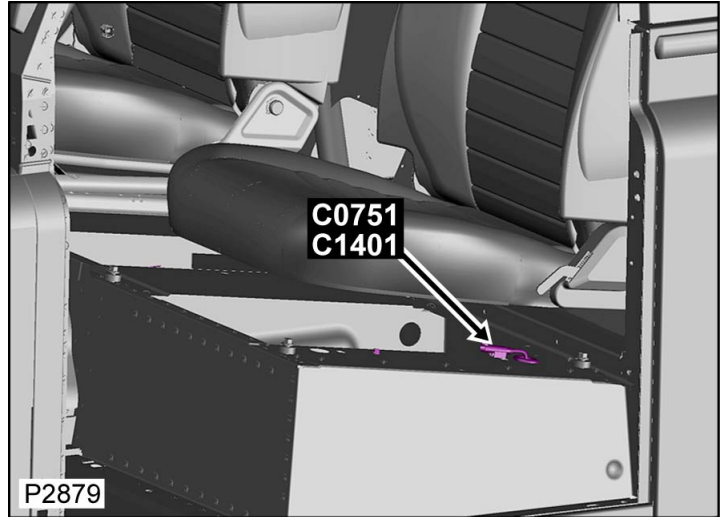
**Cavities: 2WY**

**Harness: MAIN LH + RH HARNESS**

CAV	TERMINAL	CSA	COL	CCT	DESTN
1	YPJ100640	0.75D	US	766	C0250
2	YPJ100620	0.5D	B	766	S/JOINT SJ12

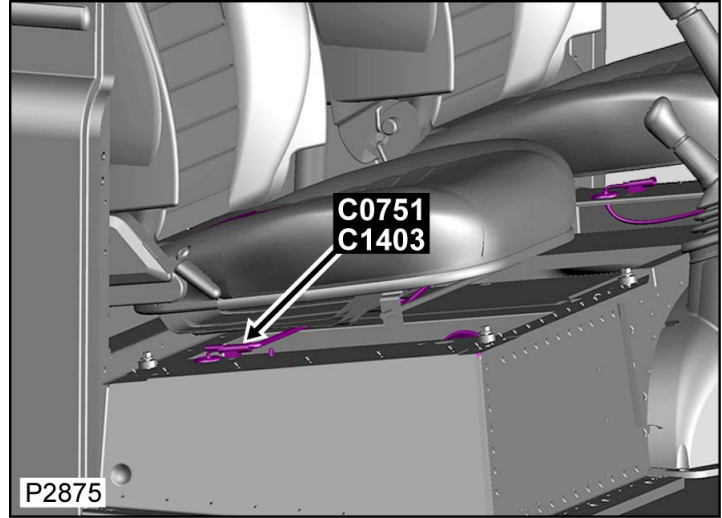
Cavities: **2WY**

Harness: **MAIN LH + RH HARNESS**

CAV	TERMINAL	CSA	COL	CCT	DESTN
1	YPJ100640	0.75D	UK	766	C0249
2	YPJ100620	0.5D	B	766	S/JOINT SJ12

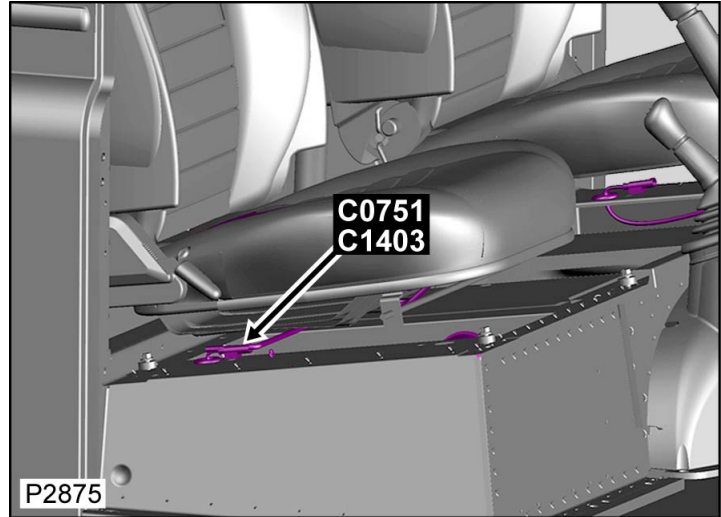
**Cavities: 2WY**

**Harness: MAIN LH + RH HARNESS**

CAV	TERMINAL	CSA	COL	CCT	DESTN
1	YPJ100640	0.75D	UK	766	C0249
2	YPJ100620	0.5D	B	766	S/JOINT SJ12

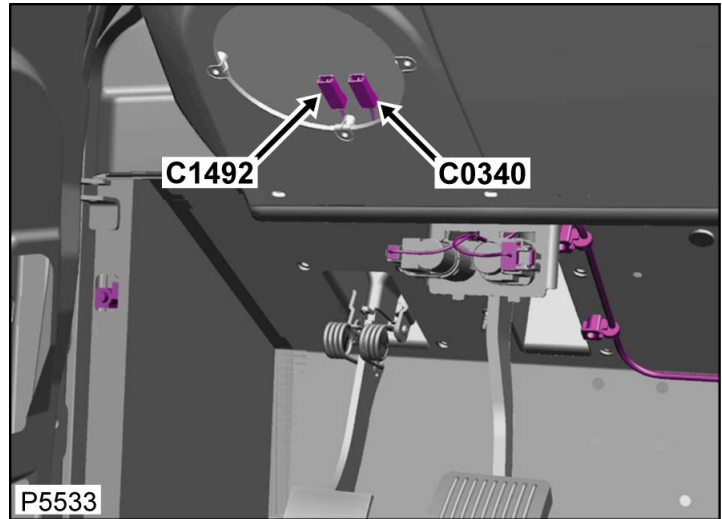
Location: **Instrument panel-left-lower**

Part No.: **AAUI010**

Colour: **BLACK**

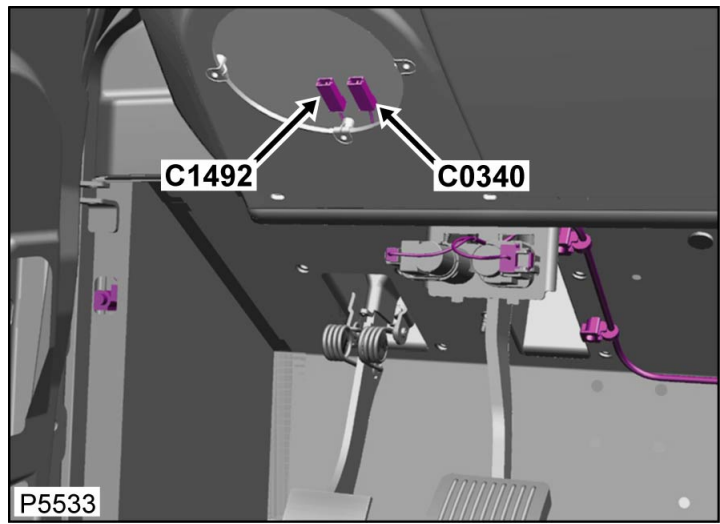
**Cavities: IWY**

**Harness: MAIN LH + RH HARNESS**

CAV	TERMINAL	CSA	COL	CCT	DESTN
I	ADU9566	0.5D	BN	769	C0092
I	ADU9566	0.5D	BN	769	C0530

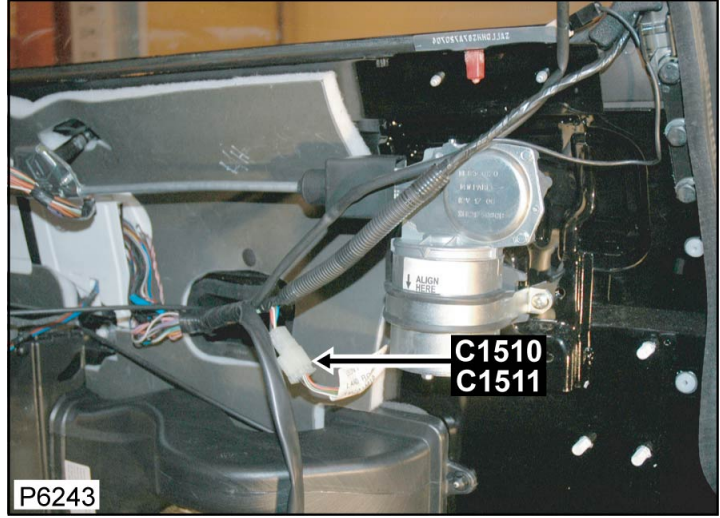
Location: **Behind RH side of Instrument panel**

CAV	TERMINAL	CSA	COL	CCT	DESTN
1	YPJ10006	2.0D	B	I39L	C0289
2	YPJ10006	2.0D	NLG	I39L	C0303L
3	YPJ10006	2.0D	ULG	I39L	C1740
4	YPJ10006	2.0D	WG	I39L	S/JOINT SJ45
5	YPJ10006	2.0D	RLG	I39L	C1740

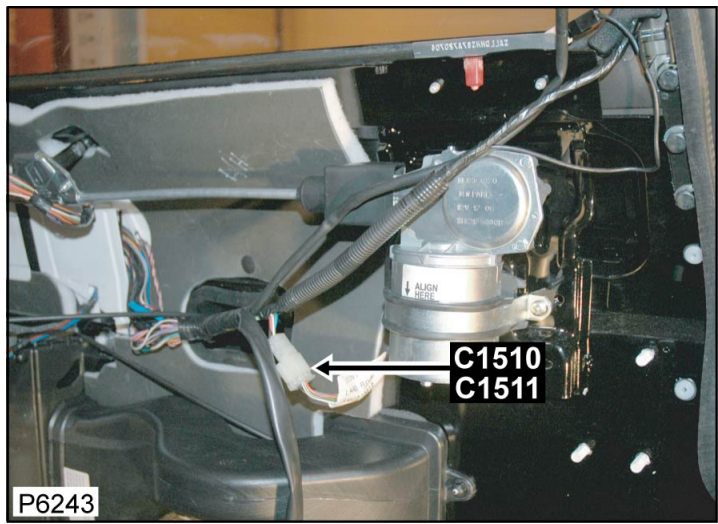
Cavities: **6WY**

Harness: **MAIN LH + RH HARNESS**

CAV	TERMINAL	CSA	COL	CCT	DESTN
1	YPJ10006	2.0D	B	I39L	C0289
2	YPJ10006	2.0D	NLG	I39L	C0303L
3	YPJ10006	2.0D	ULG	I39L	C1740
4	YPJ10006	2.0D	WG	I39L	S/JOINT SJ45
5	YPJ10006	2.0D	RLG	I39L	C1740

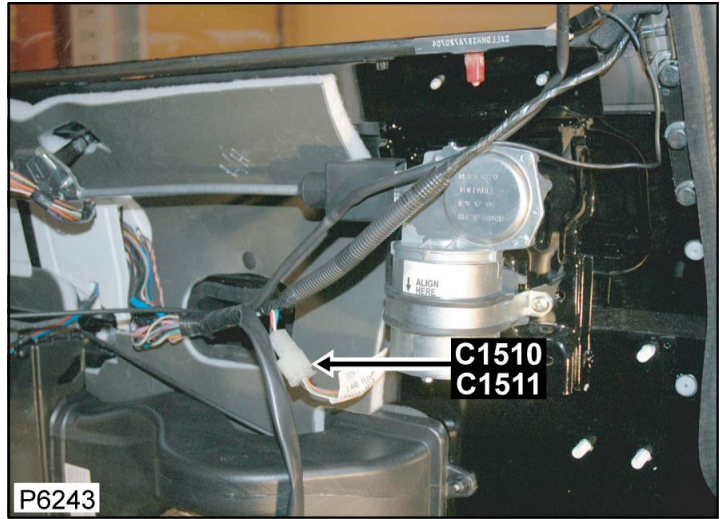
Location: **Behind RH side of Instrument panel**

CAV	TERMINAL	CSA	COL	CCT	DESTN
1	AFU3560	1.0D	B	499	C0030
2	AFU3560	1.0D	NLG	499	C0030
3	AFU3560	1.0D	ULG	499	C0030
4	YPL10002	1.5D	WG	499	C0030
5	AFU3560	1.0D	RLG	499	C0030

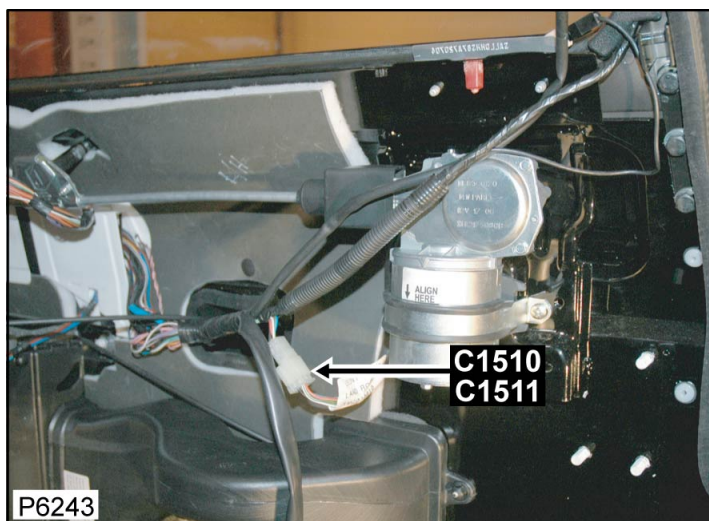
**Cavities: 6WY**

**Harness: WIPER MOTOR LINK-LH HARNESS**

CAV	TERMINAL	CSA	COL	CCT	DESTN
1	AFU3560	1.0D	B	499	C0030
2	AFU3560	1.0D	NLG	499	C0030
3	AFU3560	1.0D	ULG	499	C0030
4	YPL10002	1.5D	WG	499	C0030
5	AFU3560	1.0D	RLG	499	C0030

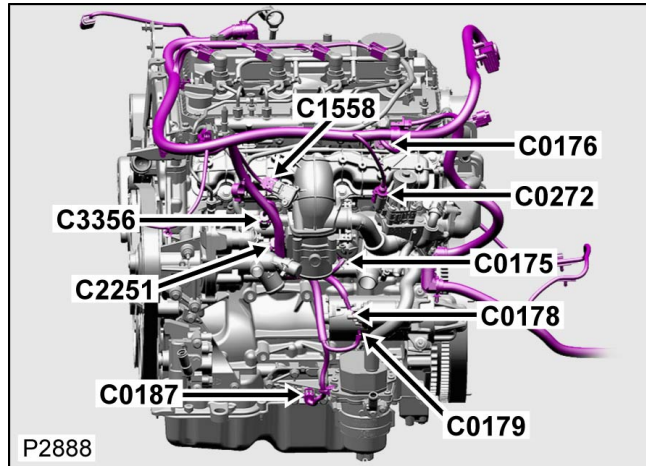
Location: **LH side of engine**

CAV	TERMINAL	CSA	COL	CCT	DESTN
1		0.5	GP	254	C0411
2		0.5	OB	254	C0411
3		0.5	UG	254	C0411

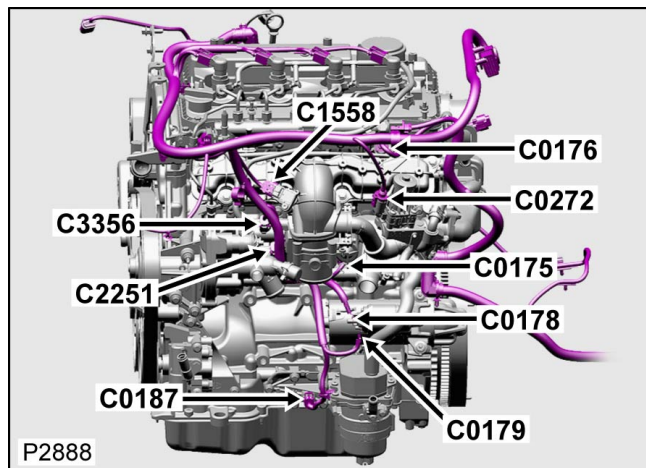
Location: **LH side of engine**

CAV	TERMINAL	CSA	COL	CCT	DESTN
1		0.5	GP	254	C0411

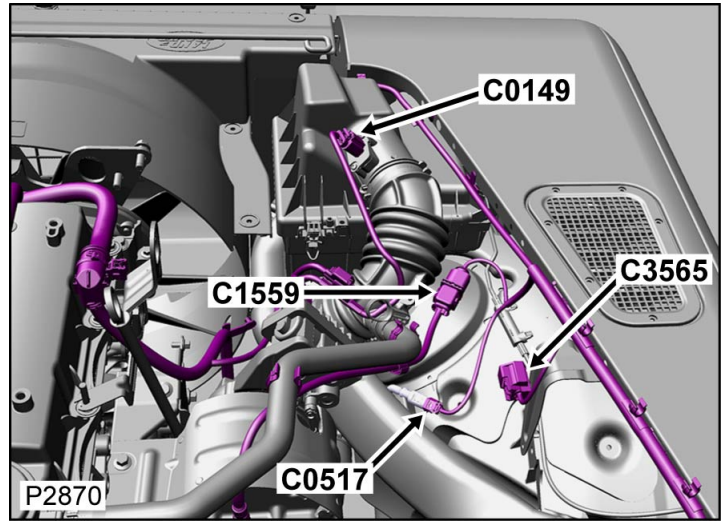
Location: **RH side of engine compartment**

CAV	TERMINAL	CSA	COL	CCT	DESTN
1	YPL901740	0.5D	R	254	C2518
2	YPL901740	0.5D	Y	254	C2518
3	YPL901740	1.0D	W	254	C2518
4	YPL901740	1.0D	G	254	S/JOINT SJ31
5	YPL901740	0.5D	SU	254	C2518
6	YPL901740	0.5D	B	254	C2518

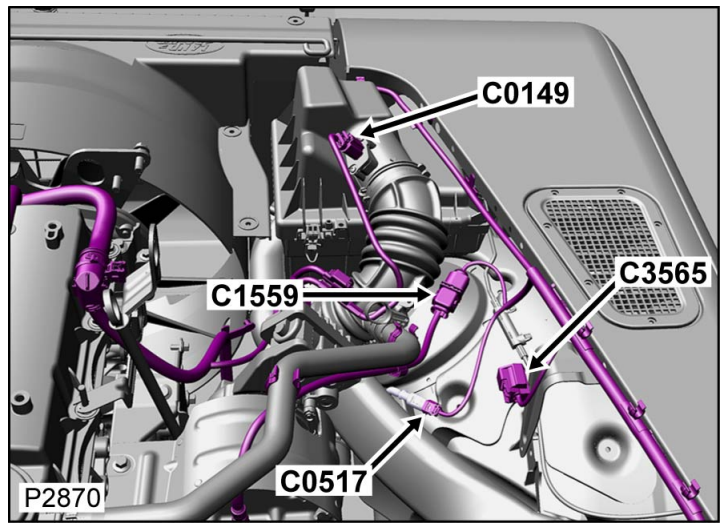
**Cavities: 6WY**

**Harness: MAIN LH + RH HARNESS**

CAV	TERMINAL	CSA	COL	CCT	DESTN
1	YPL901740	0.5D	R	254	C2518
2	YPL901740	0.5D	Y	254	C2518
3	YPL901740	1.0D	W	254	C2518
4	YPL901740	1.0D	G	254	S/JOINT SJ31
5	YPL901740	0.5D	SU	254	C2518
6	YPL901740	0.5D	B	254	C2518

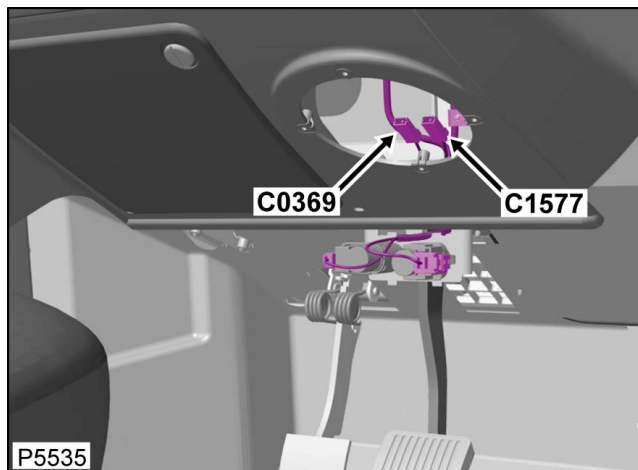
Location: **Instrument panel-right-lower**

CAV	TERMINAL	CSA	COL	CCT	DESTN
I	AGUI318	0.5D	BK	769	C0531
I	AGUI318	0.5D	BK	769	C0092

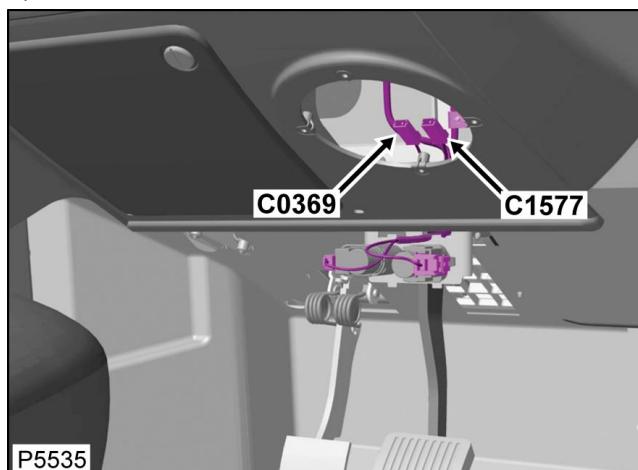
Location: **Instrument panel-right-lower**

CAV	TERMINAL	CSA	COL	CCT	DESTN
I	AGUI318	0.5D	BK	769	C0531
I	AGUI318	0.5D	BK	769	C0092

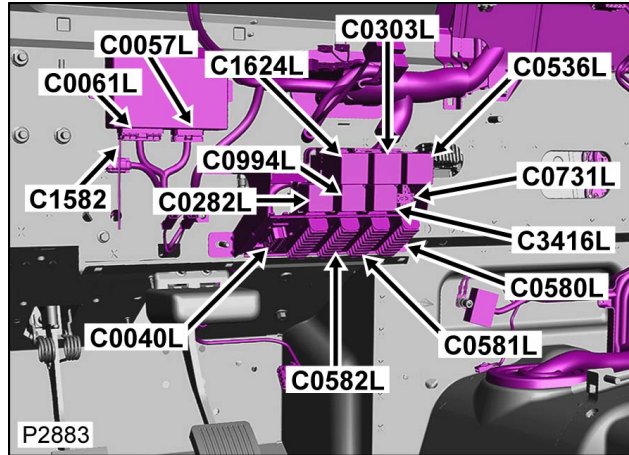
Location: **Behind LH side of Instrument panel**

Qualifier: **LHD condition illustrated**

CAV	TERMINAL	CSA	COL	CCT	DESTN
I	CUT_BARE_END	0.5D	SCR	22L	C0061L
I	CUT_BARE_END	0.5D	SCR	22R	C0061R

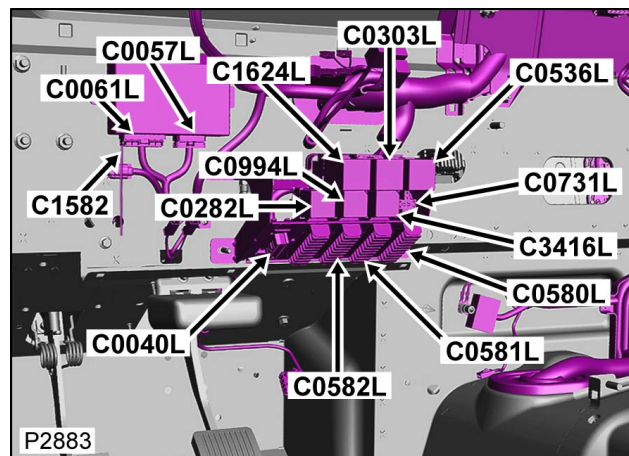
Location: **Behind LH side of Instrument panel**

Qualifier: **LHD condition illustrated**

CAV	TERMINAL	CSA	COL	CCT	DESTN
I	CUT_BARE_END	0.5D	SCR	22L	C0061L
I	CUT_BARE_END	0.5D	SCR	22R	C0061R
