DEFENDER - VIN: 412051 >

Electrical Reference Library (1a)

JLR 16 25 21\_IE

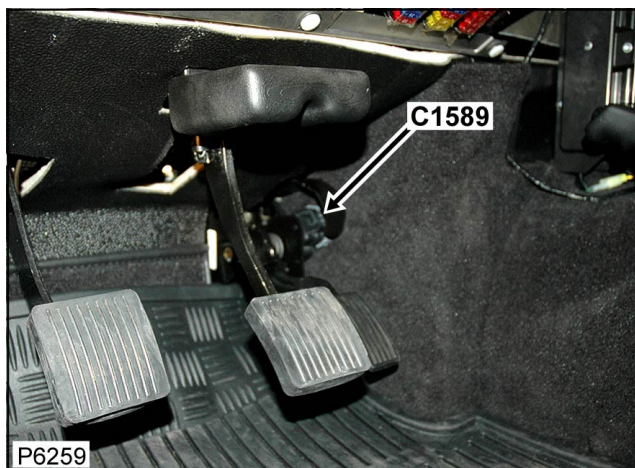
Location: **Beneath footwell carpet - LH side**

CAV	TERMINAL	CSA	COL	CCT	DESTN
B	YPLI0111	0.5D	PN	254L	C0872
D	YPLI0111	0.5D	WG	254L	C0872
F	YPLI0111	0.5D	RG	254L	C0872
K	YPLI0111	0.5D	WS	254L	C0872
G	YPLI0111	0.5D	B	254L	C0872
J	YPLI0064	0.75D	B	254L	C0872

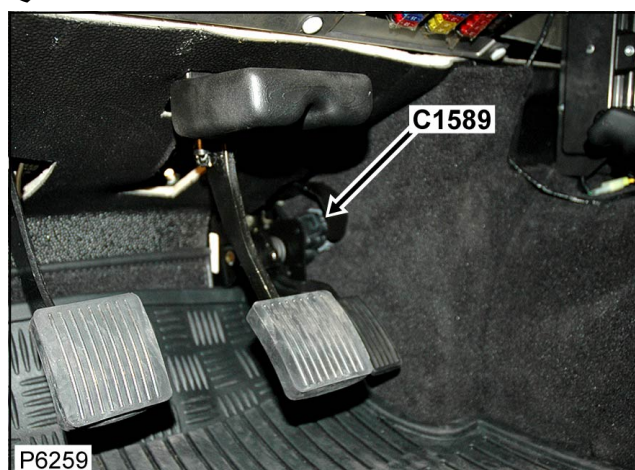
Location: **Beneath footwell carpet - LH side**

CAV	TERMINAL	CSA	COL	CCT	DESTN
B	YPLI0111	0.5D	PN	254L	C0872
D	YPLI0111	0.5D	WG	254L	C0872

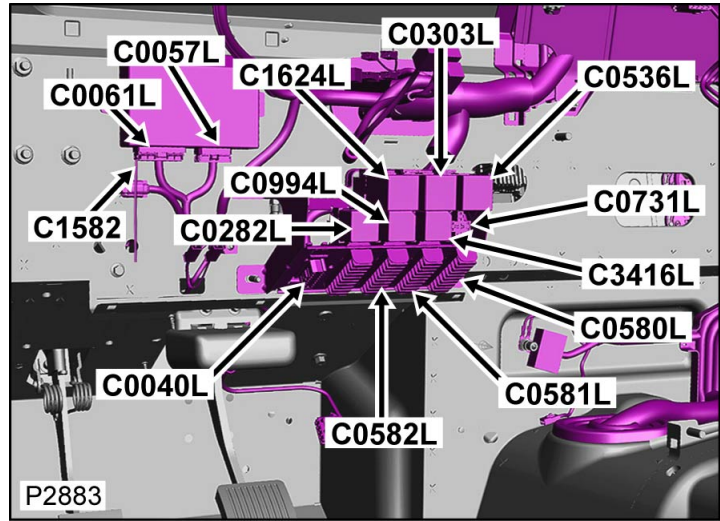
Location: **Behind LH side of Instrument panel**

Qualifier: **LHD condition illustrated**

CAV	TERMINAL	CSA	COL	CCT	DESTN
2	AFU3228	0.5D	B	766L	C0289
4	AFU3228	0.5D	WG	766L	C0285
5	AFU3228	0.5D	KO	109L	C0131
6	AFU3228	0.5D	WN	109L	C1040L
8	AFU3228	0.5D	PY	109L	C0994L

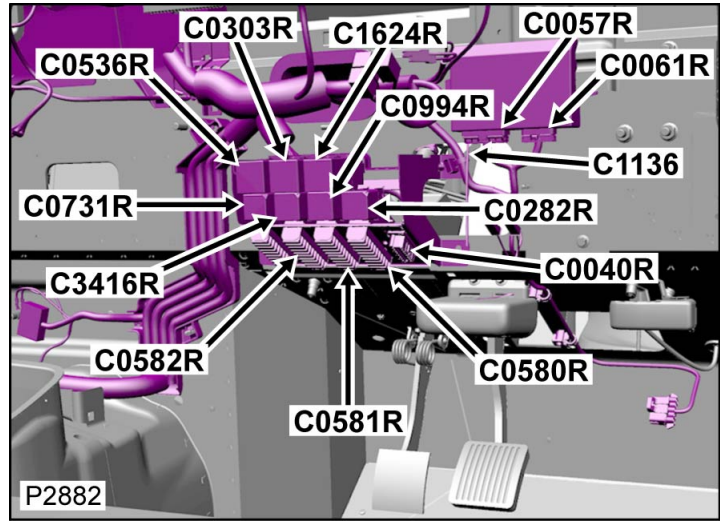
Location: **Behind RH side of Instrument panel**

Qualifier: **RHD condition illustrated**

CAV	TERMINAL	CSA	COL	CCT	DESTN
2	AFU3228	0.5D	B	766R	C0289
4	AFU3228	0.5D	WG	766R	C0285
5	AFU3228	0.5D	KO	109R	C0131
6	AFU3228	0.5D	WN	109R	C1040R
8	AFU3228	0.5D	PY	109R	C0994R

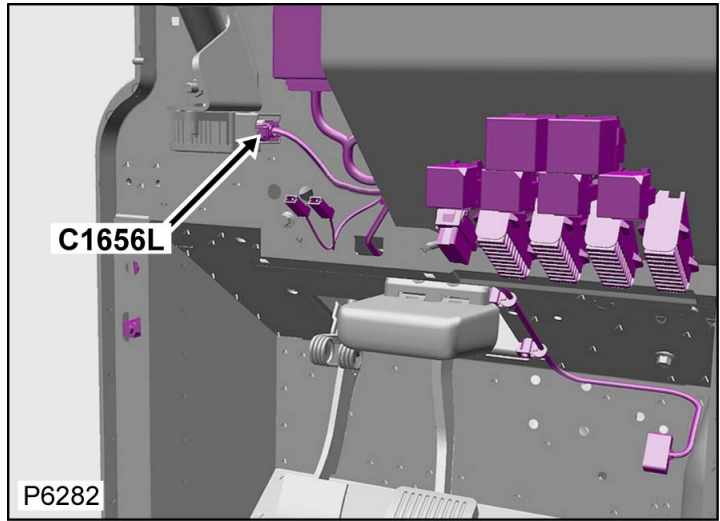
Cavities: **4WY**

Harness: **MAIN LH + RH HARNESS**

CAV	TERMINAL	CSA	COL	CCT	DESTN
1	YPL101500	0.5D	B	9	S/JOINT SJ46
2	YPL101500	0.5D	GB	9	C0501L
3	YPL101500	0.5D	UB	9	C0501L
4	YPL101500	0.5D	GO	9	S/JOINT SJ34

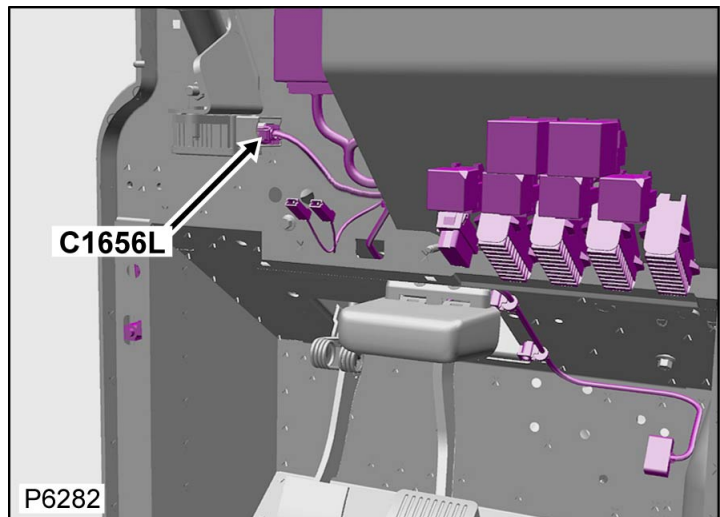
**Cavities: 4WY**

**Harness: MAIN LH + RH HARNESS**

CAV	TERMINAL	CSA	COL	CCT	DESTN
I	YPL101500	0.5D	B	9	S/JOINT SJ46

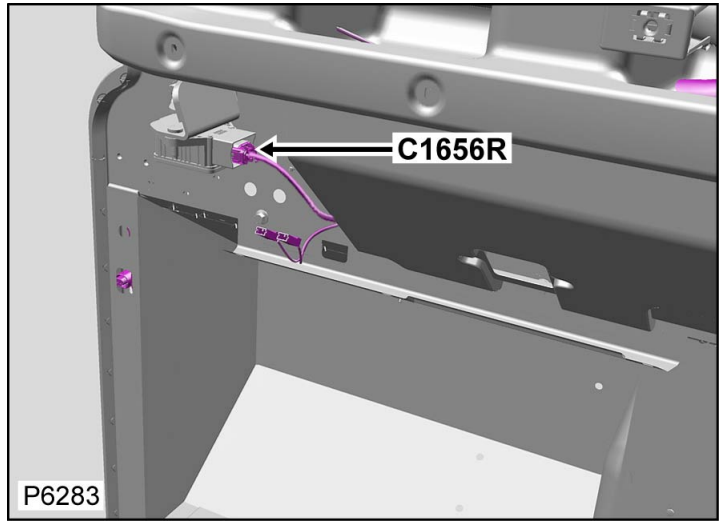
Cavities: **4WY**

Harness: **MAIN LH + RH HARNESS**

CAV	TERMINAL	CSA	COL	CCT	DESTN
1	YPL101500	0.5D	B	10	S/JOINT SJ66
2	YPL101500	0.5D	GB	10	C0501R
3	YPL101500	0.5D	UB	10	C0501R
4	YPL101500	0.5D	GO	10	S/JOINT SJ63

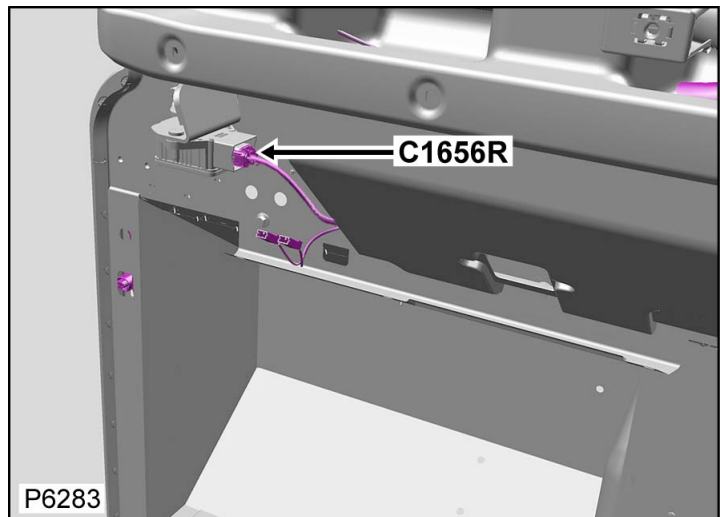
**Cavities: 4WY**

**Harness: MAIN LH + RH HARNESS**

CAV	TERMINAL	CSA	COL	CCT	DESTN
I	YPL101500	0.5D	B	10	S/JOINT SJ66

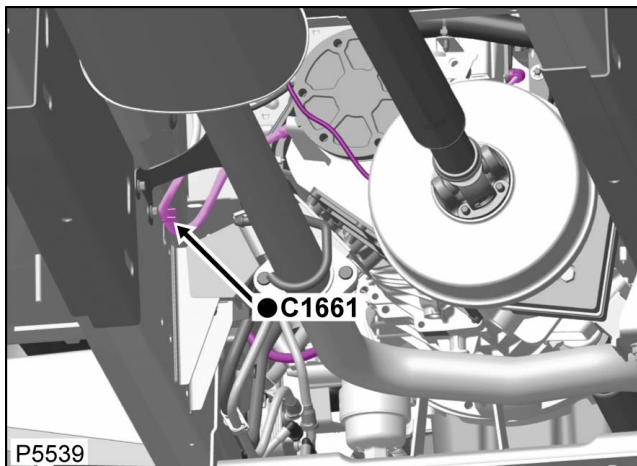
Location: **Lower LH front of engine compartment**

CAV	TERMINAL	CSA	COL	CCT	DESTN
I	-	50.0D	B	499	C0045
I	-	50.0D	B	499	C3307

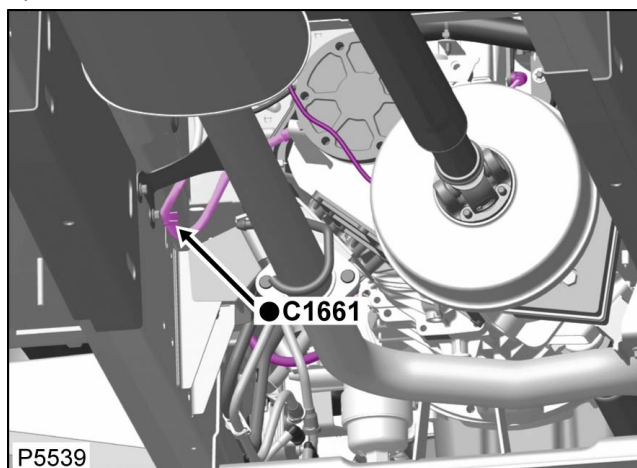
Location: **Lower LH front of engine compartment**

CAV	TERMINAL	CSA	COL	CCT	DESTN
I	-	50.0D	B	499	C0045
I	-	50.0D	B	499	C3307

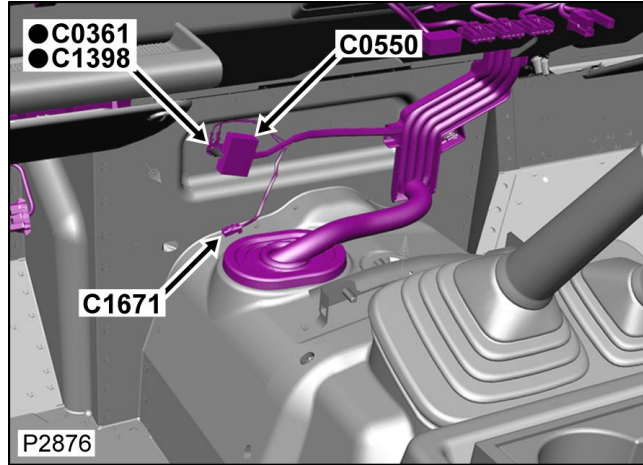
Location: **Behind center of Instrument panel**

CAV	TERMINAL	CSA	COL	CCT	DESTN
1	YPLI02180	1.0D	B	14	S/JOINT SJ14
2	YPLI02180	0.75D	BS	14	C0872
3	YPLI02180	1.0D	BS	14	S/JOINT SJ21

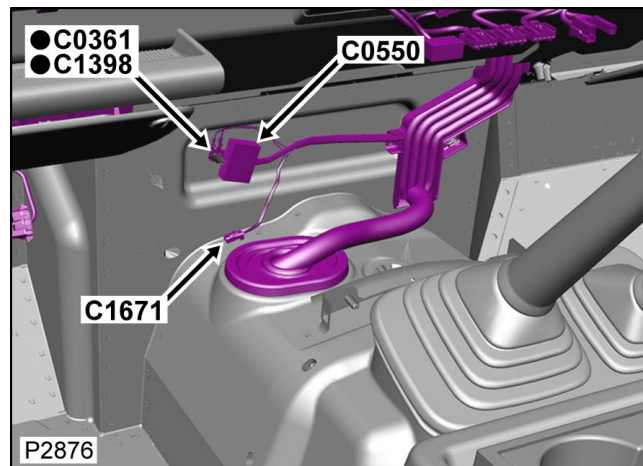
Location: **Behind center of Instrument panel**

CAV	TERMINAL	CSA	COL	CCT	DESTN
1	YPLI02180	1.0D	B	14	S/JOINT SJ14
2	YPLI02180	0.75D	BS	14	C0872

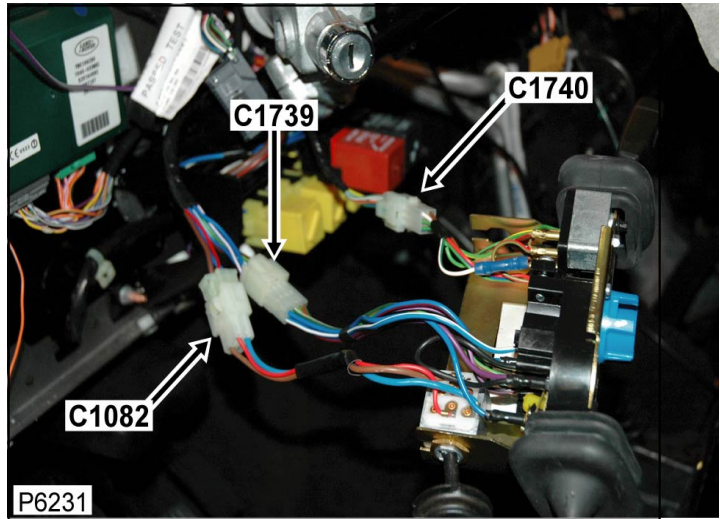
Location: **Underside of steering column**

CAV	TERMINAL	CSA	COL	CCT	DESTN
1	YPL10002	2.0D	U	I39L	S/JOINT SJ38
2	AFU3572	0.5D	GW	I39L	C0287
3	YPL10002	1.5D	LGN	I39L	S/JOINT SJ79
4	AFU3572	0.5D	GR	I39L	C0287
5	YPL10002	2.0D	UW	I39L	C0581L
6	YPL10002	1.5D	UR	I39L	C0581L
7	YPL10002	1.5D	NP	I39L	C0580L
8	YPL10002	1.5D	PB	I39L	C0287

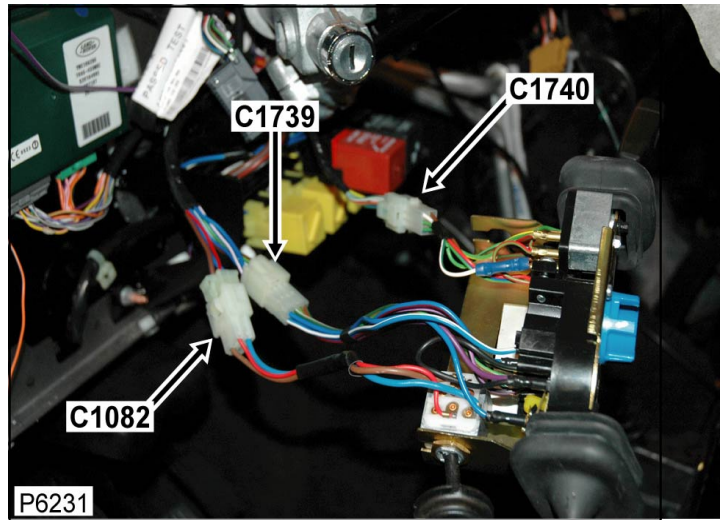
**Location: Underside of steering column**

CAV	TERMINAL	CSA	COL	CCT	DESTN
1	YPL10002	2.0D	U	I39L	S/JOINT SJ38
2	AFU3572	0.5D	GW	I39L	C0287
3	YPL10002	1.5D	LGN	I39L	S/JOINT SJ79
4	AFU3572	0.5D	GR	I39L	C0287
5	YPL10002	2.0D	UW	I39L	C0581L
6	YPL10002	1.5D	UR	I39L	C0581L
7	YPL10002	1.5D	NP	I39L	C0580L
8	YPL10002	1.5D	PB	I39L	C0287

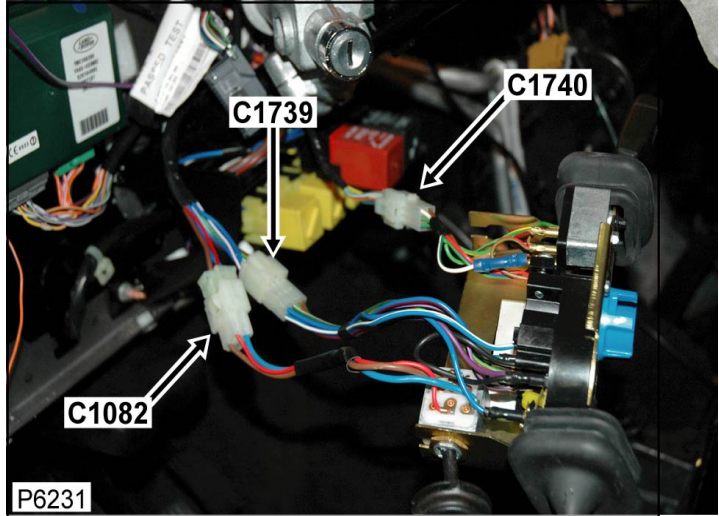
Cavities: **6WY**

Harness: **MAIN LH + RH HARNESS**

CAV	TERMINAL	CSA	COL	CCT	DESTN
1	YPL10002	2.0D	ULG	I39L	C1510
2	YPL10002	1.5D	LGB	I39L	C0285
3	YPL10002	1.5D	WG	I39L	C0303L
4	YPL10002	2.0D	YLG	I39L	C0303L
5	YPL10002	2.0D	RLG	I39L	C1510
6	YPL10002	2.0D	WG	I39L	S/JOINT SJ45

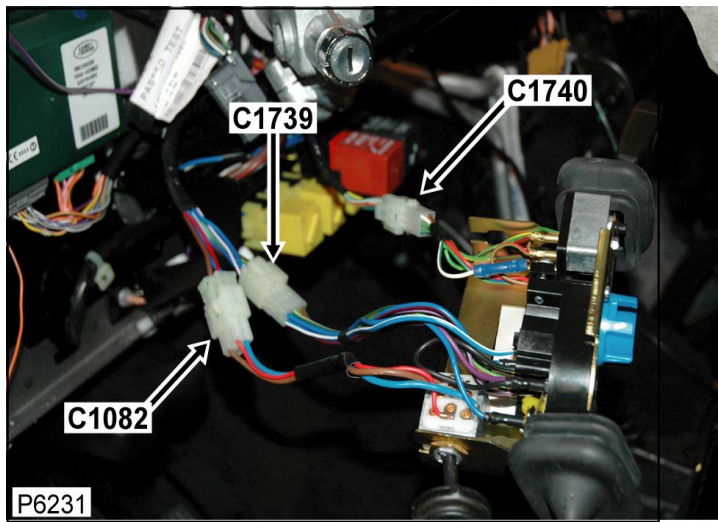
**Cavities: 6WY**

**Harness: MAIN LH + RH HARNESS**

CAV	TERMINAL	CSA	COL	CCT	DESTN
1	YPL10002	2.0D	ULG	I39L	C1510
2	YPL10002	1.5D	LGB	I39L	C0285
3	YPL10002	1.5D	WG	I39L	C0303L
4	YPL10002	2.0D	YLG	I39L	C0303L
5	YPL10002	2.0D	RLG	I39L	C1510
6	YPL10002	2.0D	WG	I39L	S/JOINT SJ45

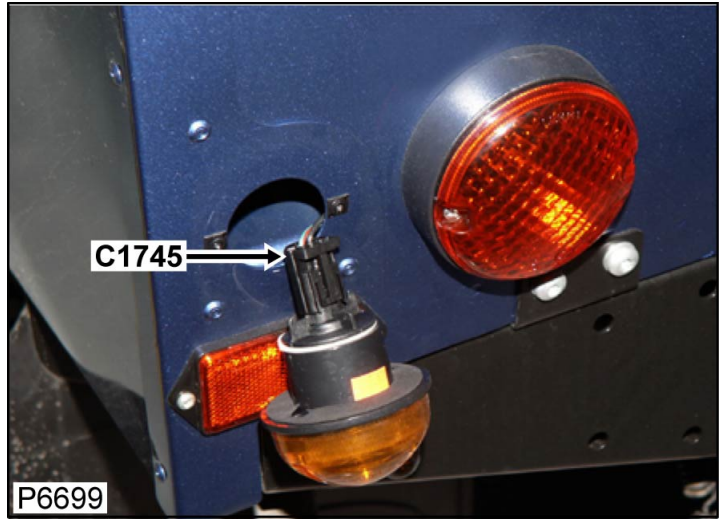
Description: **Turn signal indicator/ hazard flasher lamp-Rear-LH**

Cavities: **2WY**

Harness: **CHASSIS HARNESS**

CAV	TERMINAL	CSA	COL	CCT	DESTN
1	AFU3802	1.5D	B	772	S/JOINT SJ1
1	AFU3802	1.5D	B	985	S/JOINT SJ1
2	AFU3802	1.5D	GR	772	S/JOINT SJ22
2	AFU3802	1.5D	GR	985	S/JOINT SJ7

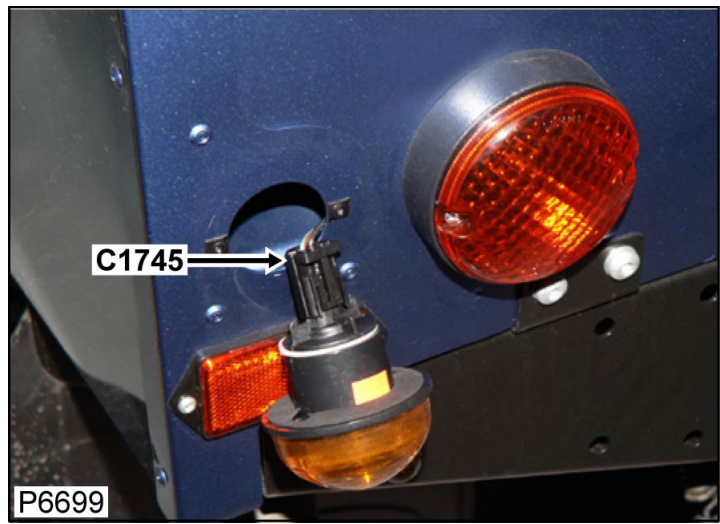
Description: **Turn signal indicator/ hazard flasher lamp-Rear-LH**

Cavities: **2WY**

Harness: **CHASSIS HARNESS**

CAV	TERMINAL	CSA	COL	CCT	DESTN
1	AFU3802	1.5D	B	772	S/JOINT SJ1
1	AFU3802	1.5D	B	985	S/JOINT SJ1
2	AFU3802	1.5D	GR	772	S/JOINT SJ22
2	AFU3802	1.5D	GR	985	S/JOINT SJ7

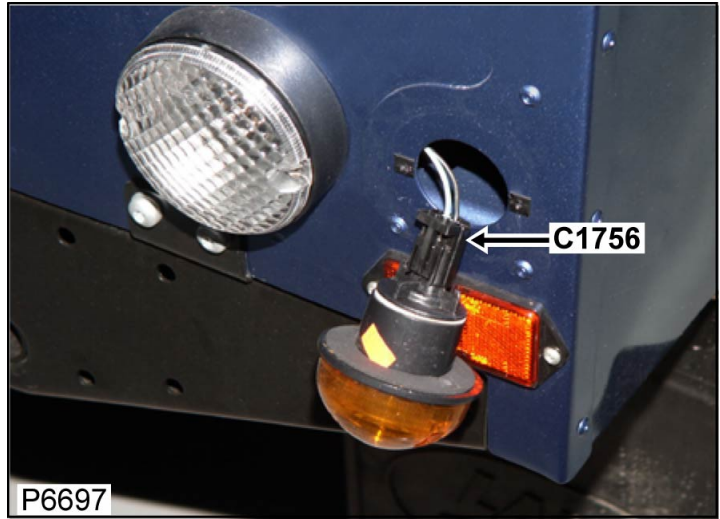
Description: **Turn signal indicator/ hazard flasher lamp-Rear-RH**

Cavities: **2WY**

Harness: **CHASSIS HARNESS**

CAV	TERMINAL	CSA	COL	CCT	DESTN
1	AFU3802	1.5D	B	772	S/JOINT SJ26
1	AFU3802	1.5D	B	985	S/JOINT SJ4
2	AFU3802	1.5D	GW	772	S/JOINT SJ25
2	AFU3802	1.5D	GW	985	S/JOINT SJ6

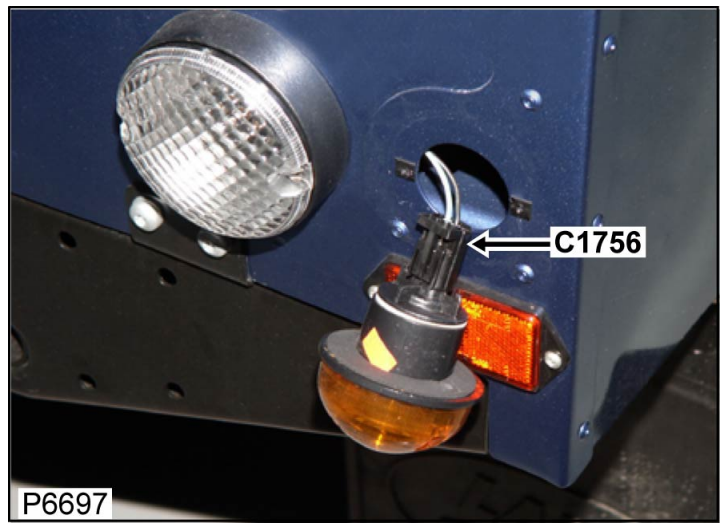
Description: **Turn signal indicator/ hazard flasher lamp-Rear-RH**

Cavities: **2WY**

Harness: **CHASSIS HARNESS**

CAV	TERMINAL	CSA	COL	CCT	DESTN
1	AFU3802	1.5D	B	772	S/JOINT SJ26
1	AFU3802	1.5D	B	985	S/JOINT SJ4
2	AFU3802	1.5D	GW	772	S/JOINT SJ25
2	AFU3802	1.5D	GW	985	S/JOINT SJ6

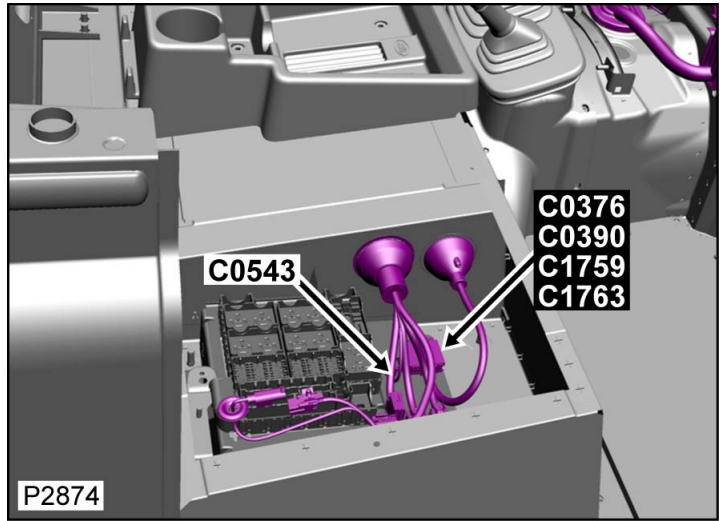
Location: **Beneath RH Front seat**

Part No.: **YPC803300**

Colour: **GREY**

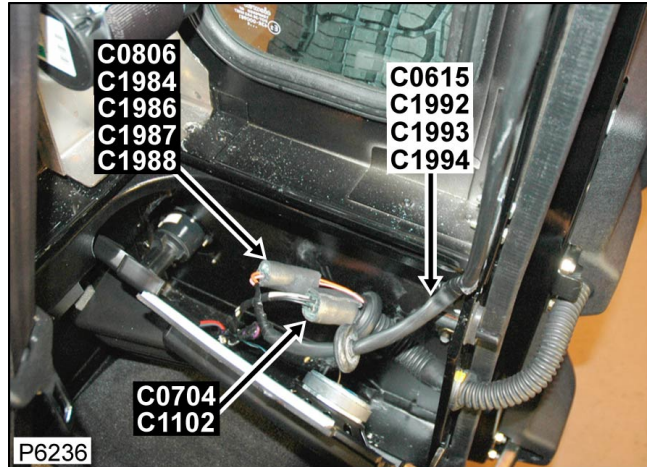
Location: **Base of 'D' post RH side**

CAV	TERMINAL	CSA	COL	CCT	DESTN
1	YPLI0027	1.5D	K	907	C0259
2	YPLI0027	1.5D	O	907	C0259

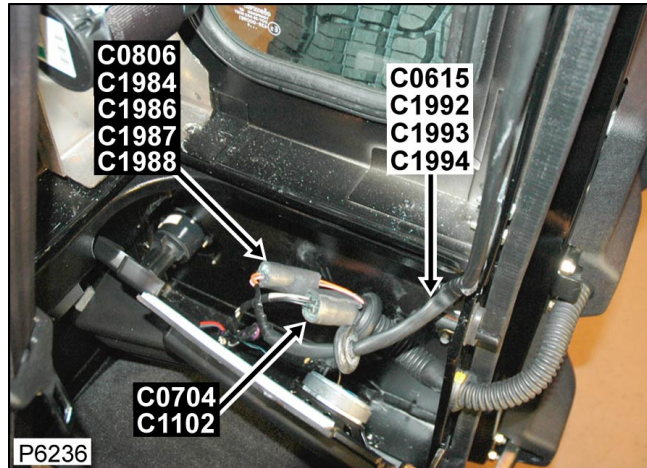
Location: **Base of 'D' post RH side**

CAV	TERMINAL	CSA	COL	CCT	DESTN
1	YPLI0027	1.5D	K	905	C0259
2	YPLI0027	1.5D	O	905	C0259

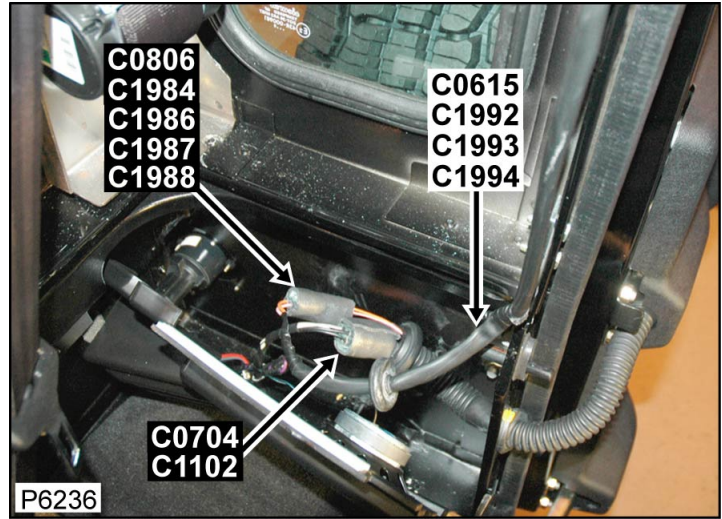
Location: **Base of 'D' post RH side**

CAV	TERMINAL	CSA	COL	CCT	DESTN
1	DBP8550	0.5D	K	767	C0617
2	DBP8550	0.5D	O	767	C0617

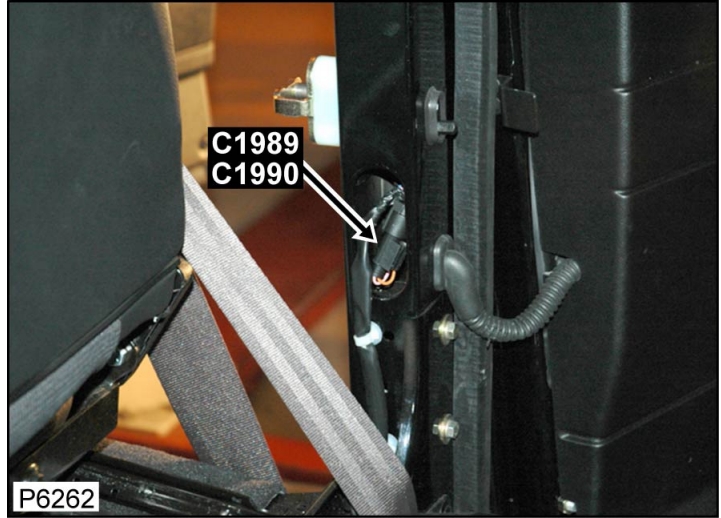
Harness: **C/POST ASSY REAR SIDE DOORS HARNESS**

CAV	TERMINAL	CSA	COL	CCT	DESTN
1	YPL101500	0.5D	O	767	S/JOINT SJ5
2	YPL101500	0.5D	K	767	S/JOINT SJ6

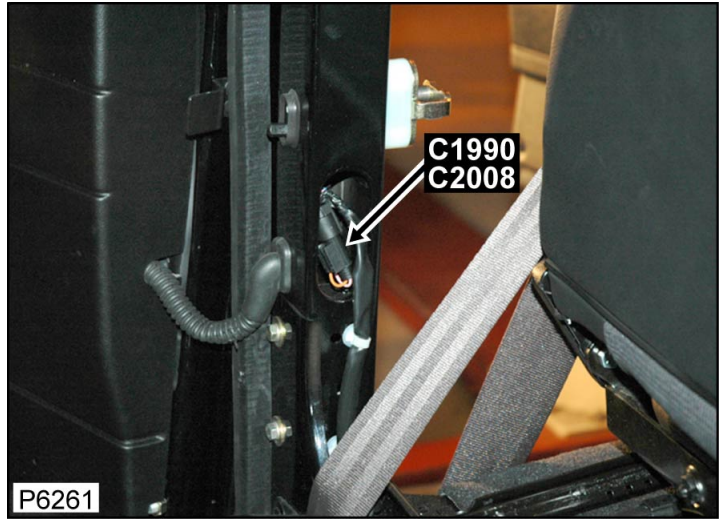
Harness: **REAR DOOR HARNESS**

CAV	TERMINAL	CSA	COL	CCT	DESTN
1	YPJ100640	0.75D	O	499	C1996
2	YPJ100640	0.75D	K	499	C1996

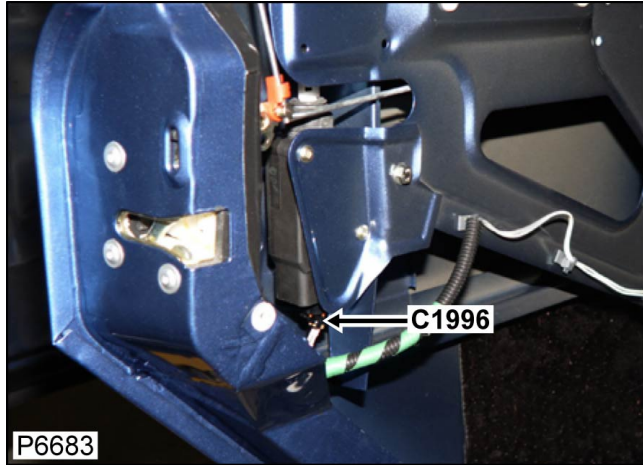
Location: **Behind rear door trim panel**

CAV	TERMINAL	CSA	COL	CCT	DESTN
1	YPL000080	0.75D	O	499	C1990
2	YPL000080	0.75D	K	499	C1990

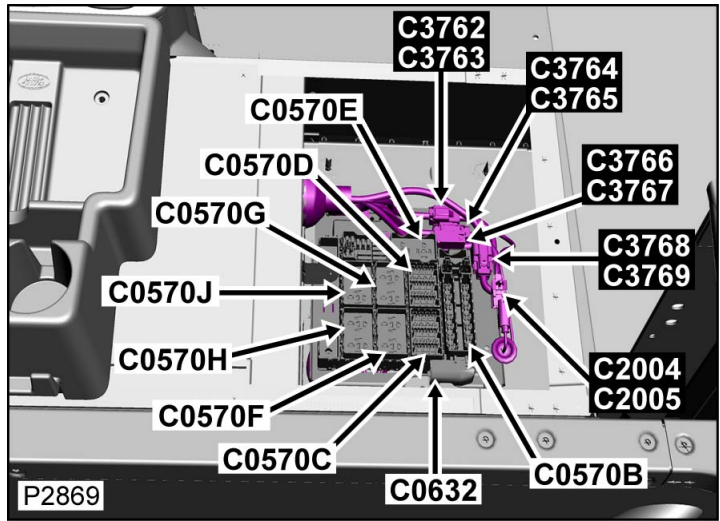
Location: **Beneath RH Front seat**

CAV	TERMINAL	CSA	COL	CCT	DESTN
1	AFU3753	1.0D	K	767	S/JOINT SJ6
2	AFU3753	1.0D	PU	499	S/JOINT SJ1
3	AFU3753	1.0D	O	767	S/JOINT SJ5

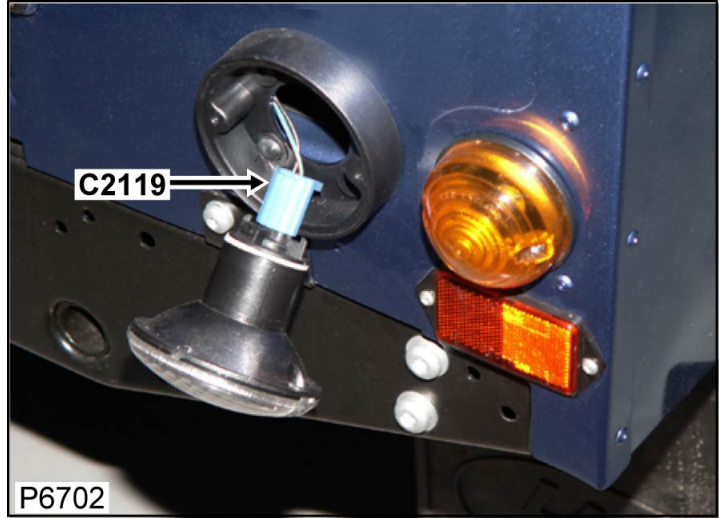
Harness: **CHASSIS HARNESS**

CAV	TERMINAL	CSA	COL	CCT	DESTN
1	AFU3802	1.5D	B	771	S/JOINT SJ3
1	AFU3802	1.5D	B	770	S/JOINT SJ2
2	AFU3802	1.5D	S	770	C0390
2	AFU3802	1.5D	S	771	C1759

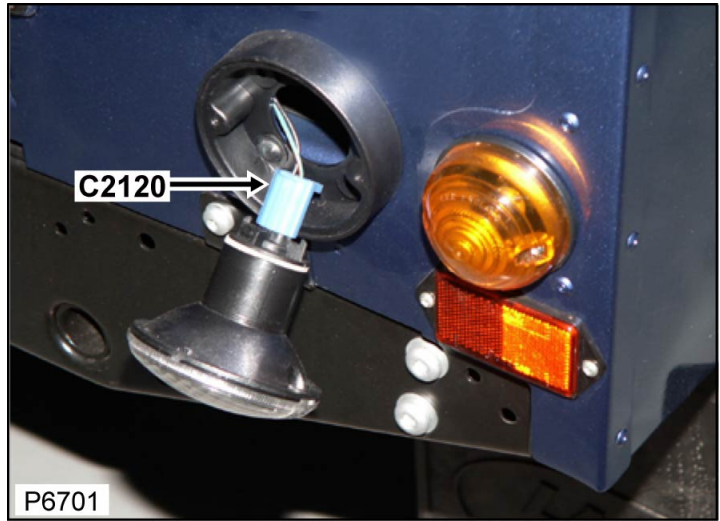
Harness: **CHASSIS HARNESS**

CAV	TERMINAL	CSA	COL	CCT	DESTN
1	AFU3802	2.0D	B	772	S/JOINT SJ26
1	AFU3802	2.0D	B	985	S/JOINT SJ4
2	AFU3802	1.5D	S	772	C1763
2	AFU3802	1.5D	S	985	C1759

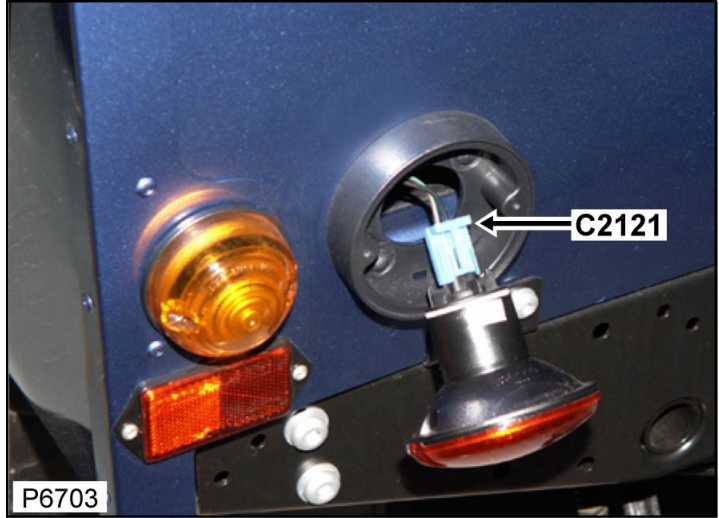
Harness: **CHASSIS HARNESS**

CAV	TERMINAL	CSA	COL	CCT	DESTN
1	AFU3802	1.5D	B	772	C0139
1	AFU3802	1.5D	B	985	C0139
2	AFU3802	1.5D	W	772	C1763
2	AFU3802	1.5D	W	985	C1759

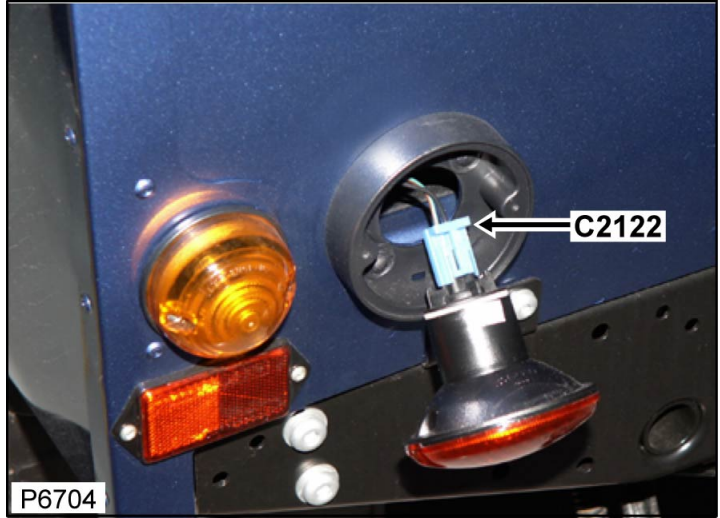
Harness: **CHASSIS HARNESS**

CAV	TERMINAL	CSA	COL	CCT	DESTN
1	AFU3802	1.5D	B	771	S/JOINT SJ28
1	AFU3802	1.5D	B	770	S/JOINT SJ27
2	AFU3802	1.5D	W	770	C0390
2	AFU3802	1.5D	W	771	C1759

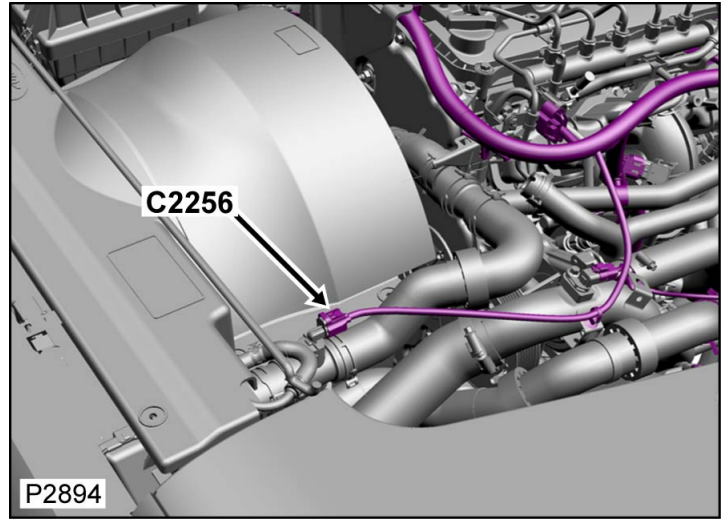
Harness: **ENGINE DIESEL HARNESS**

CAV	TERMINAL	CSA	COL	CCT	DESTN
1	YPL801120	0.5	Y	254	C0411
2	YPL801120	0.5	NG	254	C0411

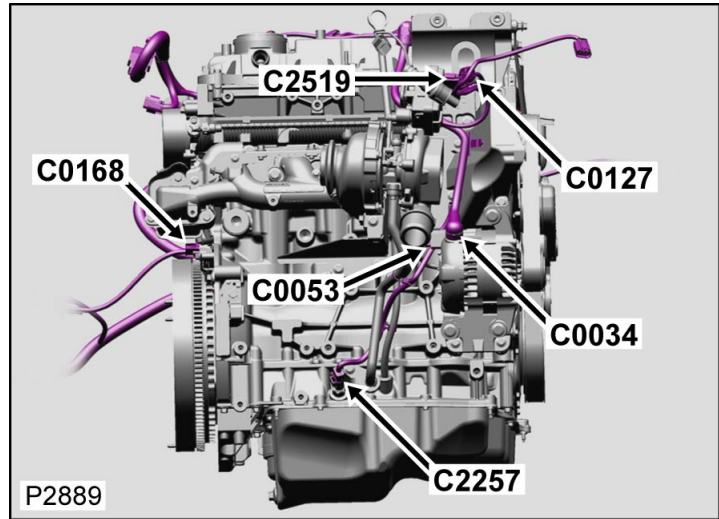
Location: **RH side of engine**

CAV	TERMINAL	CSA	COL	CCT	DESTN
1	YPL902720	0.75	GP	254	C0411
2	YPL902720	0.75	NY	254	C0411
3	YPL902720	0.75	OS	254	C0411

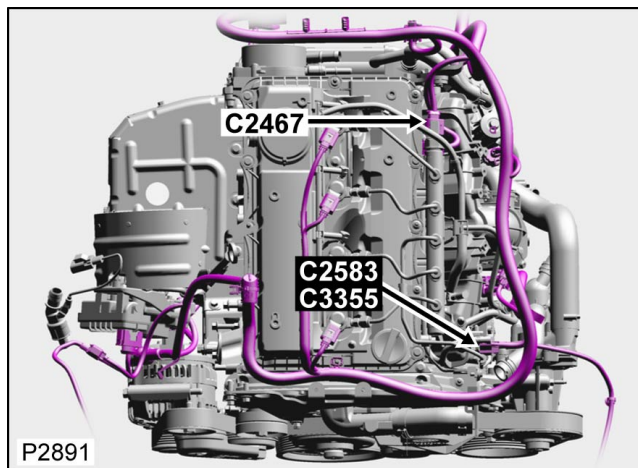
Harness: **ENGINE DIESEL HARNESS**

CAV	TERMINAL	CSA	COL	CCT	DESTN
1	YPLI02230	0.75	OU	254	C0411
2	YPLI02230	0.75	UN	254	C0411
3	YPLI02230	0.75	NU	254	C0411

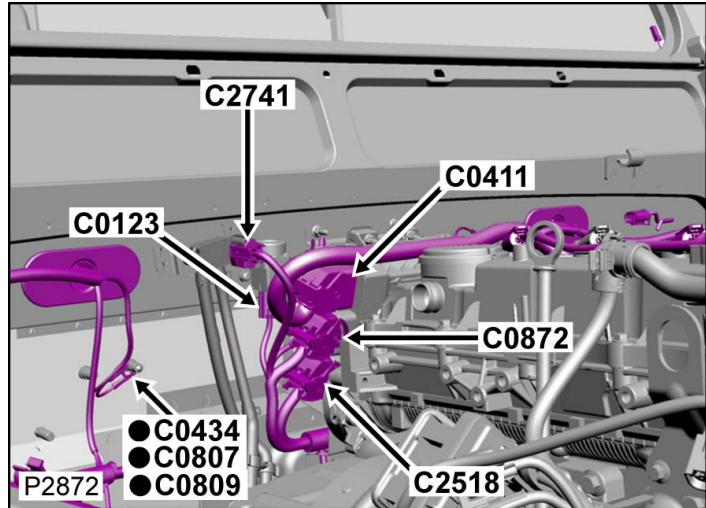
Harness: **MAIN LH + RH HARNESS**

CAV	TERMINAL	CSA	COL	CCT	DESTN
3	YPL802000	1.0D	W	254	C1559
6	YPL801990	0.75D	OY	254L	C2870L
6	YPL801990	0.75D	OY	254R	C2870R
8	YPLI04080	0.5D	R	254	C2741
9	YPLI04080	0.5D	PS	254	C0448
11	YPLI04080	0.5D	GN	254L	C2870L
11	YPLI04080	0.5D	GN	254R	C2870R
13	YPLI04080	0.5D	SU	254	C1559
14	YPLI04080	0.5D	R	254	C1559
15	YPLI04080	0.5D	U	254	C0448
16	YPLI04080	0.5D	Y	254	C1559
19	YPLI04080	0.5D	RO	254	C3693
20	YPLI04080	0.75D	O	499	C2518
22	YPLI04080	0.5D	RU	254	C3691
24	YPLI04080	0.5D	YP	254	C0448
27	YPLI04080	0.5D	B	254	C1559

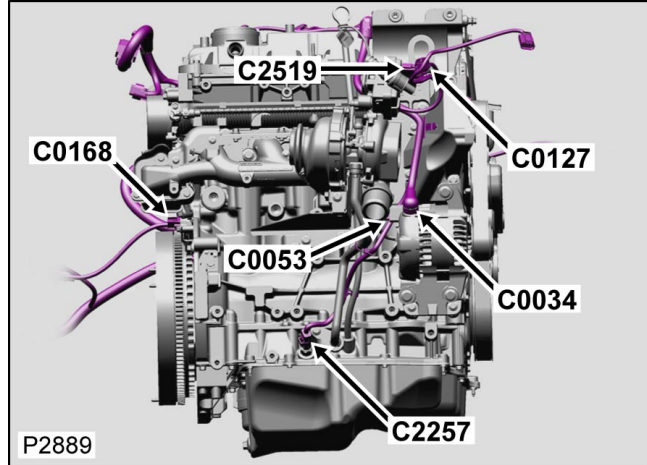
Cavities: **5WY**

Harness: **ENGINE DIESEL HARNESS**

CAV	TERMINAL	CSA	COL	CCT	DESTN
1	YPLI02230	0.75	W	VNT	C0411
2	YPLI02230	0.75	U	VNT	C0411
3		0.5	GW	VNT	C0411
4		0.5	PN	VNT	C0411
5		0.5	WO	VNT	C0411

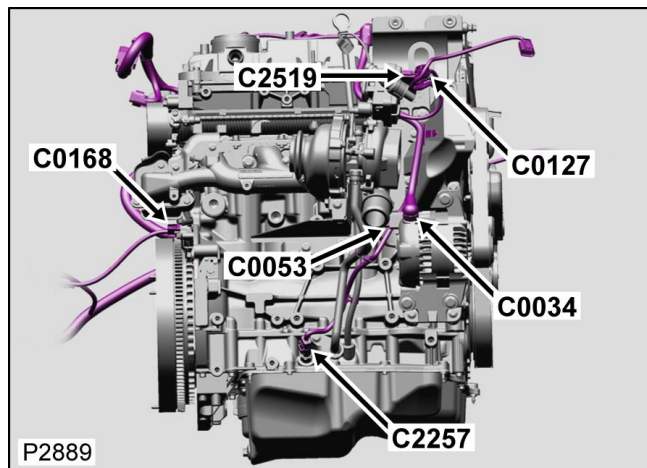
Cavities: **5WY**

Harness: **ENGINE DIESEL HARNESS**

CAV	TERMINAL	CSA	COL	CCT	DESTN
1	YPLI02230	0.75	W	VNT	C0411
2	YPLI02230	0.75	U	VNT	C0411

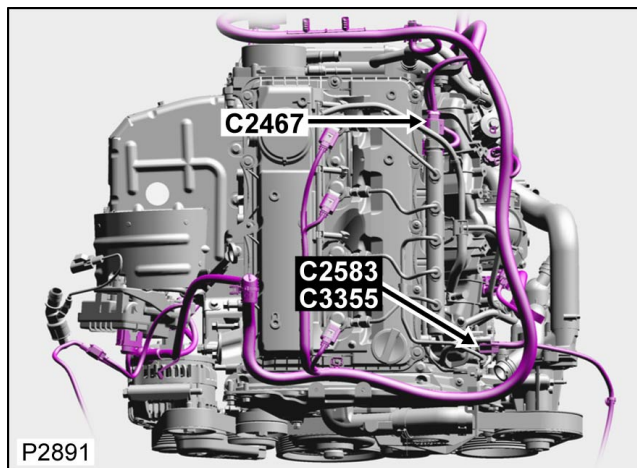
Location: **Top of engine - LH side**

CAV	TERMINAL	CSA	COL	CCT	DESTN
A		2.5	SP	254	C0189
B		2.5	UN	254	C0189
C		2.5	PW	254	C0189
D		2.5	YU	254	C0189

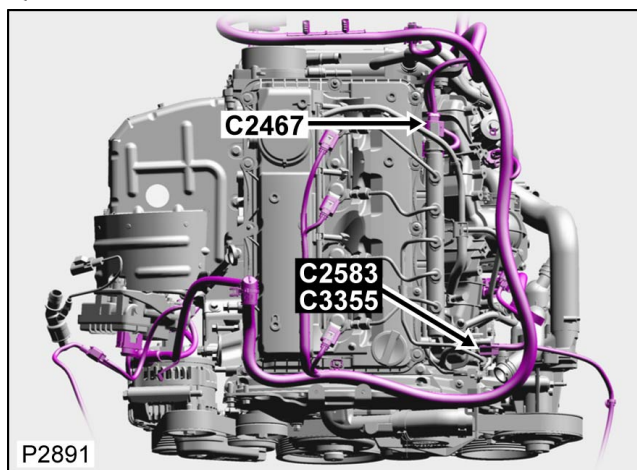
Location: **Top of engine - LH side**

CAV	TERMINAL	CSA	COL	CCT	DESTN
A		2.5	SP	254	C0189
B		2.5	UN	254	C0189

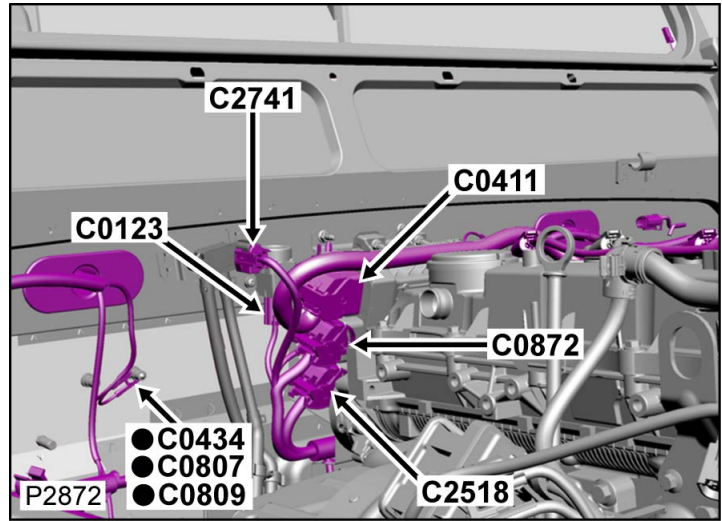
Location: **Rear RH side of engine compartment**

CAV	TERMINAL	CSA	COL	CCT	DESTN
1	YPL500560	0.5D	R	254	C2518
2	YPL500570	0.75D	B	254	C2518
3	YPL500560	0.5D	U	254	C2518

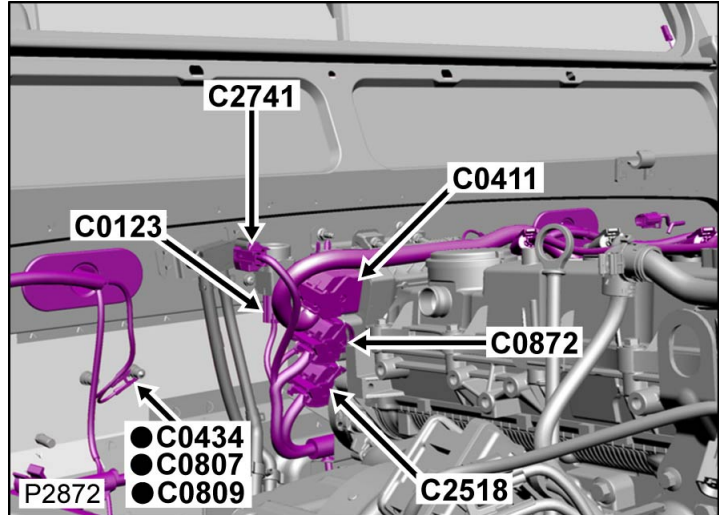
**Cavities: 3WY**

**Harness: MAIN LH + RH HARNESS**

CAV	TERMINAL	CSA	COL	CCT	DESTN
1	YPL500560	0.5D	R	254	C2518
2	YPL500570	0.75D	B	254	C2518
3	YPL500560	0.5D	U	254	C2518

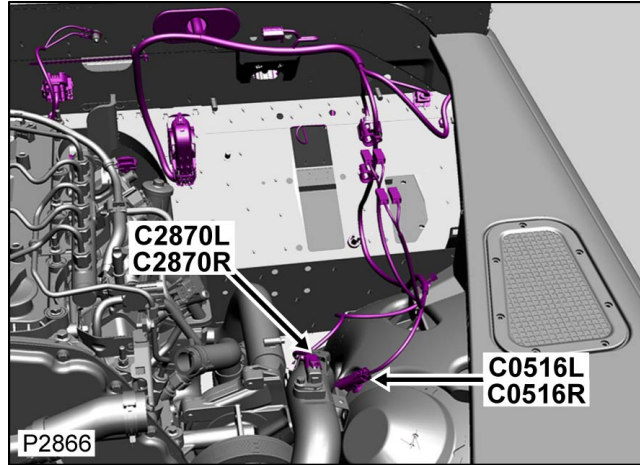
Location: **LH side of engine compartment**

CAV	TERMINAL	CSA	COL	CCT	DESTN
1	YPL905580	0.5D	GN	254L	C2518
2	YPL905580	0.75D	OY	254L	C2518

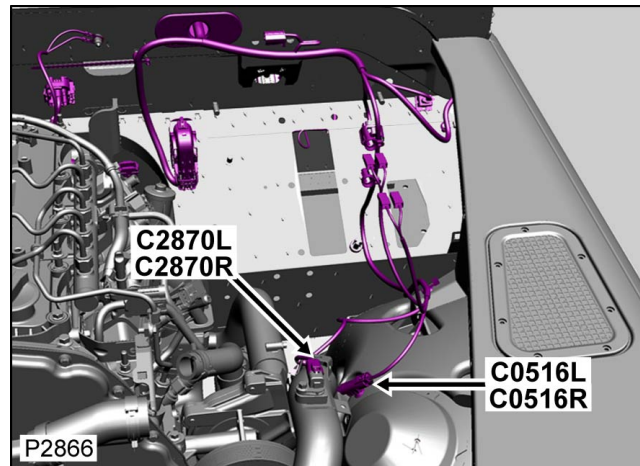
Location: **LH side of engine compartment**

CAV	TERMINAL	CSA	COL	CCT	DESTN
1	YPL905580	0.5D	GN	254L	C2518
2	YPL905580	0.75D	OY	254L	C2518

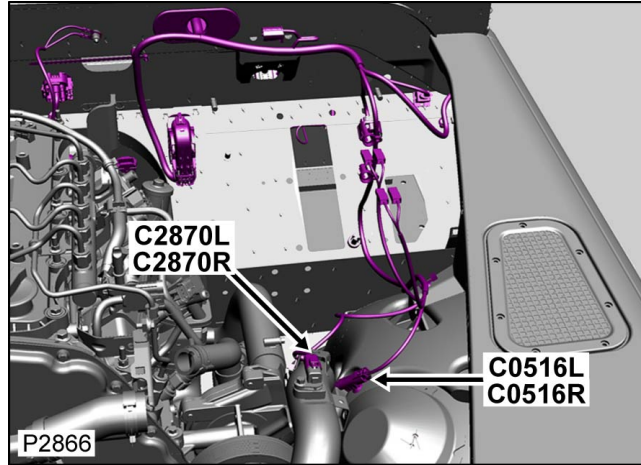
Location: **LH side of engine compartment**

CAV	TERMINAL	CSA	COL	CCT	DESTN
1	YPL905580	0.5D	GN	254R	C2518
2	YPL905580	0.75D	OY	254R	C2518

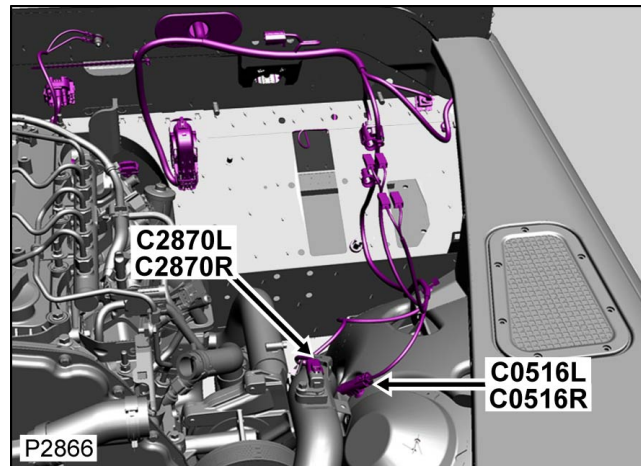
Location: **LH side of engine compartment**

CAV	TERMINAL	CSA	COL	CCT	DESTN
1	YPL905580	0.5D	GN	254R	C2518
2	YPL905580	0.75D	OY	254R	C2518

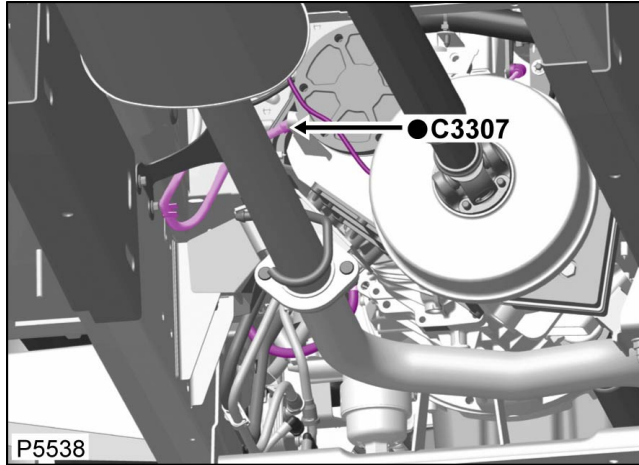
Cavities: **IWY**

Harness: **BATTERY NEGATIVE HARNESS**

CAV	TERMINAL	CSA	COL	CCT	DESTN
I	-	50.0D	B	499	CI66I

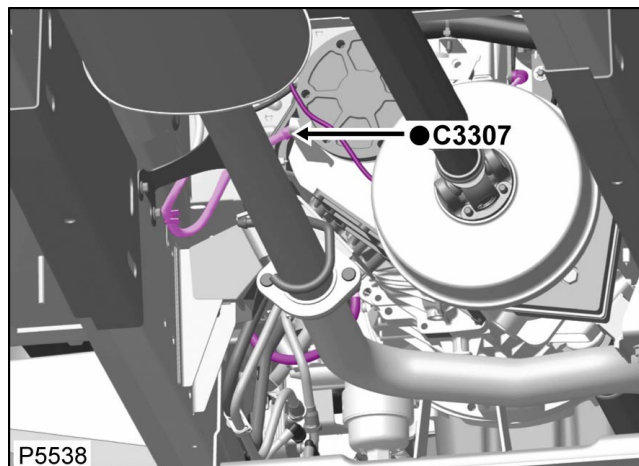
Cavities: **IWY**

Harness: **BATTERY NEGATIVE HARNESS**

CAV	TERMINAL	CSA	COL	CCT	DESTN
I	-	50.0D	B	499	CI66I

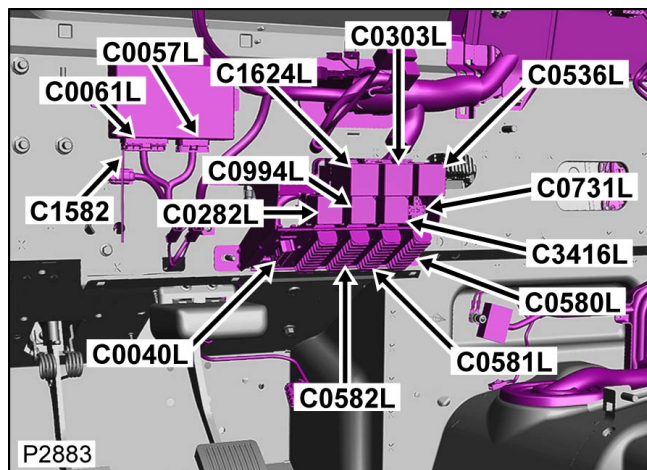
Location: **Behind LH side of Instrument panel**

Qualifier: **LHD condition illustrated**

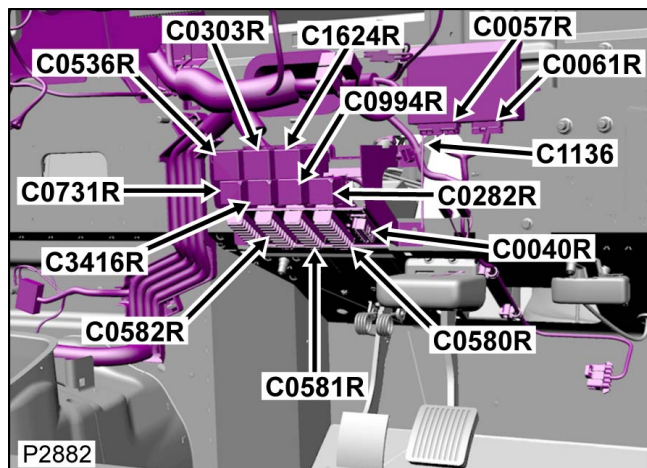
Location: **Behind RH side of Instrument panel**

Qualifier: **RHD condition illustrated**

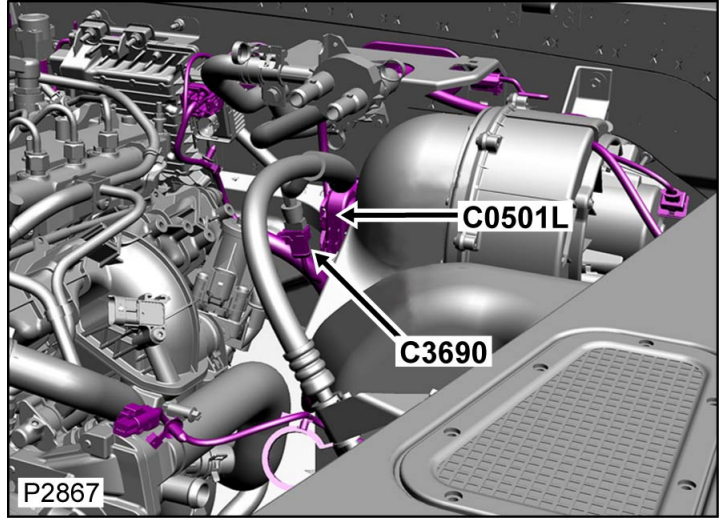
Description: **Sensor-Pressure-Air Conditioning**

Location: **Rear LH side of engine compartment**

CAV	TERMINAL	CSA	COL	CCT	DESTN
1	YPL102660	0.75D	B	14	C0872
2	YPL102660	0.75D	U	14	C0872
3	YPL102660	0.75D	R	14	C0872

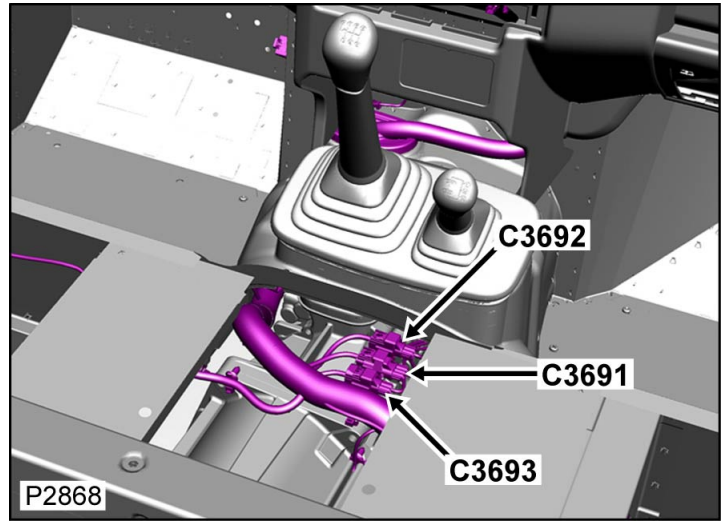
Cavities: **3WY**

Harness: **MAIN LH + RH HARNESS**

CAV	TERMINAL	CSA	COL	CCT	DESTN
1	YPL500530	0.5D	RU	254	C2518
3	YPL500530	0.5D	B	254	C2518

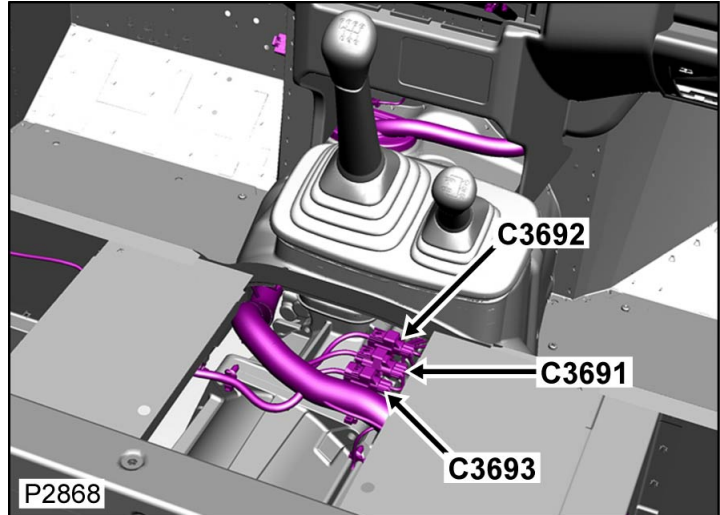
**Cavities: 3WY**

**Harness: MAIN LH + RH HARNESS**

CAV	TERMINAL	CSA	COL	CCT	DESTN
1	YPL500530	0.5D	RU	254	C2518
3	YPL500530	0.5D	B	254	C2518

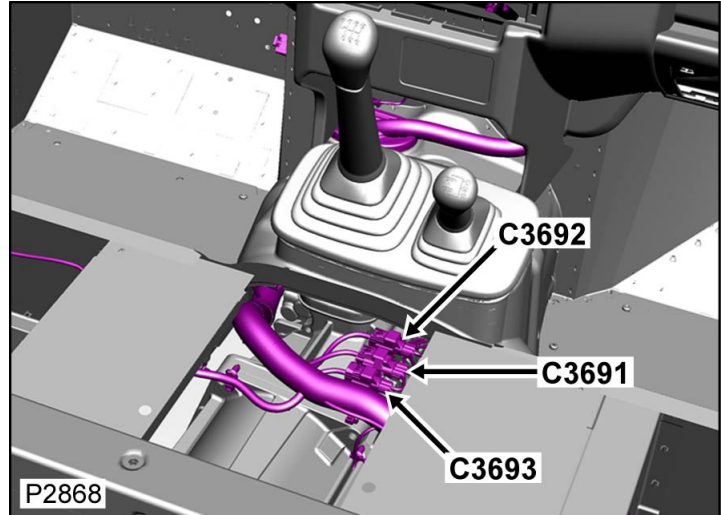
**Cavities: 2WY**

**Harness: MAIN LH + RH HARNESS**

CAV	TERMINAL	CSA	COL	CCT	DESTN
1	YPL500530	0.5D	RB	254	C2518
2	YPL500530	0.5D	B	254	C2518

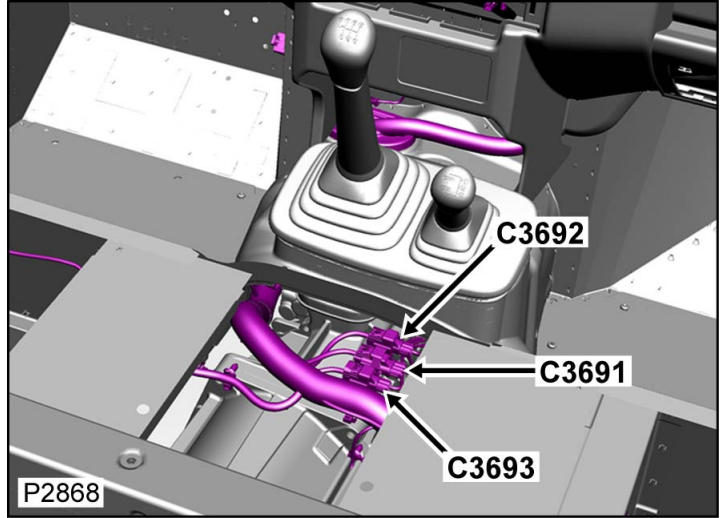
Location: **Above gearbox**

CAV	TERMINAL	CSA	COL	CCT	DESTN
1	YPL500530	0.5D	RO	254	C2518
2	YPL500530	0.5D	B	254	C2518

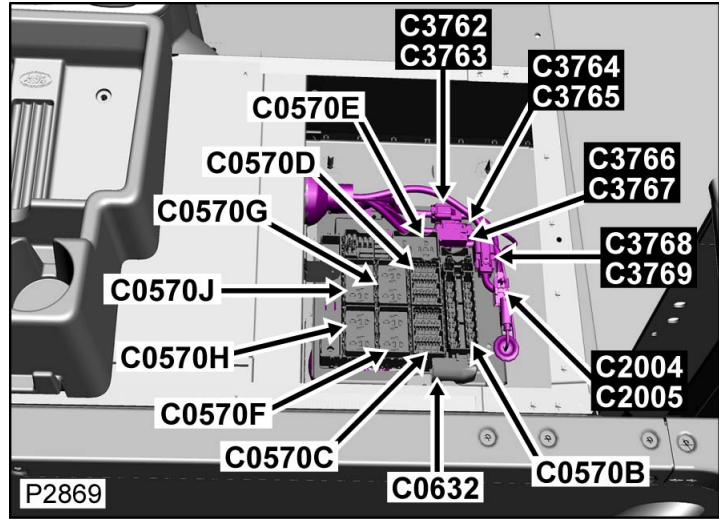
Cavities: **4WY**

Harness: **MAIN LH + RH HARNESS**

CAV	TERMINAL	CSA	COL	CCT	DESTN
1	YPL901130	2.5D	NW	9	C0501L
1	YPL901130	2.5D	NW	10	C0501R
2	YPL901140	4.0D	NR	9	C0501L
2	YPL901140	4.0D	BR	10	C0501R
3	YPL901020	6.0D	NW	139L	C0028L
3	YPL901020	6.0D	NW	200R	C0028R
4	YPL901020	6.0D	YR	499	C0190

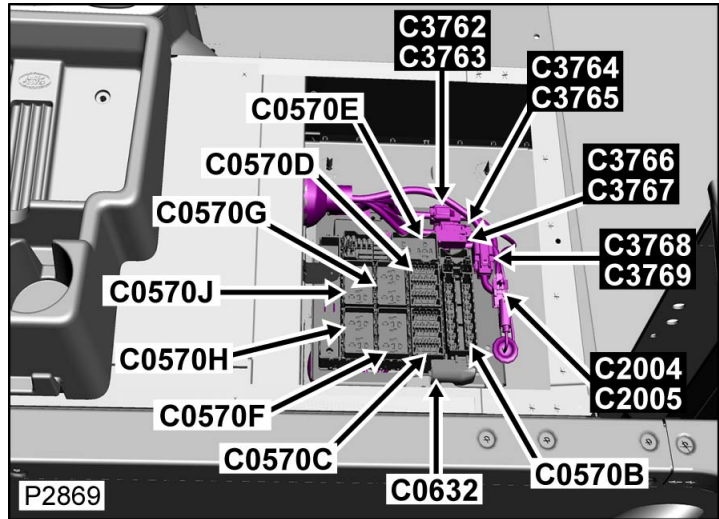
**Cavities: 4WY**

**Harness: MAIN LH + RH HARNESS**

CAV	TERMINAL	CSA	COL	CCT	DESTN
1	YPL901130	2.5D	NW	9	C0501L
1	YPL901130	2.5D	NW	10	C0501R
2	YPL901140	4.0D	NR	9	C0501L
2	YPL901140	4.0D	BR	10	C0501R
3	YPL901020	6.0D	NW	139L	C0028L
3	YPL901020	6.0D	NW	200R	C0028R
4	YPL901020	6.0D	YR	499	C0190

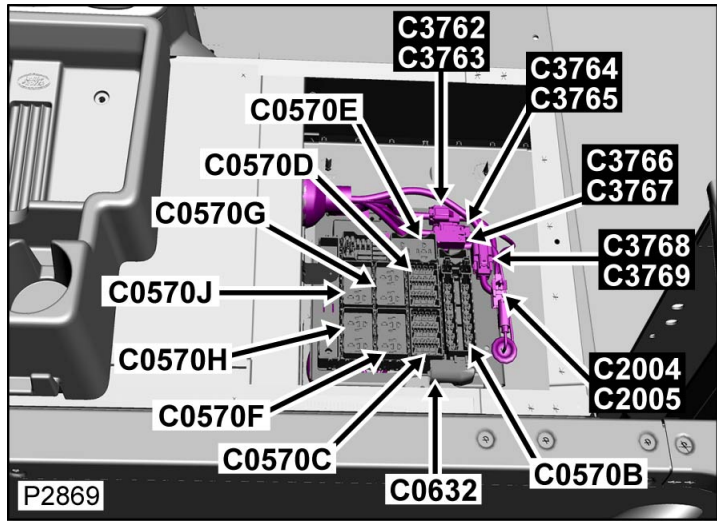
Location: **Beneath RH Front seat**

CAV	TERMINAL	CSA	COL	CCT	DESTN
1	YPJ900160	2.5D	NW	I	C0570C
2	YPJ900170	4.0D	BR	I	C0570B
3	YPJ900530	6.0D	NW	499	C0570B
4	YPJ900530	6.0D	YR	499	C0570B
