DEFENDER - VIN: 412051 >

Electrical Reference Library (1a)

JLR 16 25 21\_IE

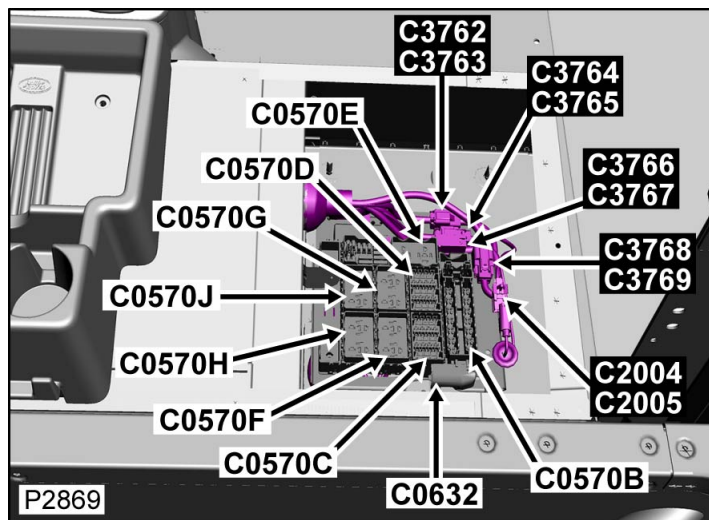
**Location: Beneath RH Front seat**

CAV	TERMINAL	CSA	COL	CCT	DESTN
1	YPJ900160	2.5D	NW	I	C0570C
2	YPJ900170	4.0D	BR	I	C0570B
3	YPJ900530	6.0D	NW	499	C0570B
4	YPJ900530	6.0D	YR	499	C0570B

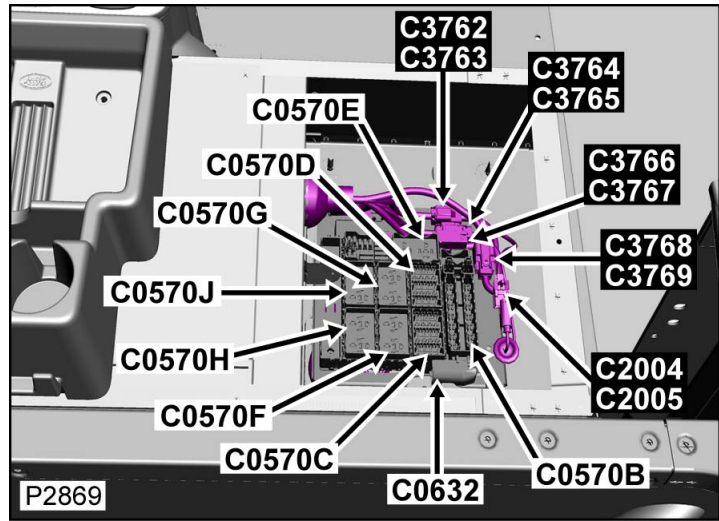
Cavities: **8WY**

Harness: **MAIN LH + RH HARNESS**

CAV	TERMINAL	CSA	COL	CCT	DESTN
1	YPL500450	2.5D	NU	200R	C0041
1	YPL500450	2.5D	NU	139L	C1082
2	YPL500450	2.5D	NP	766L	C0994L
2	YPL500450	2.5D	NP	766R	C0994R
3	YPL500450	2.5D	BG	14	C0280A
4	YPL500450	2.5D	NO	499	S/JOINT SJ30
5	YPL500450	2.5D	NS	254	C0376
6	YPL500450	2.5D	NR	499	C0448
7	YPL500450	2.5D	U	200R	C0041
7	YPL500450	2.5D	U	139L	C1082
8	YPL500450	2.5D	UR	139L	C0282L
8	YPL500450	2.5D	UR	200R	C0282R

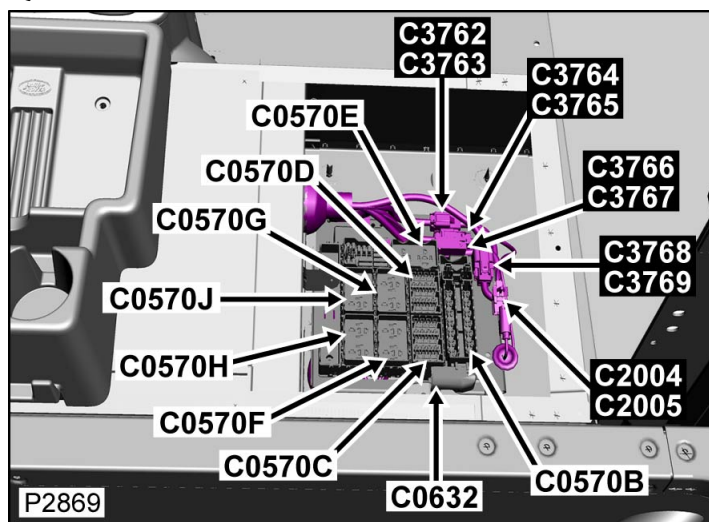
**Cavities: 8WY**

**Harness: MAIN LH + RH HARNESS**

CAV	TERMINAL	CSA	COL	CCT	DESTN
1	YPL500450	2.5D	NU	200R	C0041
1	YPL500450	2.5D	NU	139L	C1082
2	YPL500450	2.5D	NP	766L	C0994L
2	YPL500450	2.5D	NP	766R	C0994R
3	YPL500450	2.5D	BG	14	C0280A
4	YPL500450	2.5D	NO	499	S/JOINT SJ30
5	YPL500450	2.5D	NS	254	C0376
6	YPL500450	2.5D	NR	499	C0448
7	YPL500450	2.5D	U	200R	C0041
7	YPL500450	2.5D	U	139L	C1082
8	YPL500450	2.5D	UR	139L	C0282L

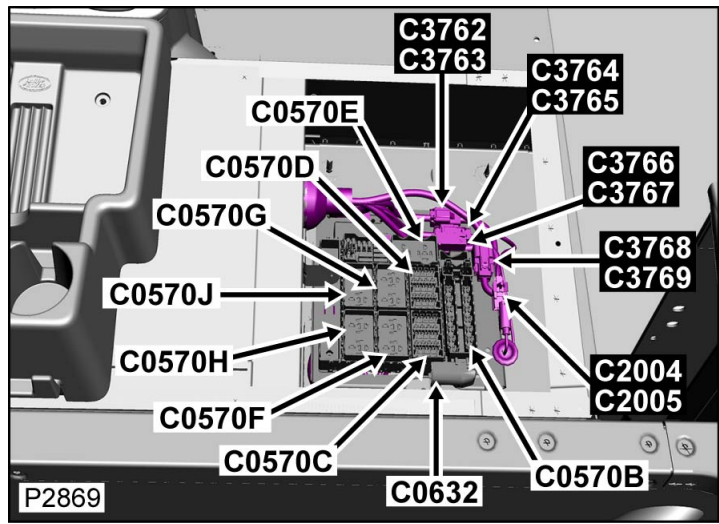
**Cavities: 8WY**

**Harness: ENGINE COMPARTMENT FUSE BOX HARNESS**

CAV	TERMINAL	CSA	COL	CCT	DESTN
1	YPJ500310	2.5D	NU	499	S/JOINT SJ3
2	YPJ500310	2.5D	NP	766	C0570C
3	YPJ500310	2.5D	BG	14	C0570J
4	YPJ500310	2.5D	NO	499	C0570H
5	YPJ500310	2.5D	NS	254	C0570G
6	YPJ500310	2.5D	NR	499	C0570G
7	YPJ500310	2.5D	U	499	C0570J
8	YPJ500310	2.5D	UR	499	C0570J

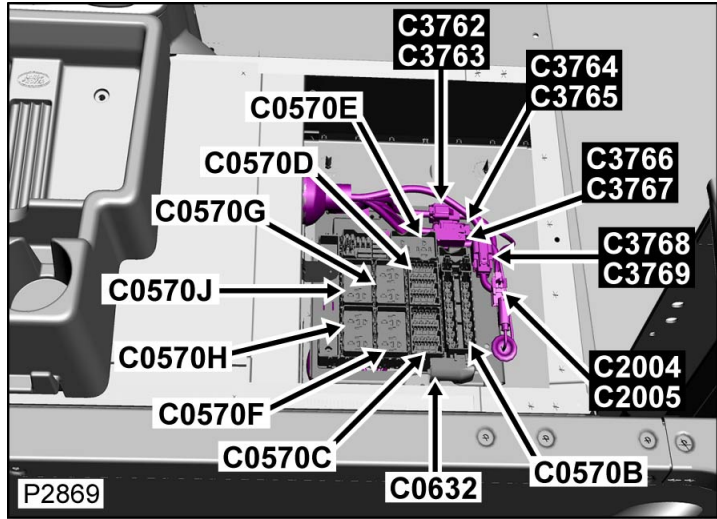
Cavities: **24WY**

Harness: **MAIN LH + RH HARNESS**

CAV	TERMINAL	CSA	COL	CCT	DESTN
1	YPL500450	2.5D	NK	139L	C0582L
1	YPL500450	2.5D	NK	200R	C0582R
2	YPL500360	0.5D	RG	499	S/JOINT SJ70
3	YPL500360	0.5D	WG	254	C0195
4	YPL500360	0.5D	UB	14	C0872
5	YPL500360	0.5D	RB	254	S/JOINT SJ71
6	YPL500360	0.5D	WB	499	C0285
7	YPL500360	0.75D	BO	499	C0872
8	YPL500510	1.0D	G	254	S/JOINT SJ31
9	YPL500510	1.0D	RG	254	S/JOINT SJ17
10	YPL500510	1.0D	LGP	254	C0163
12	YPL500520	1.5D	WB	499	C0376
13	YPL500450	2.5D	P	499	C0376

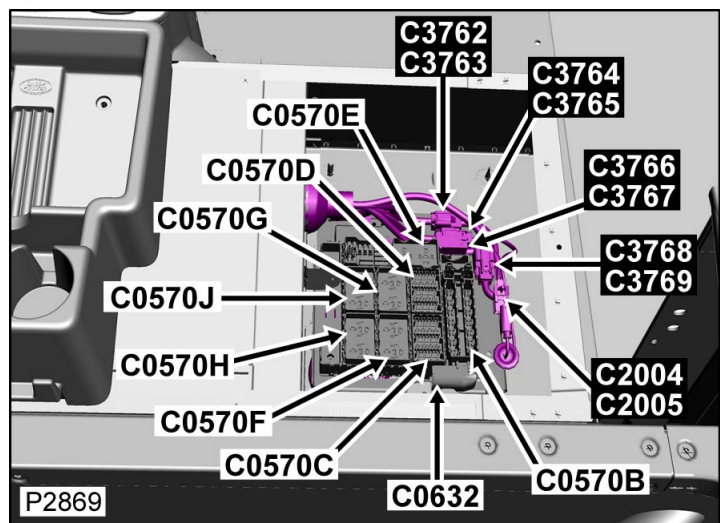
**Location: Beneath RH Front seat**

CAV	TERMINAL	CSA	COL	CCT	DESTN
I	YPL500450	2.5D	NK	I39L	C0582L

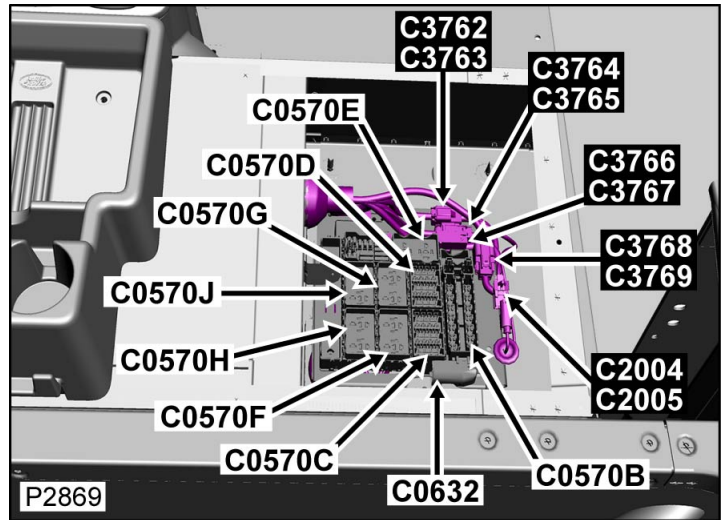
**Location: Beneath RH Front seat**

**Part No.: YPC803290**

**Colour: BLACK**

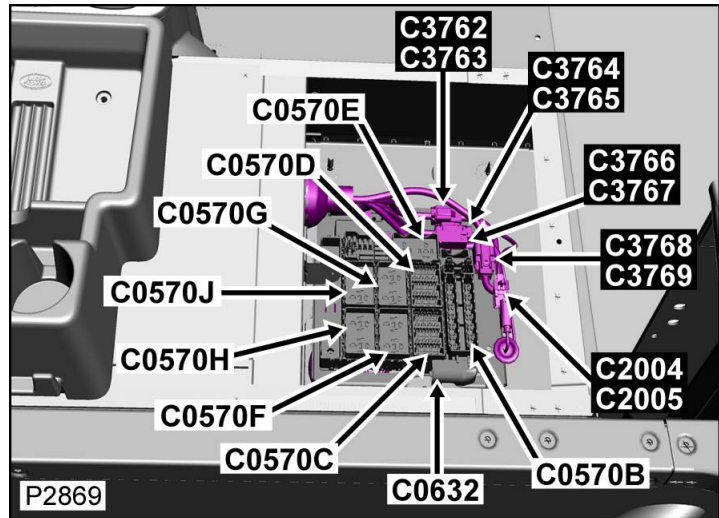
Location: **Beneath RH Front seat**

CAV	TERMINAL	CSA	COL	CCT	DESTN
1	YPJ900210	4.0D	WR	200R	C0090R
1	YPJ900210	4.0D	WR	139L	C0090L
2	YPJ900210	4.0D	NR	247L	C3416L
2	YPJ900210	4.0D	NR	247R	C3416R
2	YPJ900210	4.0D	NR	95L	C3416L
2	YPJ900210	4.0D	NR	95R	C3416R
3	YPJ900210	4.0D	N	139L	C0580L
3	YPJ900210	4.0D	N	200R	C0580R
4	YPJ900210	4.0D	W	139L	S/JOINT SJ3
4	YPJ900210	4.0D	W	200R	S/JOINT SJ4
